Provision of Environmental Team consultancy for Design and Construction of Kong Nga Po Police Training Facilities (Programme no. 279LP) Quotation No. PMB202/8480/2022/A01/A
Submission of monthly EM&A report in March 2024

**Provision of Independent Environmental Checker Consultancy for Design
and Construction of Kong Nga Po Police Training Facilities
Verification of Monthly EM&A Report (March 2024)**

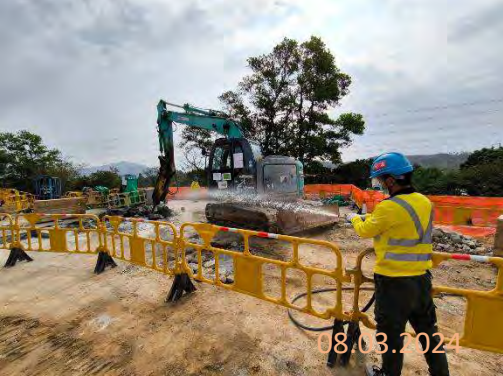
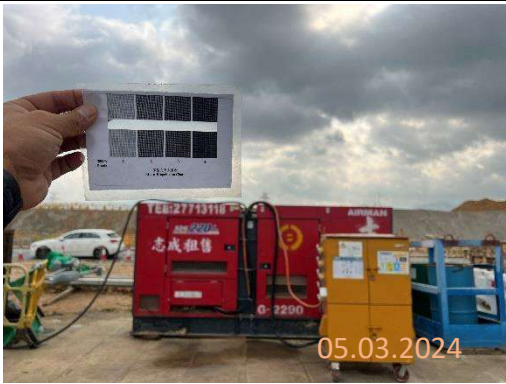
Ref*	Proposed Construction Method	Location/Working Period	Anticipated Major Impacts	Recommended Mitigation Measures	Photo Records (Partial)
EIA 3.9.1; EM&A Log 2.2	Open cut excavation	Kong Nga Po Site	Dust impact	<ul style="list-style-type: none"> • Manual water spraying for dust suppression • Regular inspection and maintenance of plant and equipment in good condition • Cover stockpile with impervious sheets or grout • Provide wheel washing facility at site entrance

<p>By main contractor at KNP site</p>

By main contractor at KNP site

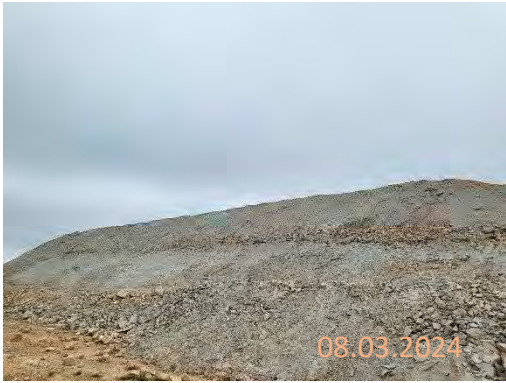
By subcontractor at KNP site

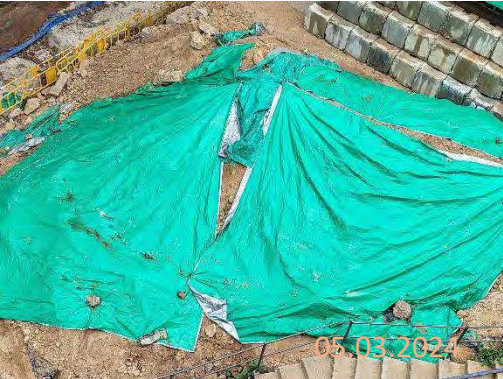
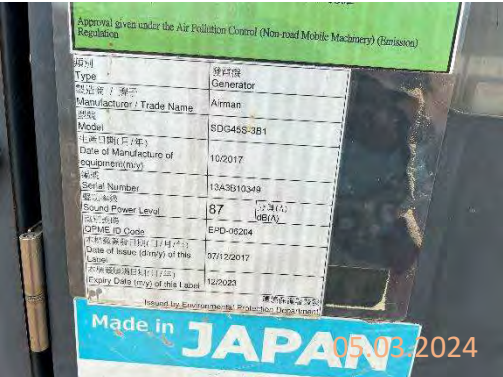
<p>By main contractor at KNP site</p>
<p>EIA 4.4.6; EM&A Log 3.2</p>			<p>Noise</p>	<ul style="list-style-type: none"> Regular inspection and maintenance of plant & equipment in good condition Deploy Quality Powered Mechanical Equipment (QPME) if possible Valid construction noise permit should be displayed at site entrance.

<p>By main contractor at KNP site</p>

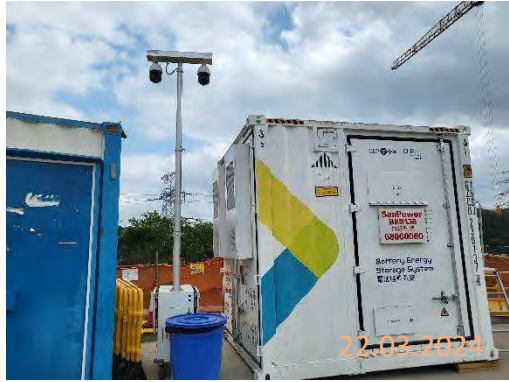
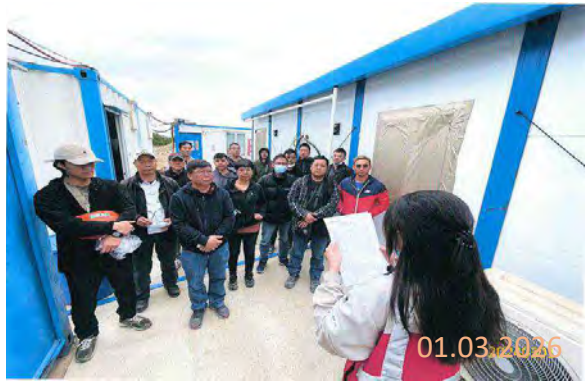
<p data-bbox="1541 639 1939 671">By main contractor at KNP site</p>
<p data-bbox="203 687 376 815">EIA 9.7.1 and EM&A Log 8.3</p>			<p data-bbox="887 687 1111 719">Ecology Concern</p>	<ul data-bbox="1133 687 1518 1150" style="list-style-type: none"> • Provide training to workers about the conservative species • Provision of protective fence for the conservative species • Regular inspection for concerned vegetation and conservative species

<p data-bbox="1541 1121 1939 1153">By main contractor at KNP site</p>

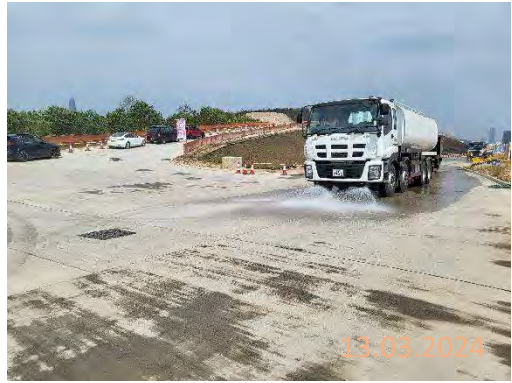
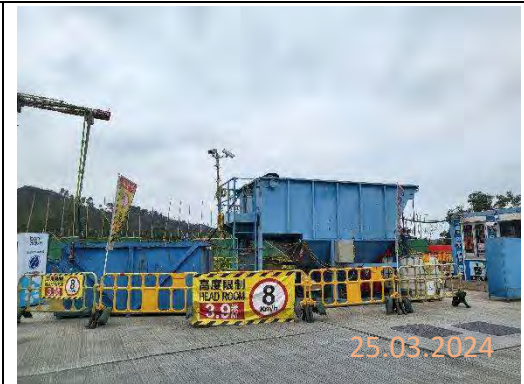
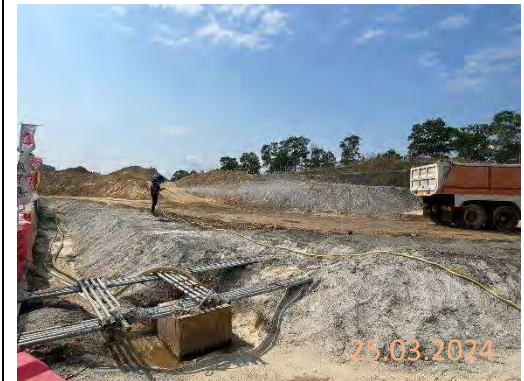
<p>By subcontractor at KNP site</p>
EIA 3.9.1; EM&A Log 2.2	Soil Removal	Kong Nga Po Site	Air	<ul style="list-style-type: none"> • Deploy water bowser for regular water spraying to enhance dust suppression • Cover dusty materials with impervious sheets • Exposed slopes covered with waterproof layers such as tarpaulin sheets or grout to reduce the potential for sediment laden runoff entering the drainage system.

<p>By subcontractor at KNP site</p>

- The speed of the trucks within the site should be controlled to about 10km/hour in order to reduce adverse dust impacts and secure the safe movement around the site.

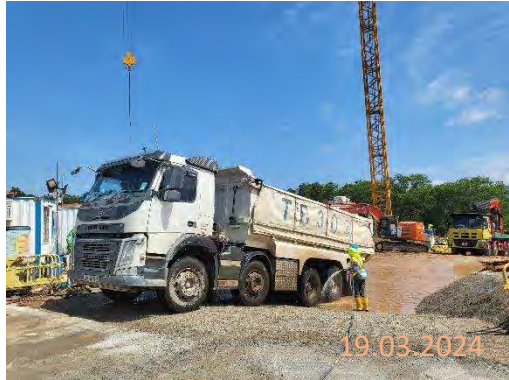
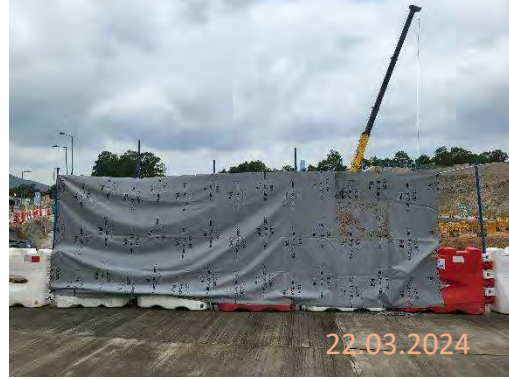
<p>By subcontractor at KNP site</p>
<p>EIA 4.4.6; EM&A Log 3.2</p>			<p>Noise</p>	<ul style="list-style-type: none"> • Regular inspection and maintenance of plant & equipment in good condition • Deploy Quality Powered Mechanical Equipment (QPME) if possible • Noise insulating fabric adopted for excavator.

<p>By main contractor at KNP site</p>

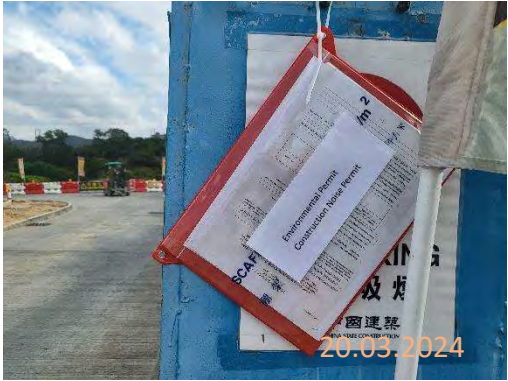
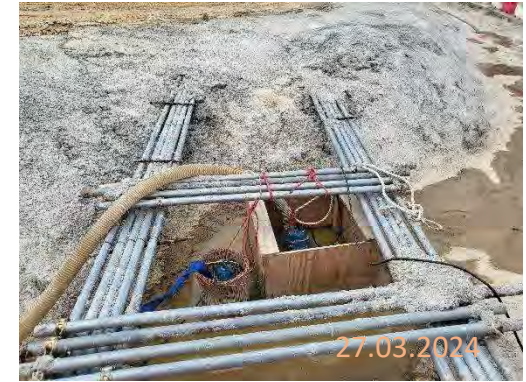
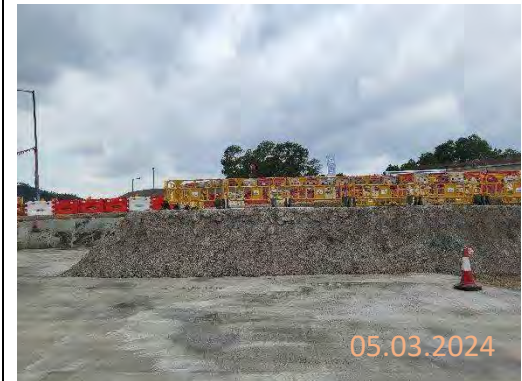
EIA 5.6.1.2
and EM&A
Log 4.2

Water Quality

- Cover exposed slopes with impervious sheets or cement grout.
- Wastewater pumped out of the excavation areas shall be treated to remove suspended solid prior to discharge.
- Provide desilting/ sedimentation devices for wastewater treatment prior to discharge.
- Provide drip tray to prevent spillage of fuels

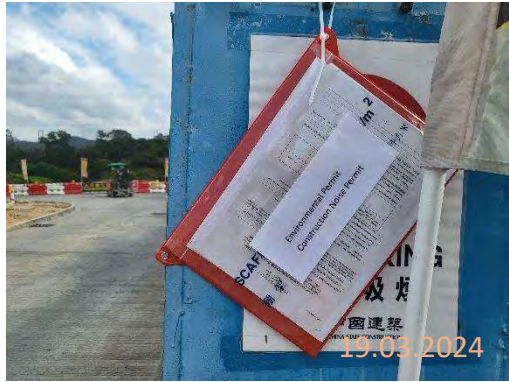
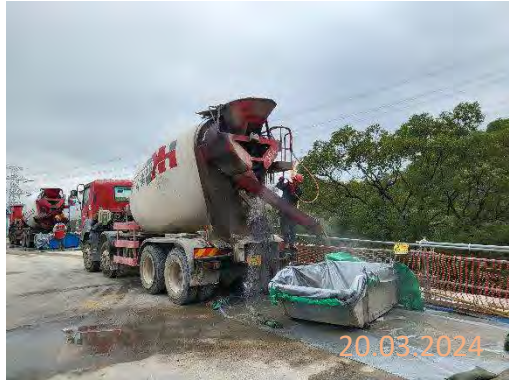
<p>By main contractor at KNP site</p>
EIA 5.6.1.3 and EM&A Log 4.2			Water Quality	<ul style="list-style-type: none"> • Surface water from concrete batching areas and the rest of the site should be separated as far as possible. • Temporary drainage is free of obstruction. • Gullies are sealed to prevent silt or debris from entering the

<p>By subcontractor at KNP site</p>

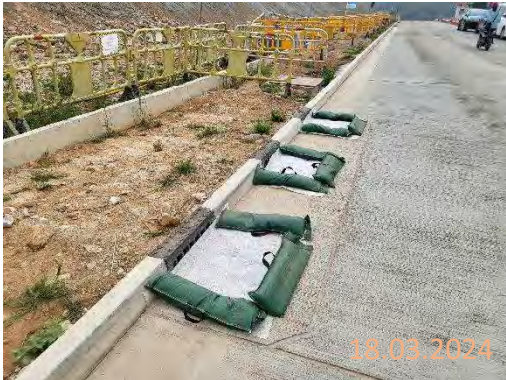
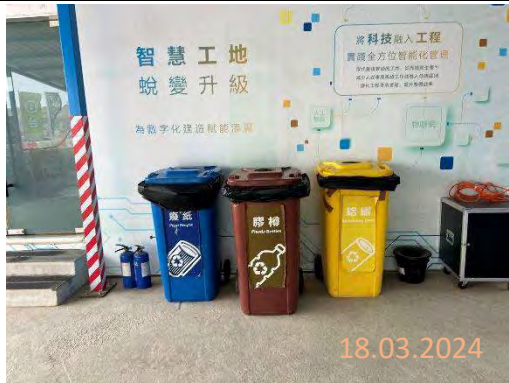
<p>EIA 7.5.1.2 and EM&A Log 6.2</p>			<p>Waste Management</p>	<ul style="list-style-type: none"> • Segregation and storage of different types of waste in different containers or skips or stockpiles to enhance reuse or recycling of materials and their proper disposal • Sort non-inert C&D materials to recover any recyclable portions 	  <p>By main contractor at KNP site</p>   <p>By main contractor at KNP site</p>
---	--	--	-------------------------	--	--

<p>By main contractor at KNP site</p>
--	--	--	--	--	---

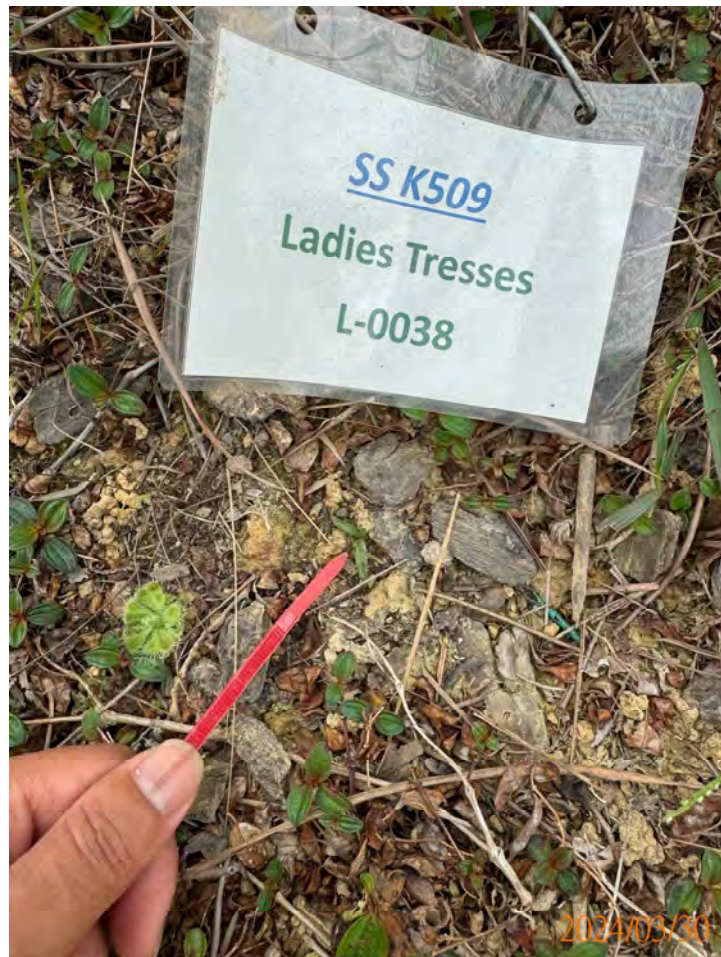
L-0037	<i>Spiranthes sinensis</i>	F	F	Leaf observed
L-0038	<i>Spiranthes sinensis</i>	P	P	Leaf observed
L-0039	<i>Spiranthes sinensis</i>	-	-	Not observed
L-0040	<i>Spiranthes sinensis</i>	F	F	Leaf observed
L-0041	<i>Spiranthes sinensis</i>	-	-	Not observed
L-0042	<i>Spiranthes sinensis</i>	-	-	Not observed

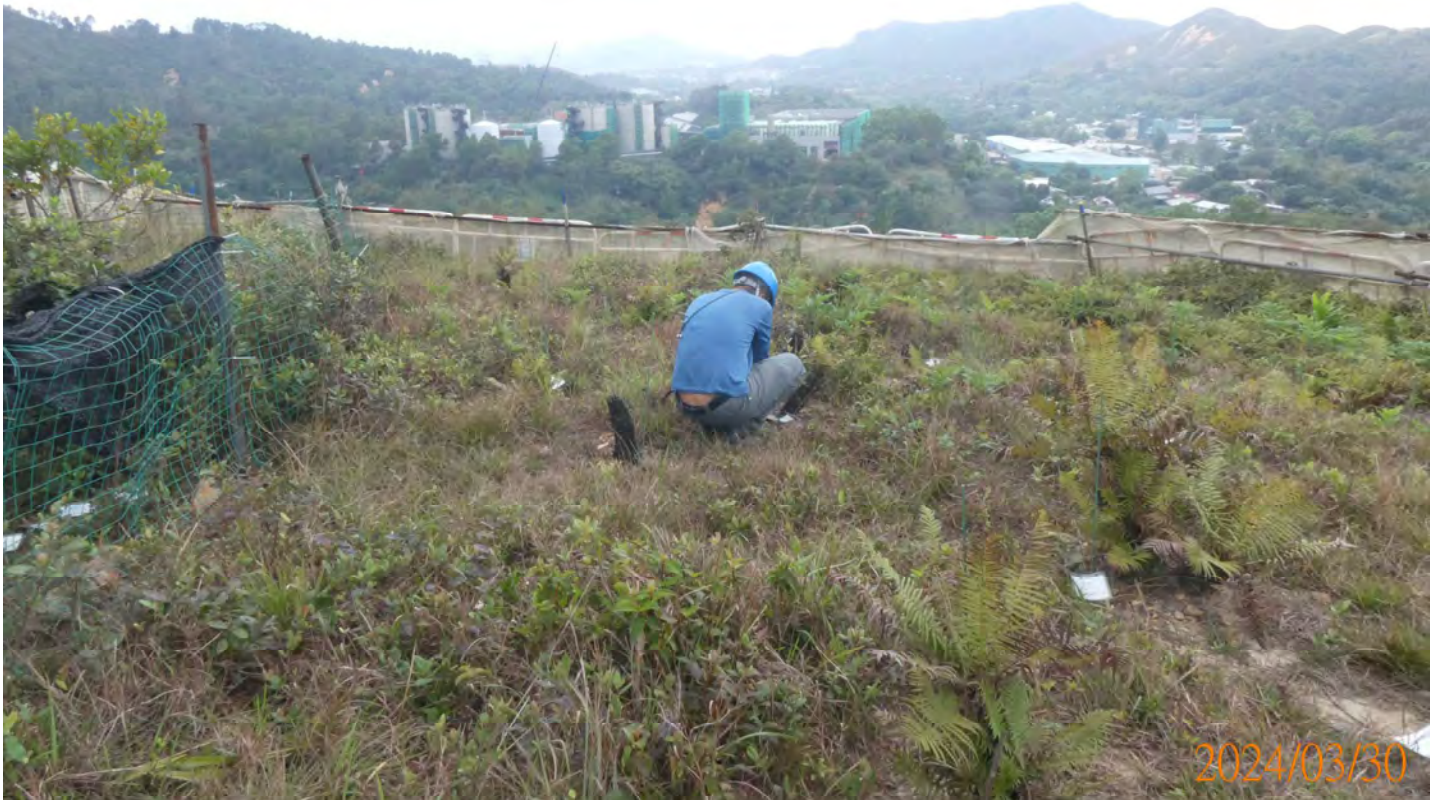
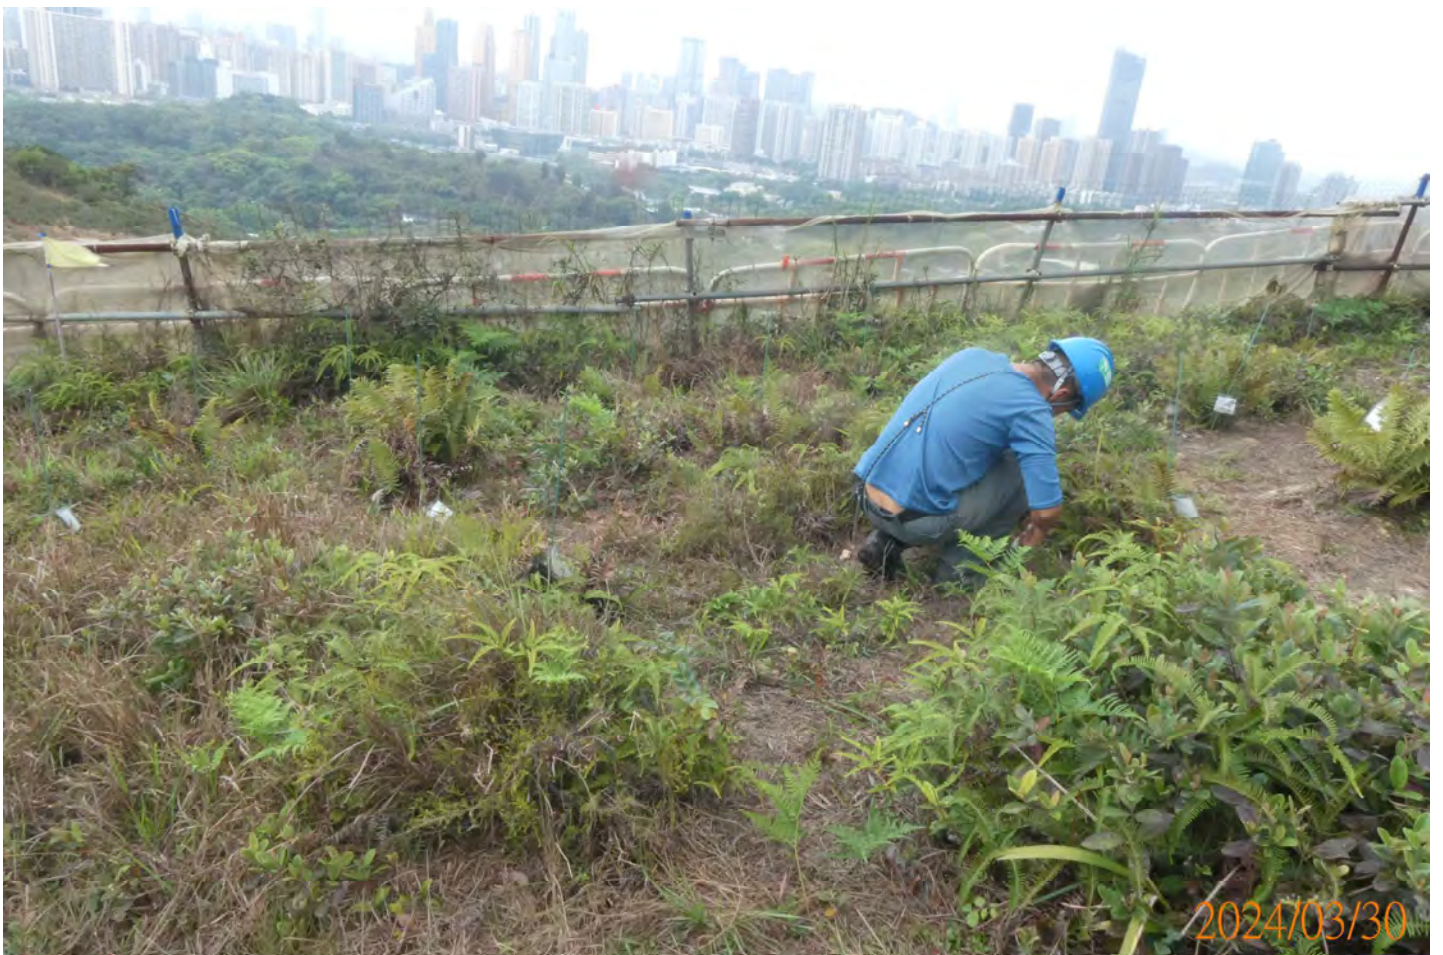
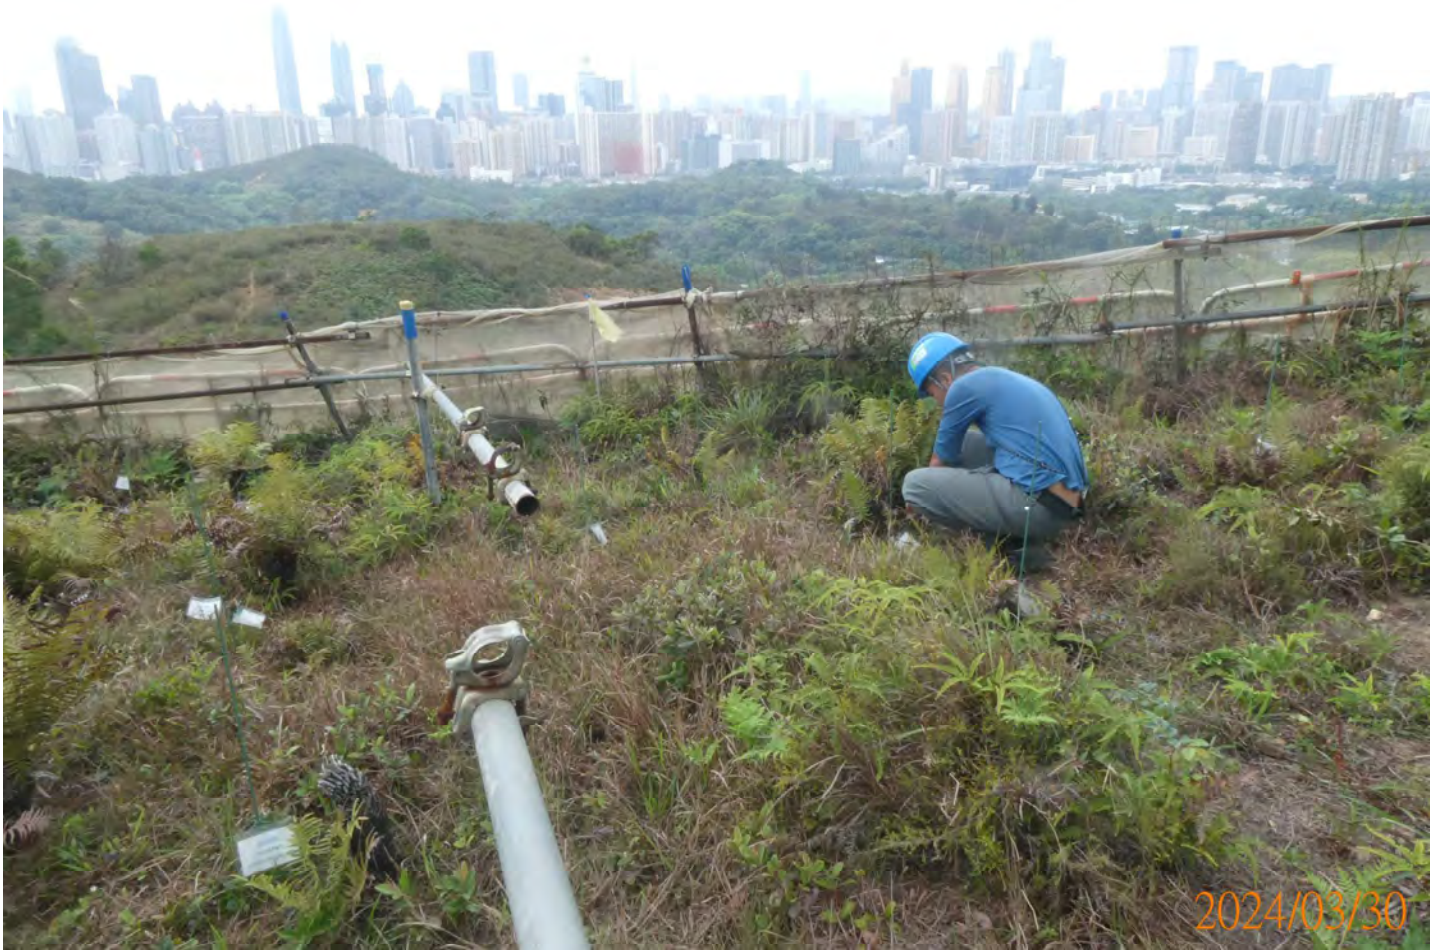
weeding (1)

weeding (2)

weeding (3)

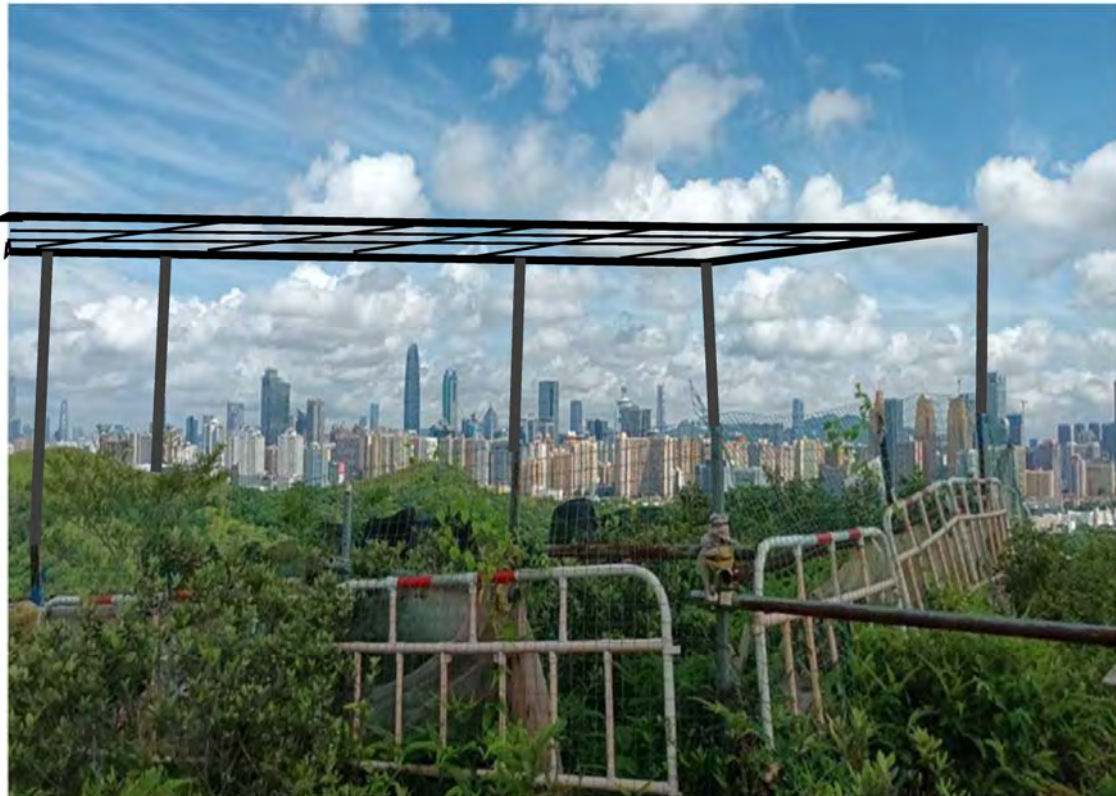
The installation of a shaded net

- To maintain soil moisture, daily watering is required;
- To install a shaded net;
- To refer to the Guidelines on Soil Improvement issued by the Greening, Landscape and Tree Management Section (GLTMS) of the Development Bureau (2022) for the effective monitoring and maintenance of transplanted flora species; and
- The wild plants that are growing in undesirable areas should be removed, as they compete with the cultivated flora species of conservation interest.

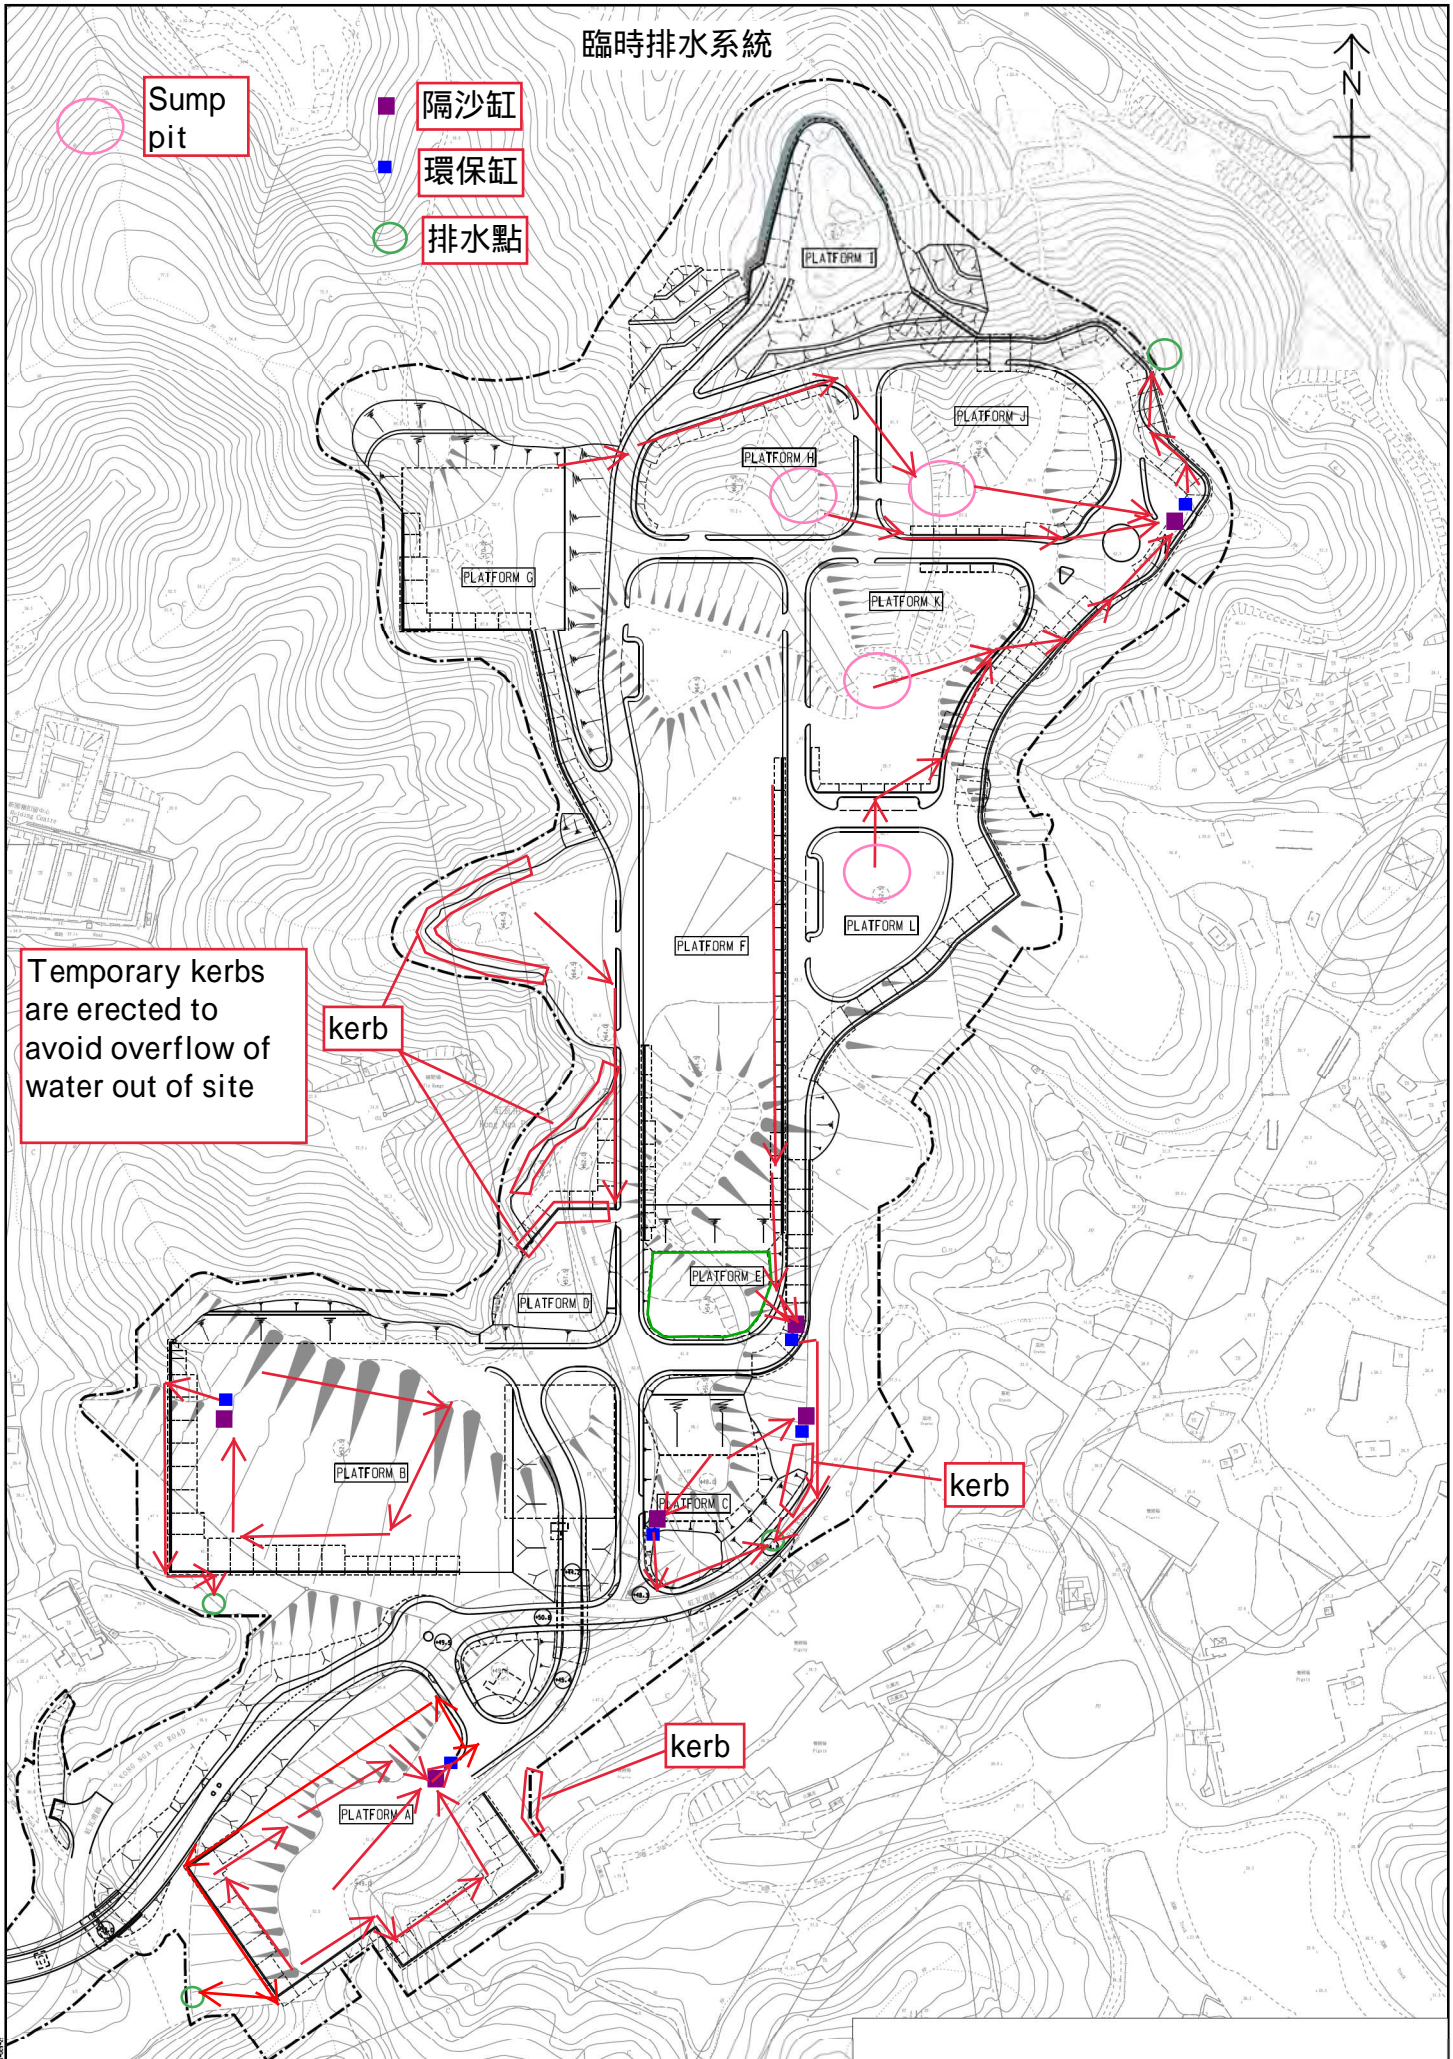
Temporary kerbs are erected to avoid overflow of water out of site
