**Provision of Independent Environmental Checker Consultancy for Design  
and Construction of Kong Nga Po Police Training Facilities  
Verification of Monthly EM&A Report (June 2024)**

**Provision of Environmental Team consultancy  
for Design and Construction of Kong Nga Po Police  
Training Facilities (Programme No. 279LP)**

**Monthly Environmental Monitoring and  
Audit Report for June 2024  
(Version 3)**

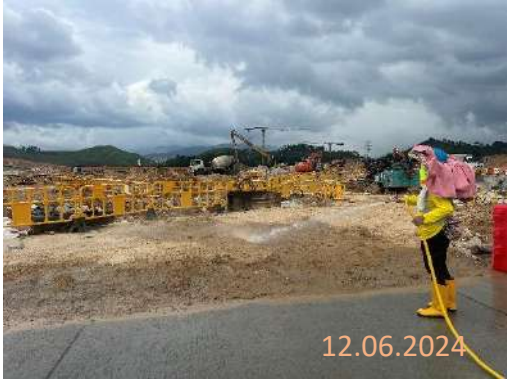
Ref*	Proposed Construction Method	Location/Working Period	Anticipated Major Impacts	Recommended Mitigation Measures	Photo Records (Partial)
EIA 3.9.1; EM&A Log 2.2	Open cut excavation	Kong Nga Po Site	Dust impact	<ul style="list-style-type: none"> <li>• Manual water spraying for dust suppression</li> <li>• Regular inspection and maintenance of plant and equipment in good condition</li> <li>• Cover stockpile with impervious sheets or grout</li> <li>• Provide wheel washing facility at site entrance</li> </ul>

<p data-bbox="1541 930 1912 959">By subcontractor at KNP site</p>

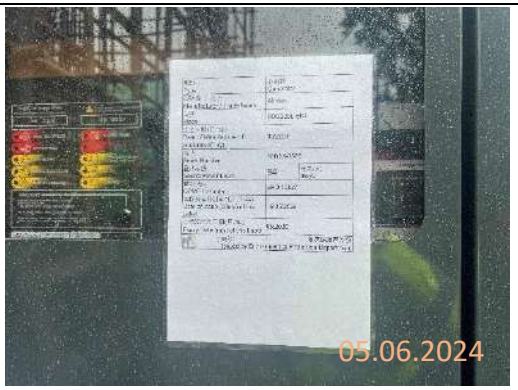
- Regular inspection and maintenance of plant & equipment in good condition
- Deploy Quality Powered Mechanical Equipment (QPME) if possible
- Valid construction noise permit should be displayed at site entrance.

By main contractor at KNP site

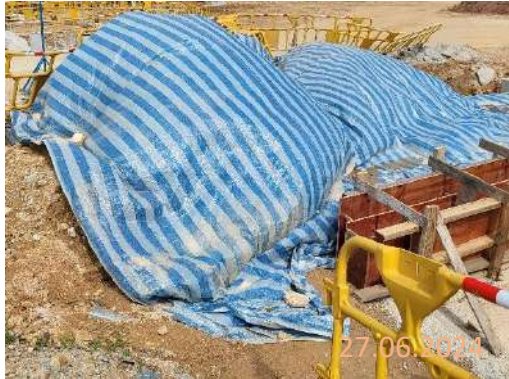
<p>By subcontractor at KNP site</p>
--	--	--	--	---	--

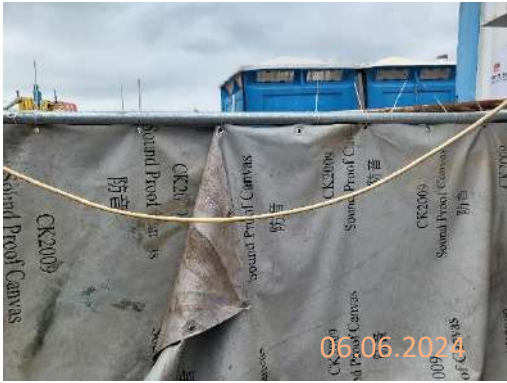
<p>EIA 4.4.6; EM&amp;A Log 3.2</p>			<p>Noise</p>	<ul style="list-style-type: none"> <li>• Regular inspection and maintenance of plant &amp; equipment in good condition</li> <li>• Deploy Quality Powered Mechanical Equipment (QPME) if possible</li> <li>• Noise insulating fabric adopted for excavator.</li> </ul>

<p>By main contractor at KNP site</p>

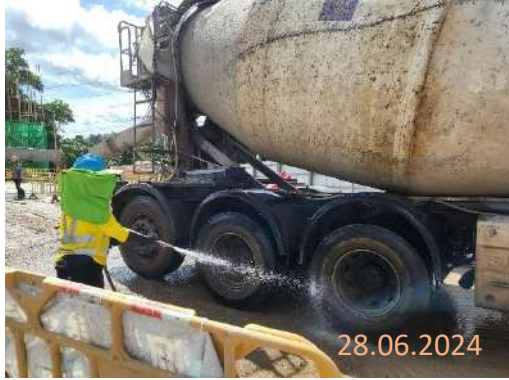
<p>By main contractor at KNP site</p>
<p>EIA 3.9.1; EM&amp;A Log 2.2</p>	<p>Construction of footings</p>	<p>Kong Nga Po Site</p>	<p>Air</p>	<ul style="list-style-type: none"> <li>• Cover dusty materials with impervious sheets</li> <li>• Exposed slopes covered with waterproof layers such as tarpaulin sheets or grout to reduce the potential for sediment laden runoff entering</li> </ul>

<p>the drainage system.</p> <ul style="list-style-type: none"> <li>Provide wheel washing facility at site entrance</li> </ul>	<p>By main contractor at KNP site</p>

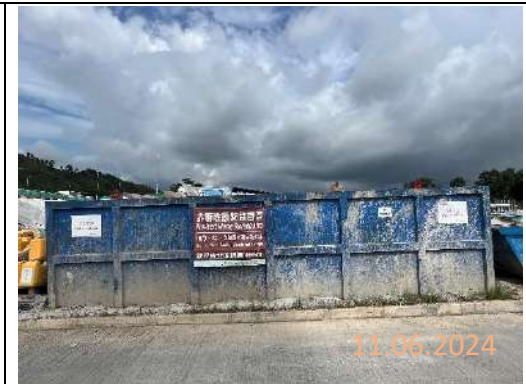
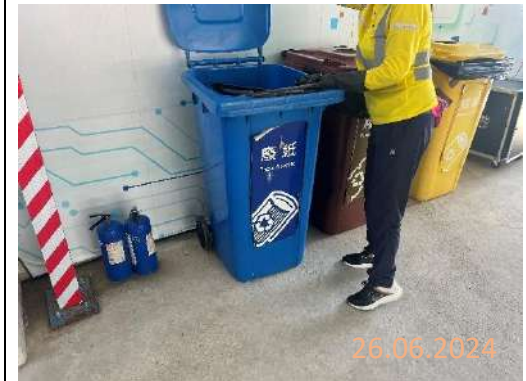
- Segregation and storage of different types of waste in different containers or skips or stockpiles to enhance reuse or recycling of materials and their proper disposal
- Sort non-inert C&D materials to recover any recyclable portions

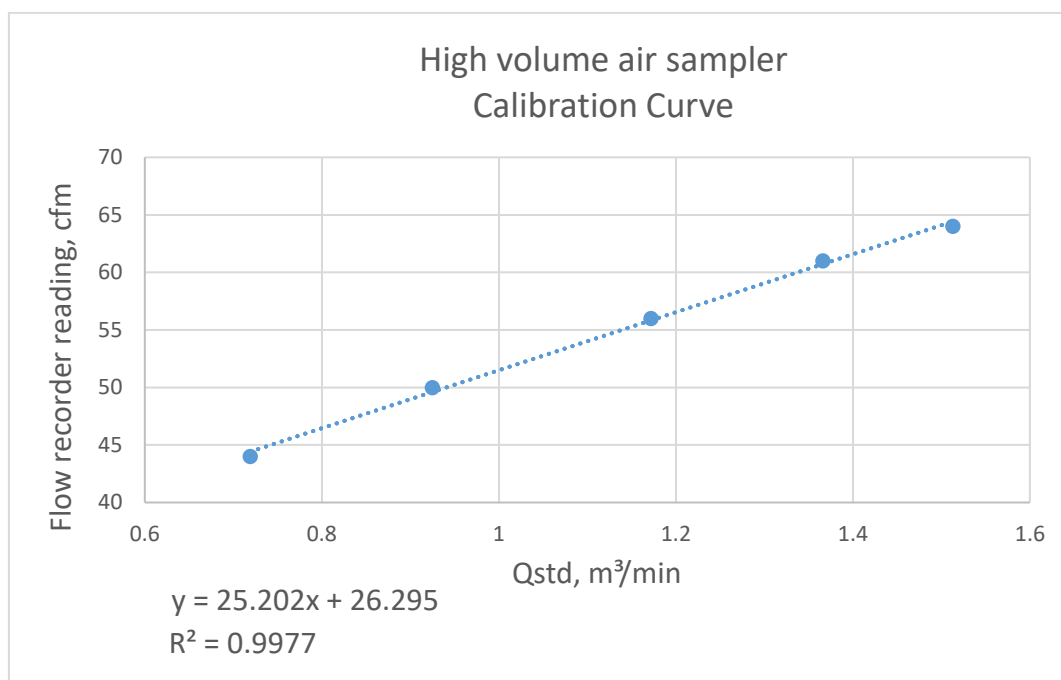
Qstd, Actual flow rate, m <sup>3</sup> /min	1.513	1.366	1.172	0.925	0.719
Flow recorder reading, cfm	64	61	56	50	44
Pressure, mm Hg	757				
Temperature, K	303

**Note : The coefficient of determination (R<sup>2</sup>) of the calibration curve greater than 0.99 after a 5-point calibration, the high volume air sampler complies with the specified requirements and deemed acceptable for use.**

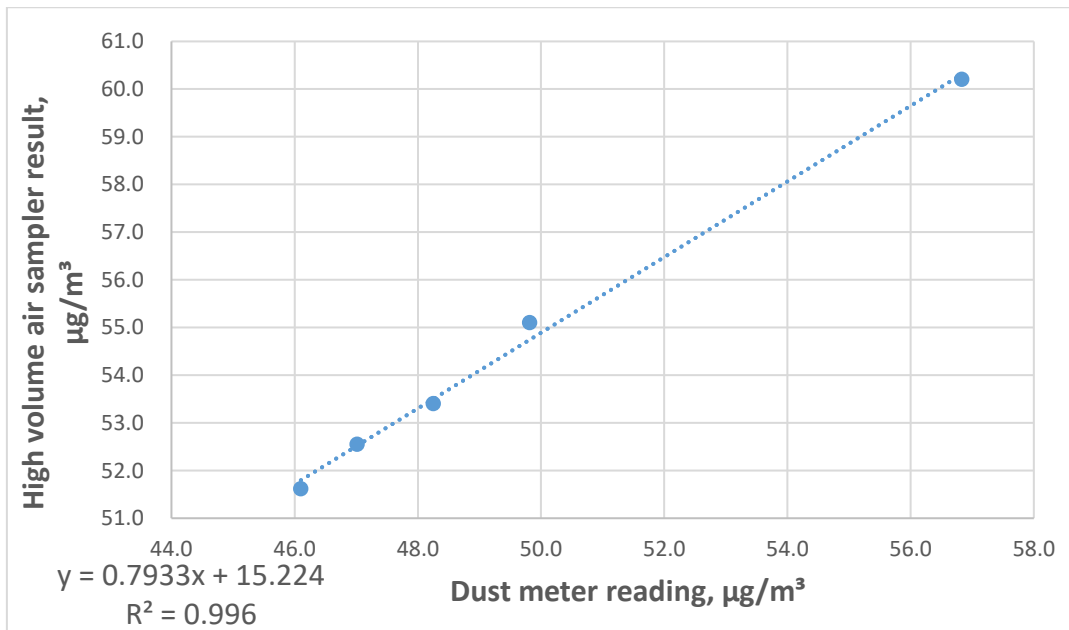
Calibration Point	Average Dust Meter reading, $\mu\text{g}/\text{m}^3$	High volume air sampler results, $\mu\text{g}/\text{m}^3$
1	56.8	60.2
2	48.3	53.4
3	46.1	51.6
4	49.8	55.1
5	47.0	52.6

- Note : 1. "Instrument Readings" presents the figures shown on item under calibration / checking regardless of equipment precision or significant figures.  
2. The coefficient of determination ( $R^2$ ) of the calibration curve greater than 0.99 after a 5-point calibration, the dust meter complies with the specified requirements and deemed acceptable for use.

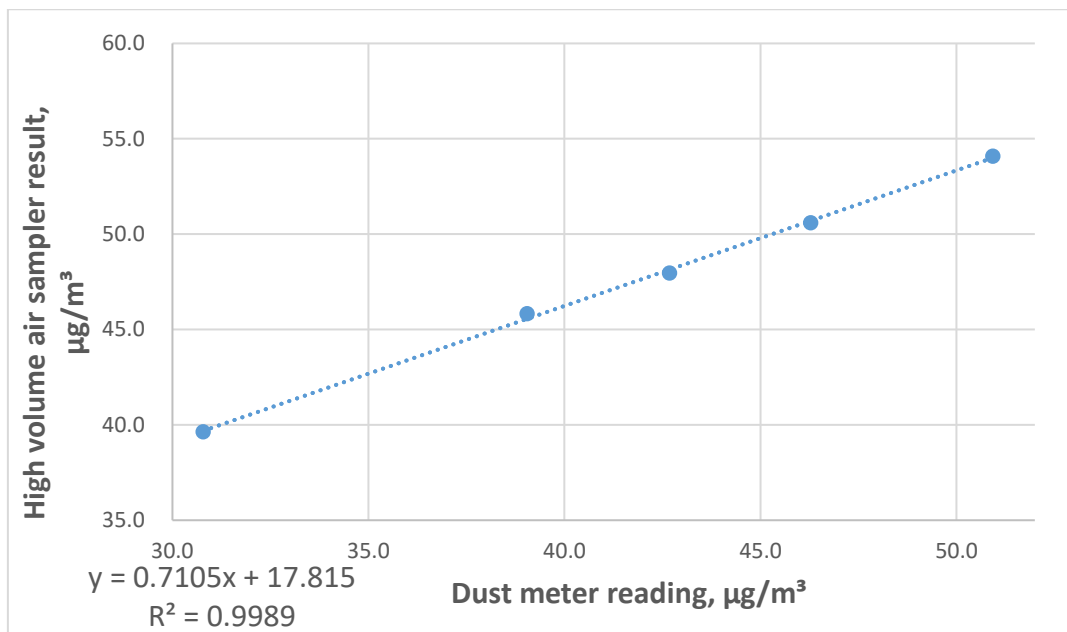
Calibration Point	Average Dust Meter reading, $\mu\text{g}/\text{m}^3$	High volume air sampler results, $\mu\text{g}/\text{m}^3$
1	30.8	39.6
2	39.1	45.8
3	46.3	50.6
4	50.9	54.1
5	42.7	48.0

- Note : 1. "Instrument Readings" presents the figures shown on item under calibration / checking regardless of equipment precision or significant figures.  
2. The coefficient of determination ( $R^2$ ) of the calibration curve greater than 0.99 after a 5-point calibration, the dust meter complies with the specified requirements and deemed acceptable for use.

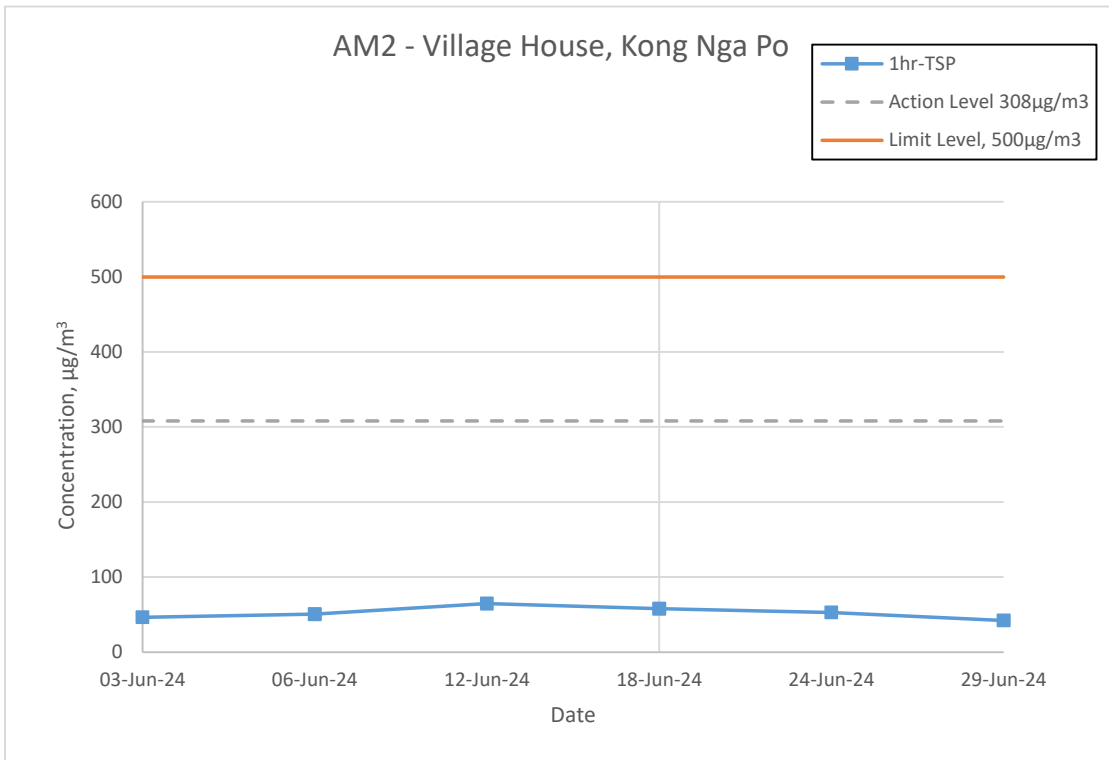
# 1-hr TSP Concentration Levels

Location AM2 - Village House, Kong Nga Po			
Date	Time	Weather	Particulate Concentration ( $\mu\text{g}/\text{m}^3$ )
03-Jun-24	13:11	Rain	46
	14:11		59
	15:11		58
06-Jun-24	13:07	Cloudy	51
	14:07		25
	15:07		49
12-Jun-24	13:01	Cloudy	65
	14:01		37
	15:01		44
18-Jun-24	13:26	Sunny	58
	14:26		63
	15:26		43
24-Jun-24	13:25	Fine	53
	14:25		56
	15:25		58
29-Jun-24	13:13	Sunny	42
	14:13		22
	15:13		34
Minimum			22
Maximum			65
Average			48

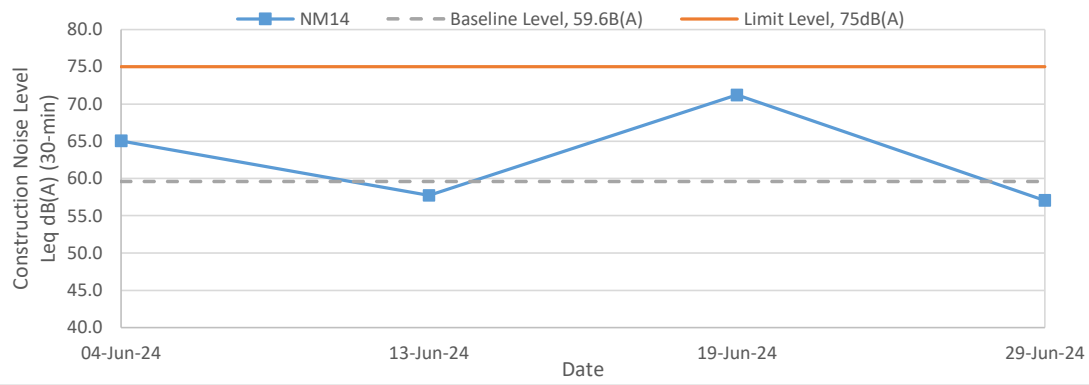
### NM14 - Village House, Kong Nga Po

Location NM14 - Village House, near Man Kam To Road									
Date	Weather	Wind Speed (m/s)	Time	Unit: dB(A) (5-min)			Average	Limit Level	Baseline
				L <sub>eq</sub>	L <sub>10</sub>	L <sub>90</sub>			
04-Jun-24	Cloudy	0.30	17:28	65.7	64.1	45.6	65.0	75.0	59.6
				49.7	53.1	41.1			
				45.5	48.0	41.5			
				47.8	50.7	42.0			
				67.4	60.0	42.2			
				69.9	74.9	49.2			
13-Jun-24	Sunny	0.00	16:50	58.4	58.7	44.5	57.7	75.0	59.6
				55.3	58.9	44.1			
				52.2	54.1	48.9			
				50.1	50.8	48.3			
				63.2	70.7	48.7			
				52.0	54.9	43.3			
19-Jun-24	Sunny	0.14	15:59	69.3	72.1	57.8	71.2	75.0	59.6
				73.2	73.7	61.1			
				68.0	71.5	60.3			
				70.9	72.8	63.3			
				66.4	70.7	58.4			
				74.3	73.5	61.4			
29-Jun-24	Sunny	0.14	13:45	57.0	42.6	41.6	57.0	75.0	59.6
				59.3	50.5	42.0			
				50.8	51.2	49.3			
				59.8	56.6	47.1			
				55.8	58.8	47.7			
				53.4	55.0	44.1

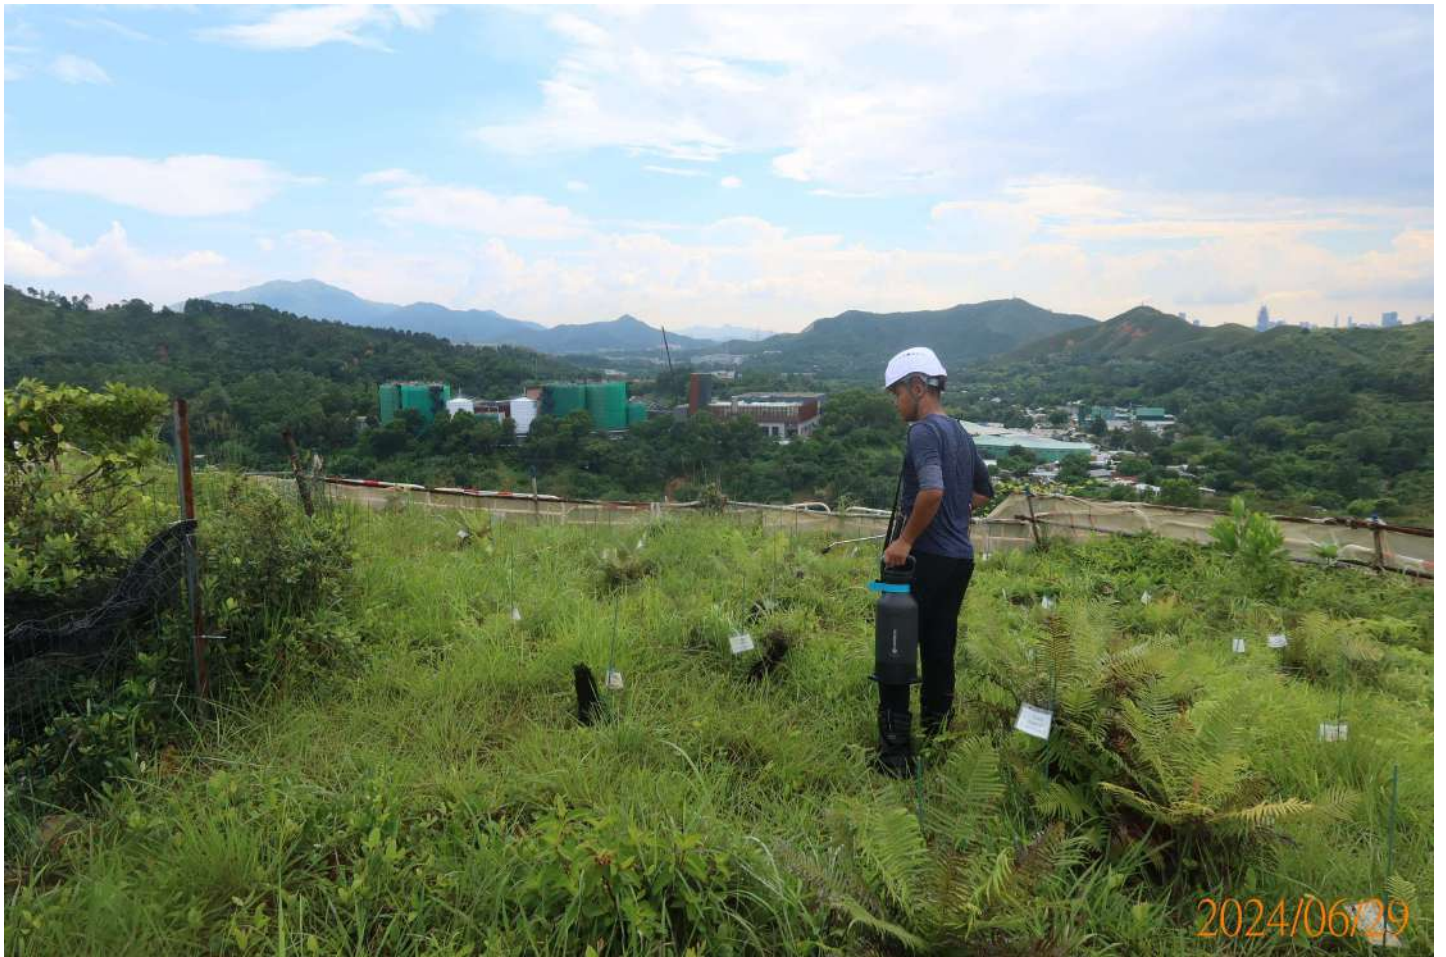
watering

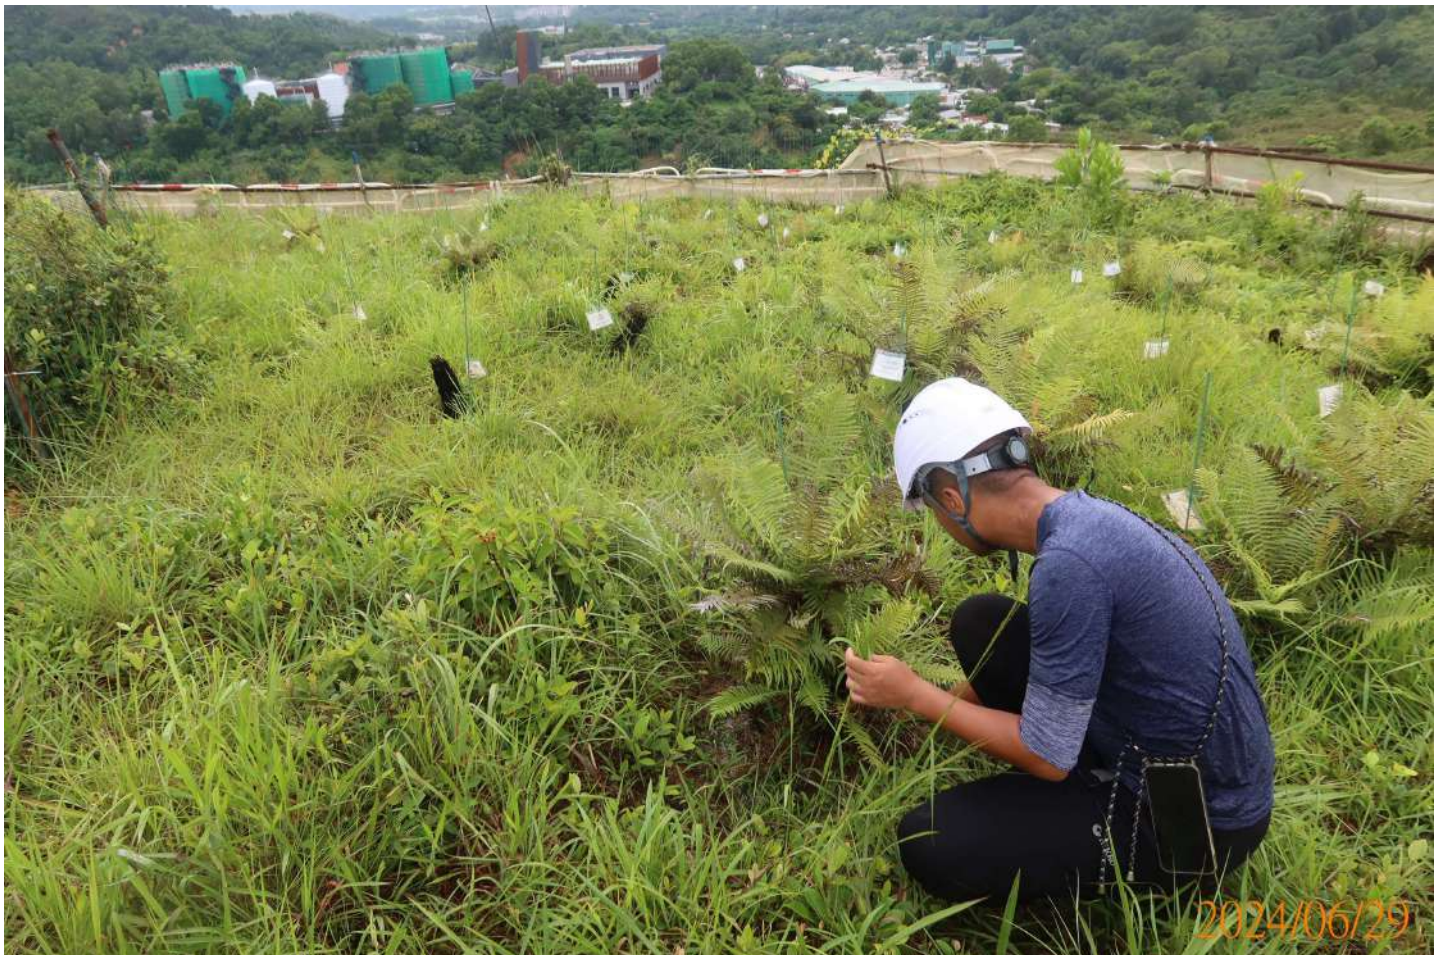
Weeding (1)

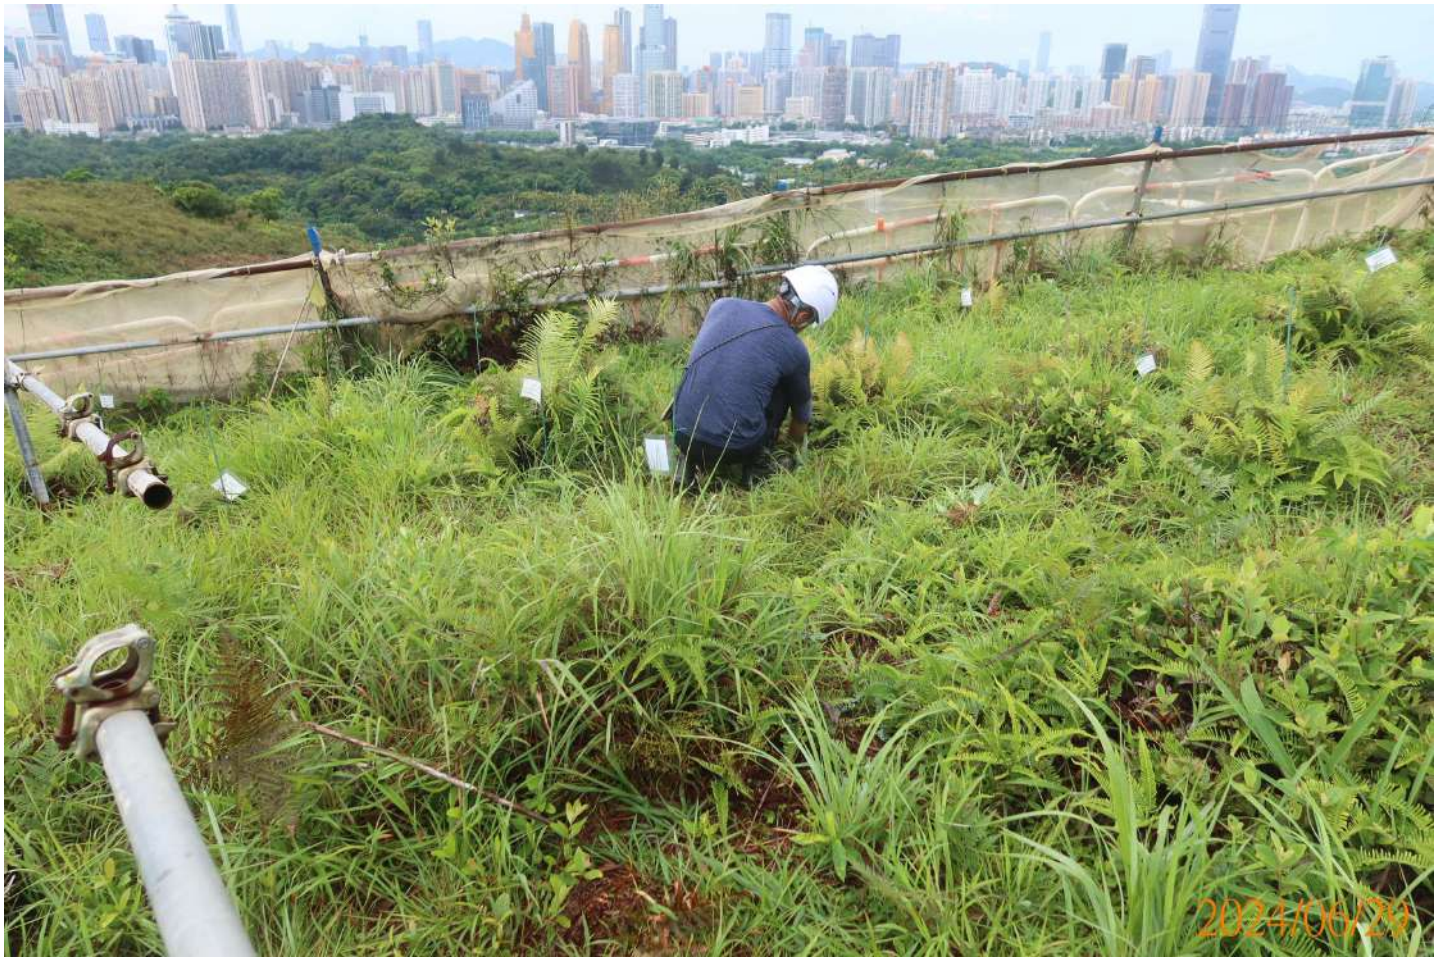
Weeding (2)

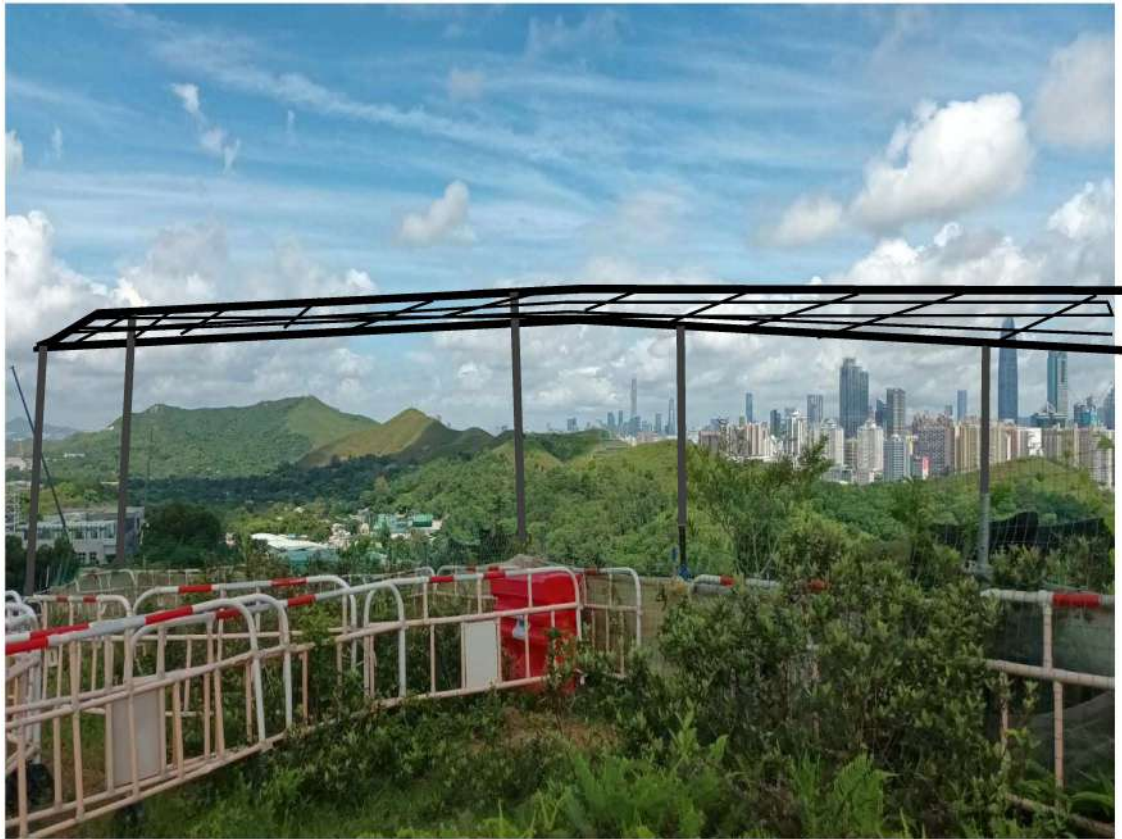
## The installation of a shaded net

Remark: Non scale & Conceptual drawing
