**Re: Contract No. SS K/509**  
**Provision of Independent Environmental Checker Consultancy for Design and Construction of Kong Nga Po Police Training Facilities**  
**Verification of Monthly EM&A Report (July 2024)**

**Provision of Environmental Team consultancy  
for Design and Construction of Kong Nga Po Police  
Training Facilities (Programme No. 279LP)**

**Monthly Environmental Monitoring and  
Audit Report for July 2024  
(Version 2)**

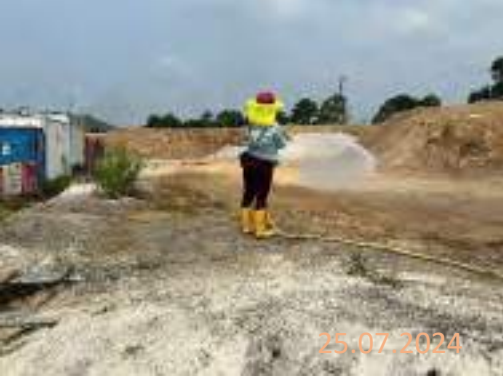
Ref*	Proposed Construction Method	Location/Working Period	Anticipated Major Impacts	Recommended Mitigation Measures	Photo Records (Partial)
EIA 3.9.1; EM&A Log 2.2	Open cut excavation	Kong Nga Po Site	Dust impact	<ul style="list-style-type: none"> <li>• Manual water spraying for dust suppression</li> <li>• Regular inspection and maintenance of plant and equipment in good condition</li> <li>• Cover stockpile with impervious sheets or grout</li> <li>• Provide wheel washing facility at site entrance</li> </ul>

<p data-bbox="1541 932 1939 959">By main contractor at KNP site</p>

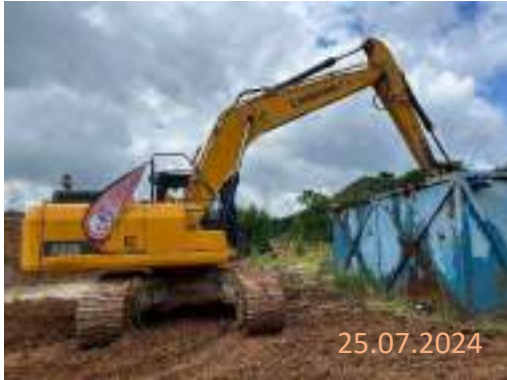
<p>25.07.2024</p> <p>By main contractor at KNP site</p>

<p>EIA 4.4.6; EM&amp;A Log 3.2</p>			<p>Noise</p>	<ul style="list-style-type: none"> <li>• Regular inspection and maintenance of plant &amp; equipment in good condition</li> <li>• Deploy Quality Powered Mechanical Equipment (QPME) if possible</li> <li>• Noise insulating fabric adopted for excavator.</li> </ul>	  <p>By main contractor at KNP site</p>
<p>EIA 5.6.1.2 and EM&amp;A Log 4.2</p>			<p>Water Quality</p>	<ul style="list-style-type: none"> <li>• Cover exposed slopes with impervious sheets or cement grout.</li> <li>• Wastewater pumped out of the excavation areas shall be treated to remove suspended solid prior to discharge.</li> <li>• Provide desilting/ sedimentation devices for wastewater</li> </ul>	  <p>By main contractor at KNP site</p>

<p>treatment prior to discharge.</p> <ul style="list-style-type: none"><li>• Provide drip tray to prevent spillage of fuels</li></ul>

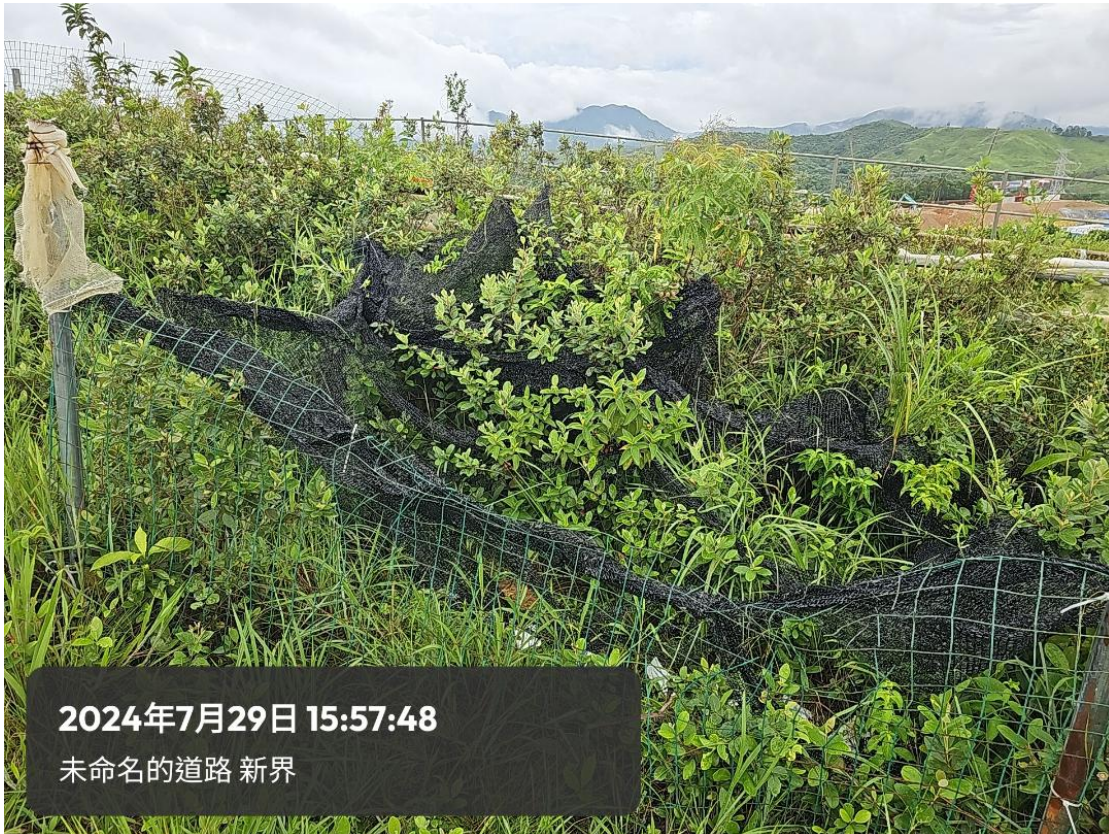
2024年7月29日 15:57:48

- 1) Please refer to the guidelines on soil improvement issued by the Greening, Landscape and Tree Management Section (GLTMS) of the development bureau (2022) to apply to monitoring and maintenance of transplanted flora species.
- 2) Daily watering frequency is needed to keep the soil moist.
- 3) Installation of a shaded net is provided below.
- 4) The wild plants that are growing in undesirable areas should be removed.
- 5) The damaged Black Shade Net should be repaired or replaced with a new one.
