**Provision of Independent Environmental Checker Consultancy for Design
and Construction of Kong Nga Po Police Training Facilities
Verification of Monthly EM&A Report (October 2024)**

**Provision of Environmental Team consultancy
for Design and Construction of Kong Nga Po Police
Training Facilities (Programme No. 279LP)**

**Monthly Environmental Monitoring and
Audit Report for October 2024
(Version 2)**

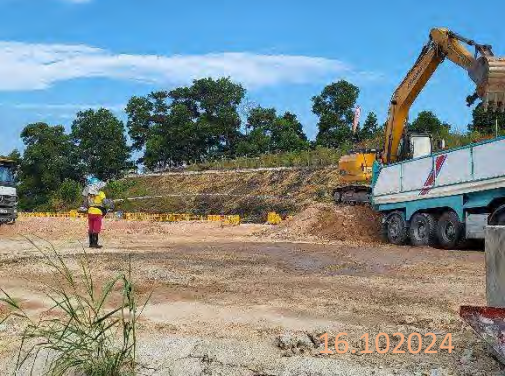
Ref*	Proposed Construction Method	Location/Working Period	Anticipated Major Impacts	Recommended Mitigation Measures	Photo Records (Partial)
EIA 3.9.1; EM&A Log 2.2	Open cut excavation	Kong Nga Po Site	Dust impact	<ul style="list-style-type: none"> Manual water spraying for dust suppression Regular inspection and maintenance of plant and equipment in good condition Cover stockpile with impervious sheets or grout Provide wheel washing facility at site entrance

<p>By main contractor at KNP site</p>

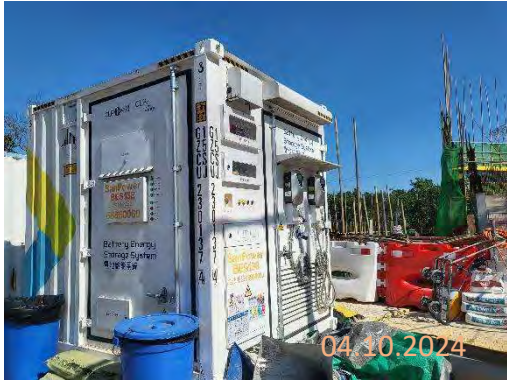
<p>By subcontractor at KNP site</p>
<p>EIA 4.4.6; EM&A Log 3.2</p>			<p>Noise</p>	<ul style="list-style-type: none"> • Regular inspection and maintenance of plant & equipment in good condition • Deploy Quality Powered Mechanical Equipment (QPME) if possible • Valid construction noise permit should be 	  <p>By main contractor at KNP site</p>

<p>displayed at site entrance.</p>

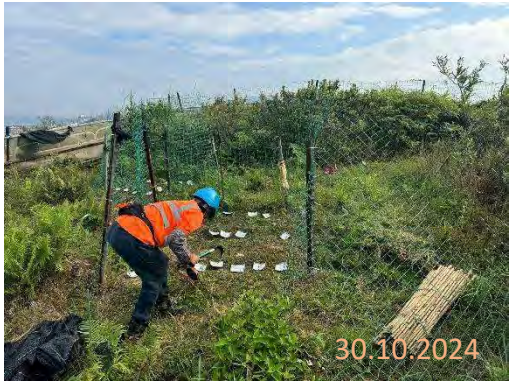
<p>By subcontractor at KNP site</p>
EIA 3.9.1; EM&A Log 2.2	Soil Removal	Kong Nga Po Site	Air	<ul style="list-style-type: none"> • Deploy water bowser for regular water spraying to enhance dust suppression • Cover dusty materials with impervious sheets • Exposed slopes covered with waterproof layers such as tarpaulin sheets or grout to reduce the potential for sediment laden runoff entering the drainage system.

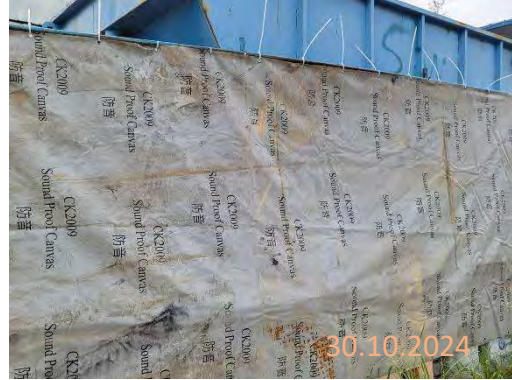
<p>EIA 5.6.1.2 and EM&A Log 4.2</p>			<p>Water Quality</p>	<ul style="list-style-type: none"> • Cover exposed slopes with impervious sheets or cement grout. • Wastewater pumped out of the excavation areas shall be treated to remove suspended solid prior to discharge. • Provide desilting/ sedimentation devices for wastewater treatment prior to discharge. • Provide drip tray to prevent spillage of fuels

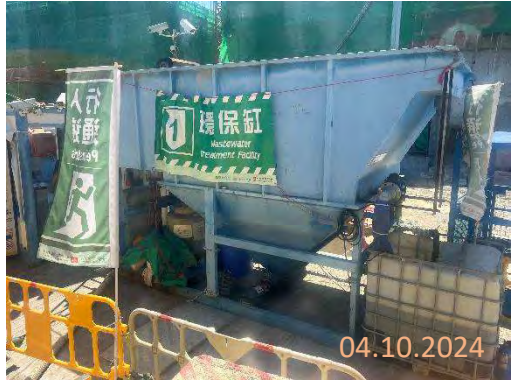
<p>By main contractor at KNP site</p>
<p>EIA 7.5.1.2 and EM&A Log 6.2</p>			<p>Waste Management</p>	<ul style="list-style-type: none"> • Segregation and storage of different types of waste in different containers or skips or stockpiles to enhance reuse or recycling of materials and their proper disposal • Sort non-inert C&D materials to recover any recyclable portions

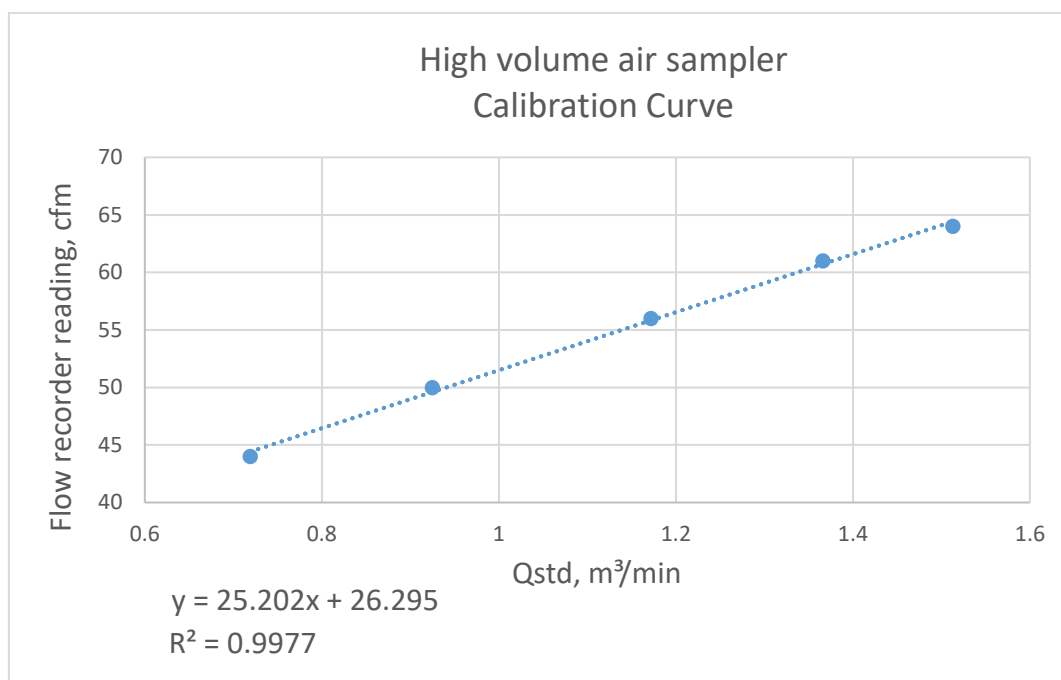
Qstd, Actual flow rate, m ³ /min	1.513	1.366	1.172	0.925	0.719
Flow recorder reading, cfm	64	61	56	50	44
Pressure, mm Hg	757				
Temperature, K	303

Note : The coefficient of determination (R^2) of the calibration curve greater than 0.99 after a 5-point calibration, the high volume air sampler complies with the specified requirements and deemed acceptable for use.

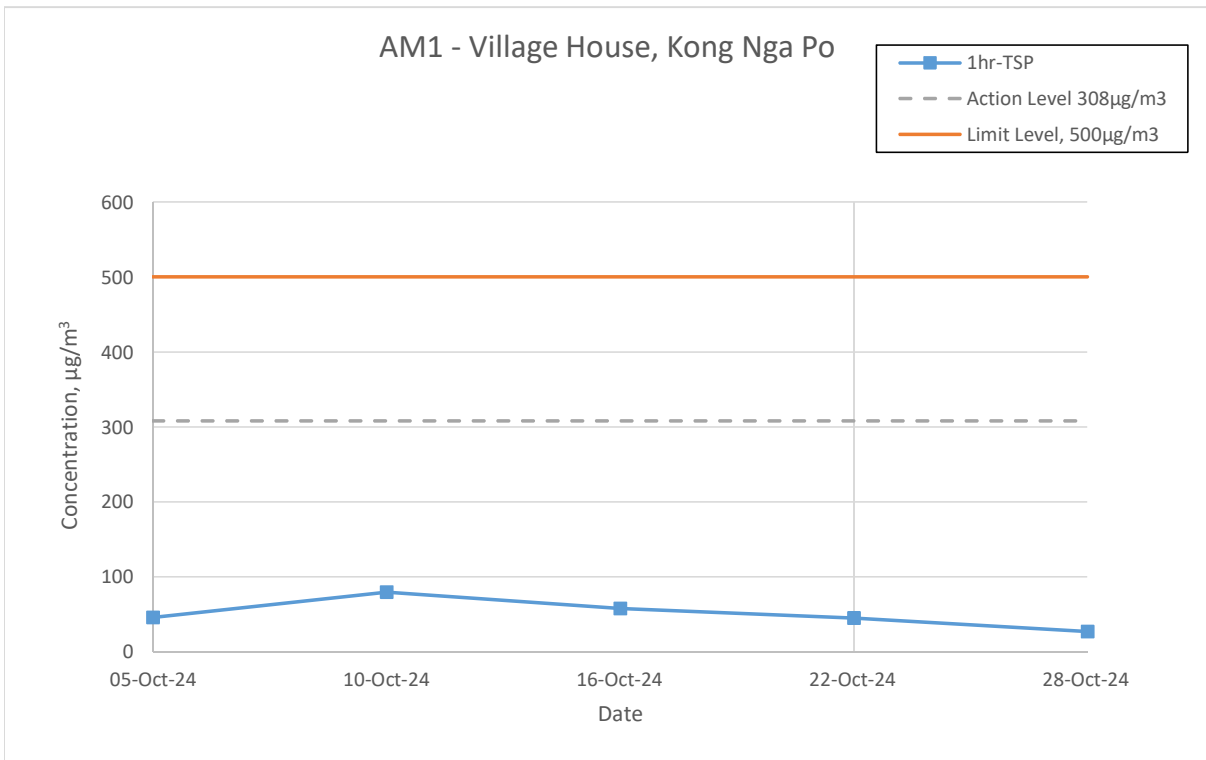
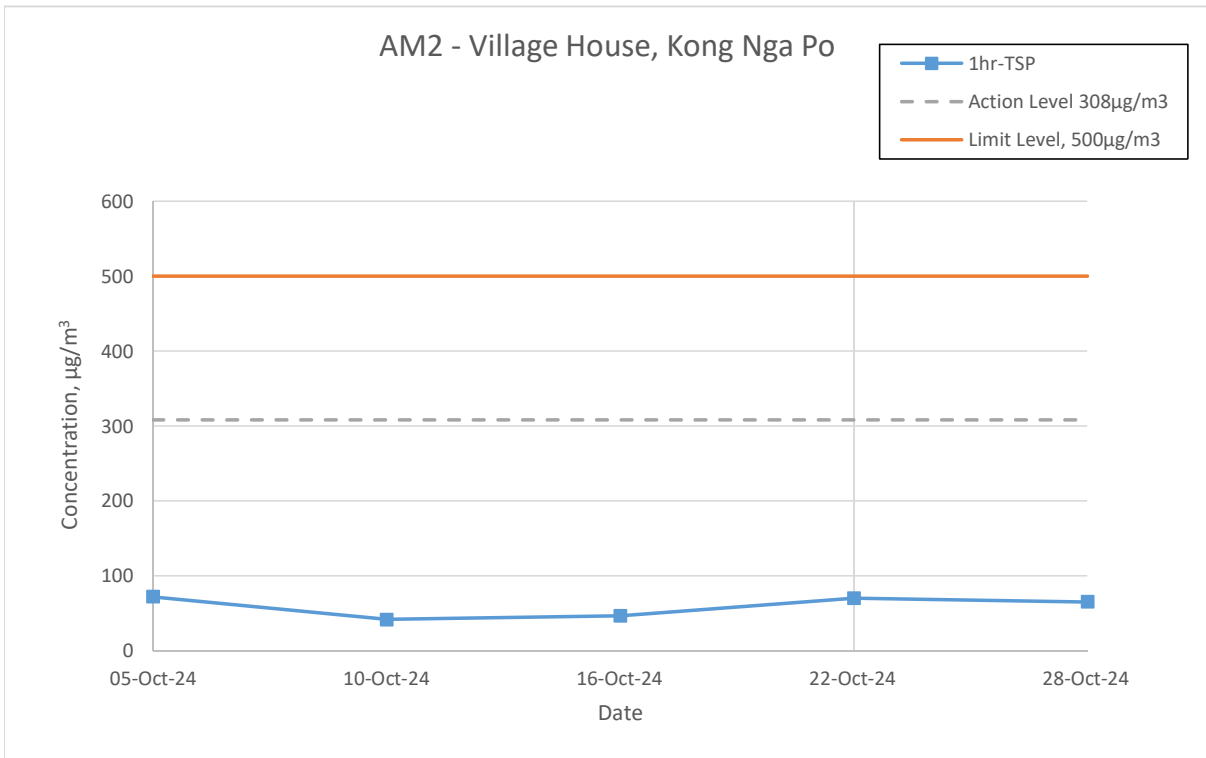
1-hr TSP Concentration Levels

Location AM2 - Village House, Kong Nga Po			
Date	Time	Weather	Particulate Concentration ($\mu\text{g}/\text{m}^3$)
05-Oct-24	13:02	Sunny	72
	14:02		53
	15:02		20
10-Oct-24	13:14	Sunny	42
	14:14		76
	15:14		44
16-Oct-24	13:23	Sunny	47
	14:23		27
	15:23		21
22-Oct-24	8:56	Sunny	70
	9:56		78
	10:56		69
28-Oct-24	13:00	Sunny	65
	14:00		67
	15:00		65
		Minimum	20
		Maximum	78
		Average	54

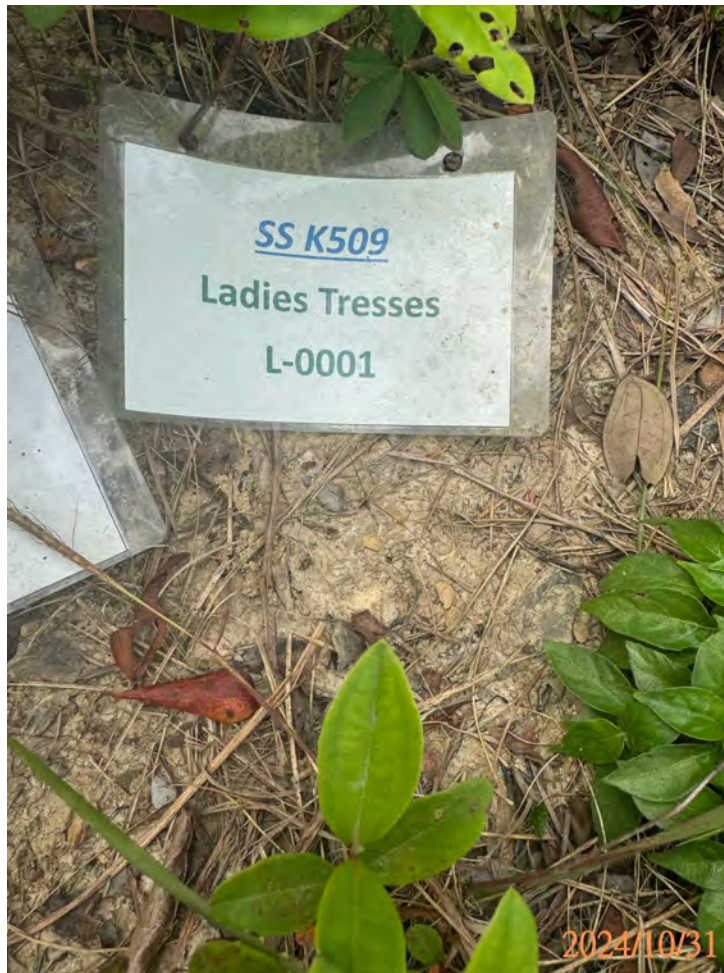
Tree/Plant/ Colony No.	Species Name	Form (Good/Fair/Poor)	Health (Good/Fair/Poor)	Remark
L-0001	<i>Spiranthes sinensis</i>	-	-	Not observed
L-0002	<i>Spiranthes sinensis</i>	-	-	Not observed
L-0003	<i>Spiranthes sinensis</i>	-	-	Not observed
L-0004	<i>Spiranthes sinensis</i>	-	-	Not observed
L-0005	<i>Spiranthes sinensis</i>	-	-	Not observed
L-0006	<i>Spiranthes sinensis</i>	-	-	Not observed
L-0007	<i>Spiranthes sinensis</i>	-	-	Not observed
L-0008	<i>Spiranthes sinensis</i>	F	F	Leaf observed
L-0009	<i>Spiranthes sinensis</i>	-	-	Not observed
L-0010	<i>Spiranthes sinensis</i>	-	-	Not observed
L-0011	<i>Spiranthes sinensis</i>	-	-	Not observed
L-0012	<i>Spiranthes sinensis</i>	-	-	Not observed
L-0013	<i>Spiranthes sinensis</i>	-	-	Not observed
L-0014	<i>Spiranthes sinensis</i>	P	P	Leaf observed
L-0015	<i>Spiranthes sinensis</i>	-	-	Not observed
L-0016	<i>Spiranthes sinensis</i>	-	-	Not observed
L-0018	<i>Spiranthes sinensis</i>	P	P	Leaf observed

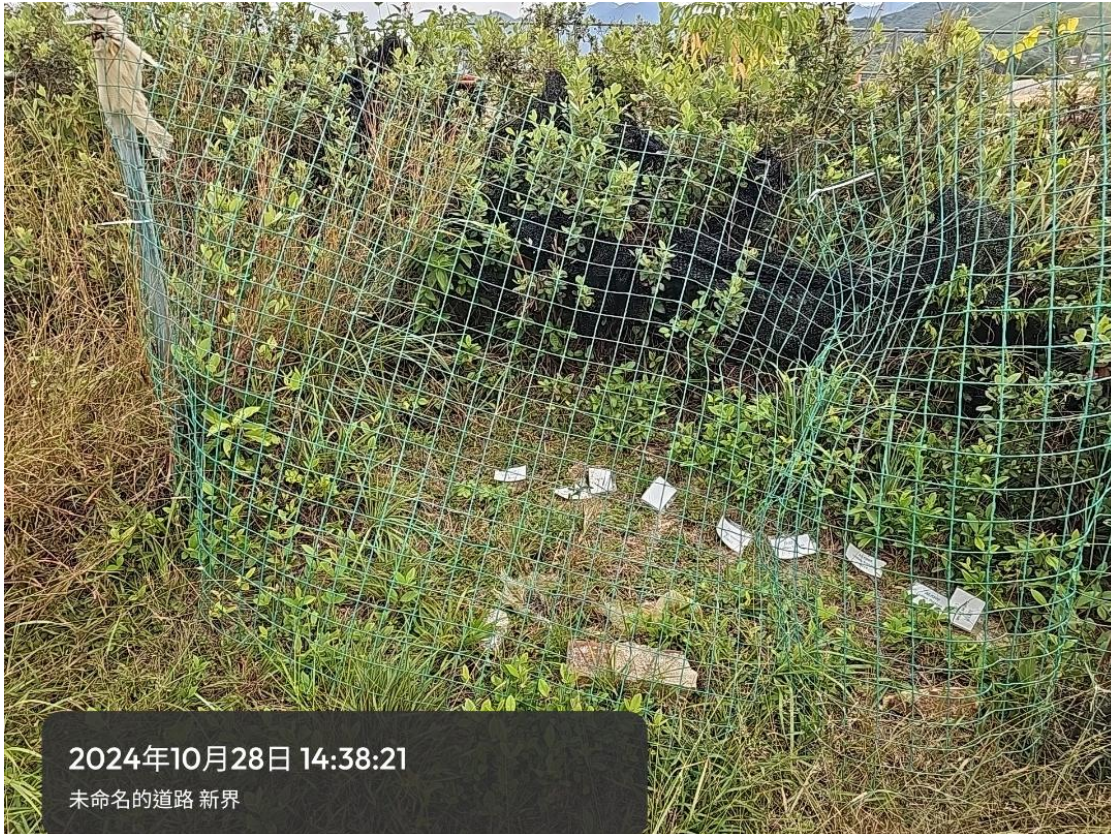
- 1) Please refer to the guidelines on soil improvement issued by the Greening, Landscape and Tree Management Section (GLTMS) of the development bureau (2022) to apply to monitoring and maintenance of transplanted flora species.
- 2) Daily watering frequency is needed to keep the soil moist.
- 3) Installation of a shaded net is provided below.
- 4) The wild plants that are growing in undesirable areas should be removed.
- 5) The damaged Black Shade Net should be repaired or replaced with a new one.

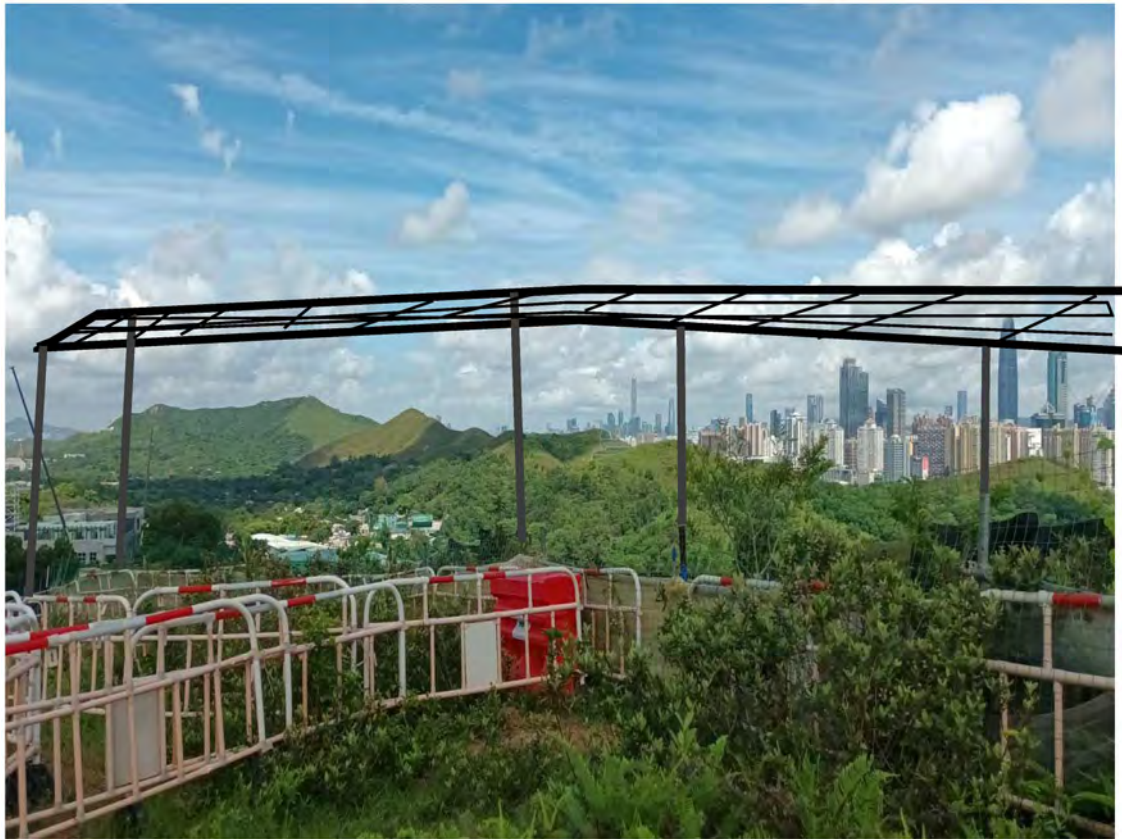
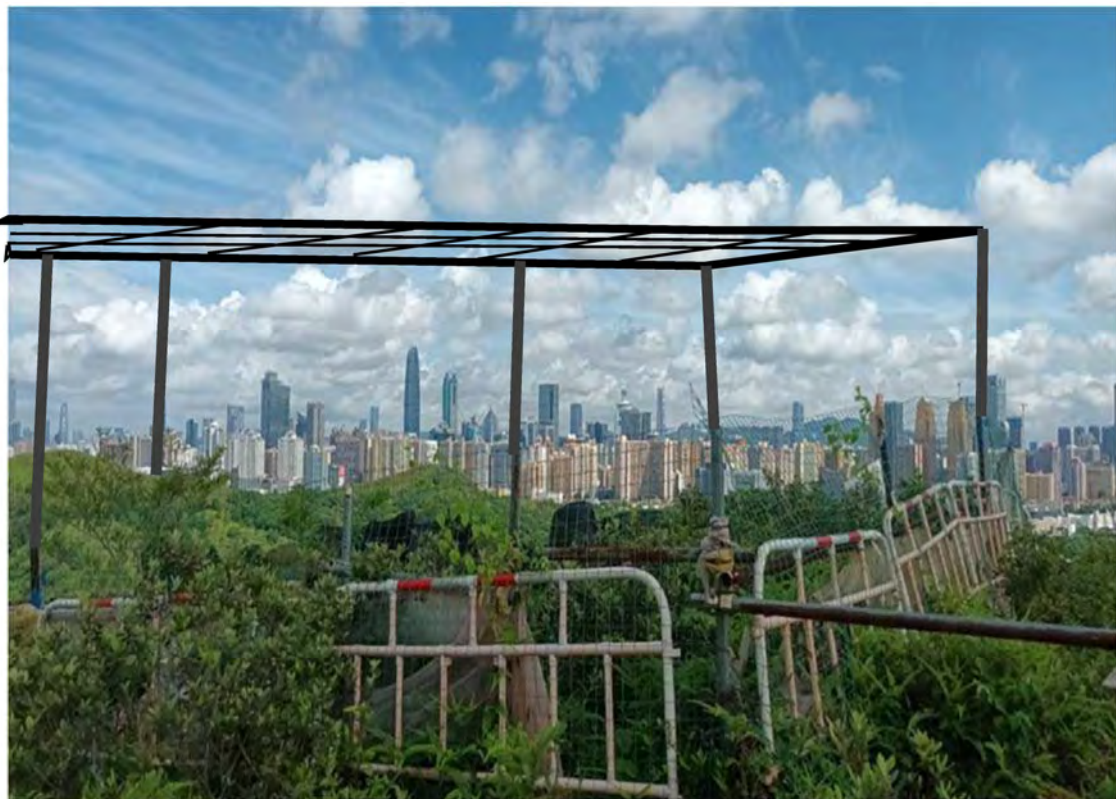
The installation of a shaded net

Remark: Non scale & Conceptual drawing
