Re: Contract No. SS K/509
Provision of Independent Environmental Checker Consultancy for Design and Construction of Kong Nga Po Police Training Facilities
Verification of Monthly EM&A Report (September 2024)

**Provision of Environmental Team consultancy
for Design and Construction of Kong Nga Po Police
Training Facilities (Programme No. 279LP)**

**Monthly Environmental Monitoring and
Audit Report for September 2024
(Version 1)**

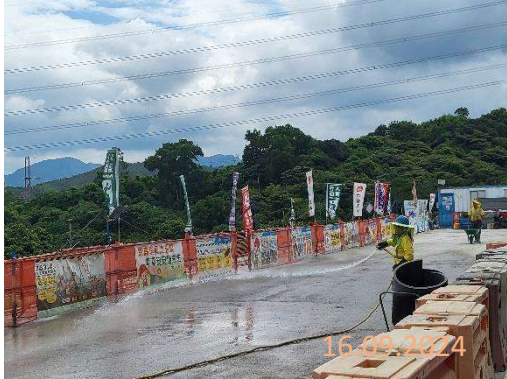
Ref*	Proposed Construction Method	Location/Working Period	Anticipated Major Impacts	Recommended Mitigation Measures	Photo Records (Partial)
EIA 3.9.1; EM&A Log 2.2	Open cut excavation	Kong Nga Po Site	Dust impact	<ul style="list-style-type: none"> • Manual water spraying for dust suppression • Regular inspection and maintenance of plant and equipment in good condition • Cover stockpile with impervious sheets or grout • Provide wheel washing facility at site entrance

<p>By main contractor at KNP site</p>

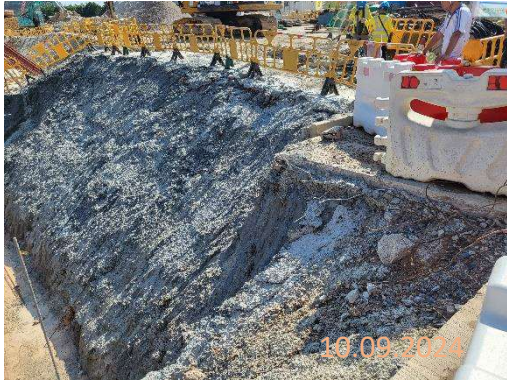
<p>By subcontractor at KNP site</p>
<p>EIA 4.4.6; EM&A Log 3.2</p>			<p>Noise</p>	<ul style="list-style-type: none"> Regular inspection and maintenance of plant & equipment in good condition Deploy Quality Powered Mechanical Equipment (QPME) if possible Valid construction noise permit should be

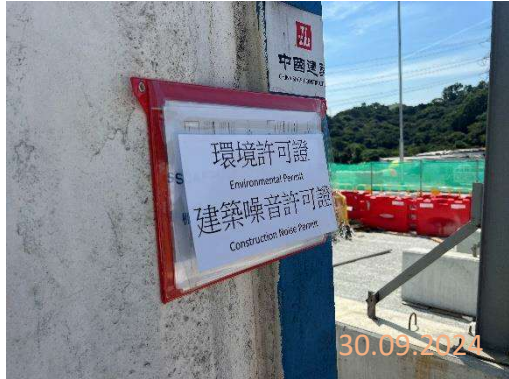
<p>By main contractor at KNP site</p>
<p>EIA 4.4.6; EM&A Log 3.2</p>			<p>Noise</p>	<ul style="list-style-type: none"> Regular inspection and maintenance of plant & equipment in good condition Deploy Quality Powered Mechanical Equipment (QPME) if possible Noise insulating fabric adopted for excavator.

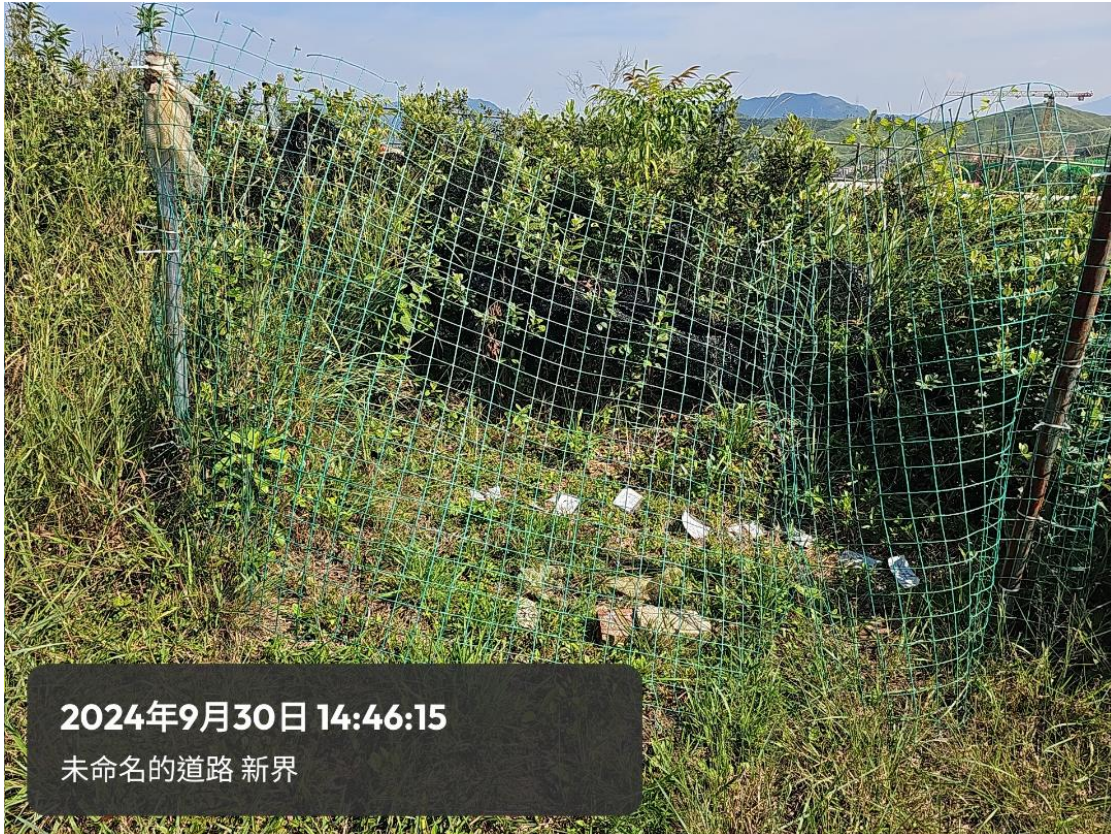
The installation of a shaded net

- 1) Please refer to the guidelines on soil improvement issued by the Greening, Landscape and Tree Management Section (GLTMS) of the development bureau (2022) to apply to monitoring and maintenance of transplanted flora species.
- 2) Daily watering frequency is needed to keep the soil moist.
- 3) Installation of a shaded net is provided below.
- 4) The wild plants that are growing in undesirable areas should be removed.
- 5) The damaged Black Shade Net should be repaired or replaced with a new one.

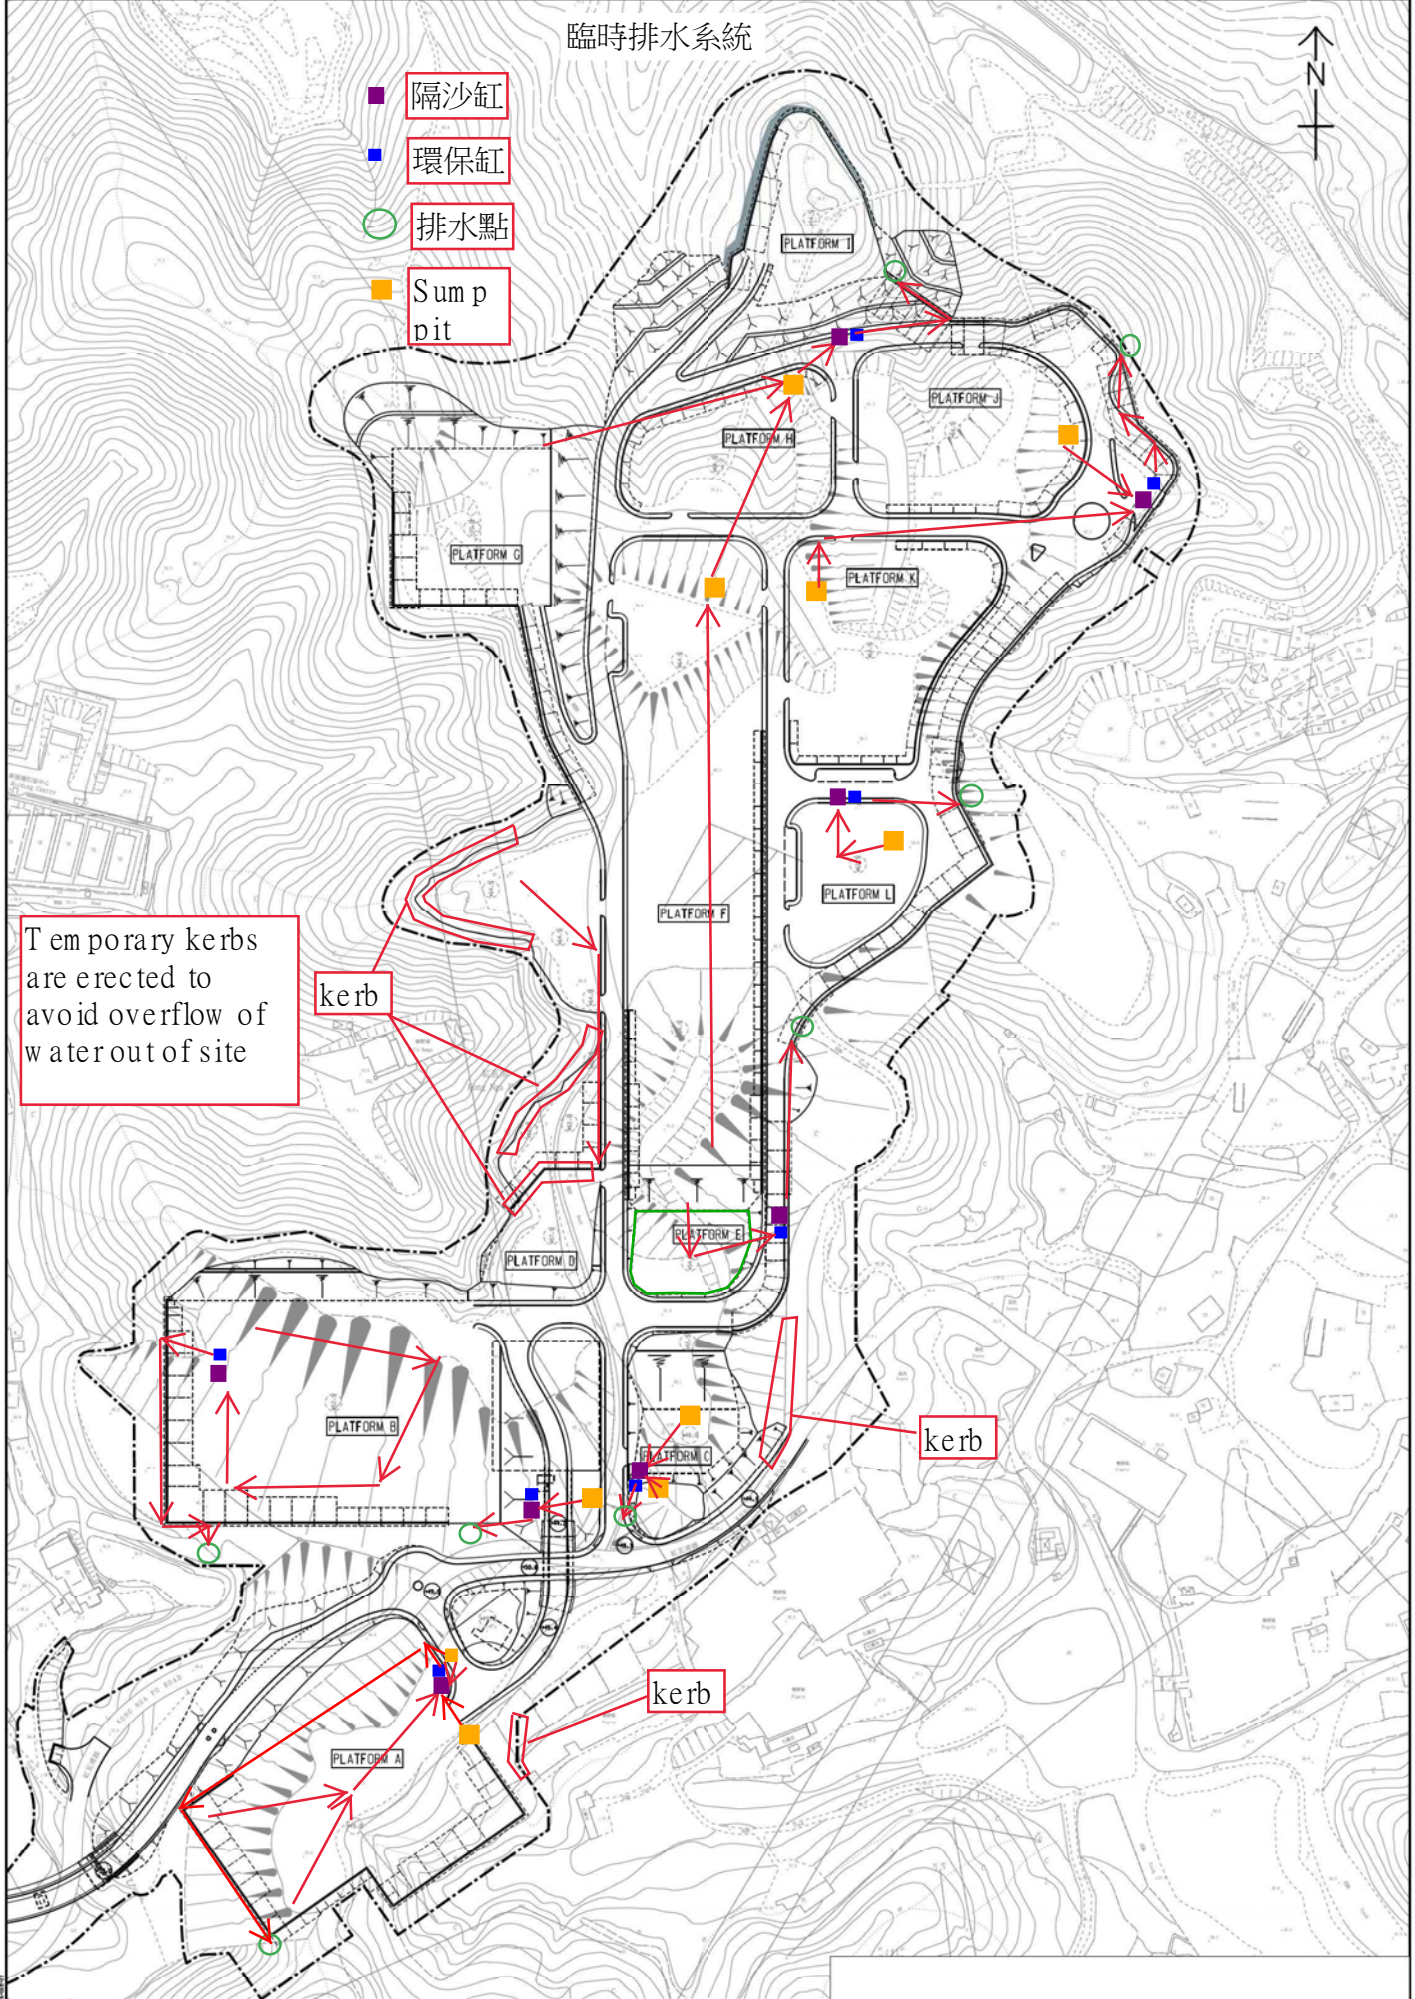
Temporary kerbs are erected to avoid overflow of water out of site
