**Provision of Independent Environmental Checker Consultancy for Design  
and Construction of Kong Nga Po Police Training Facilities  
Verification of Monthly EM&A Report (November 2024)**

**Provision of Environmental Team consultancy  
for Design and Construction of Kong Nga Po Police  
Training Facilities (Programme No. 279LP)**

**Monthly Environmental Monitoring and  
Audit Report for November 2024  
(Version 1)**

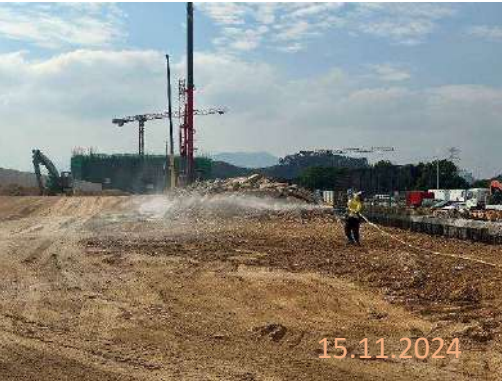
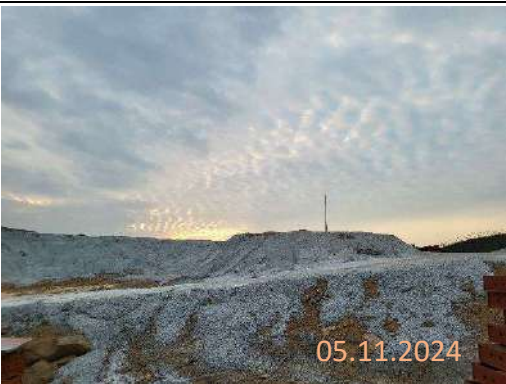
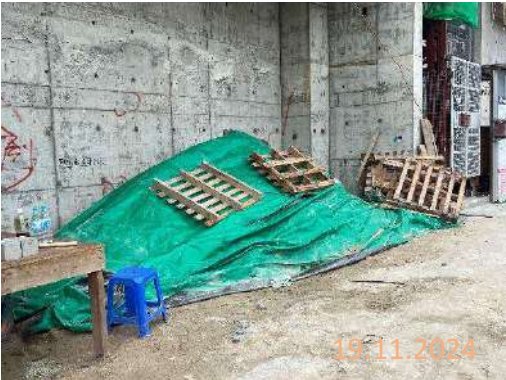
| Ref* | Proposed Construction Method | Location/Working Period | Anticipated Major Impacts | Recommended Mitigation Measures | Photo Records (Partial) |
|---|---|---|---|---|---|
| EIA 3.9.1;<br>EM&A Log<br>2.2 | Open cut excavation | Kong Nga Po Site | Dust impact | <ul style="list-style-type: none"> <li>Manual water spraying for dust suppression</li> <li>Regular inspection and maintenance of plant and equipment in good condition</li> <li>Cover stockpile with impervious sheets or grout</li> <li>Provide wheel washing facility at site entrance</li> </ul> | <p>By subcontractor at KNP site</p> |

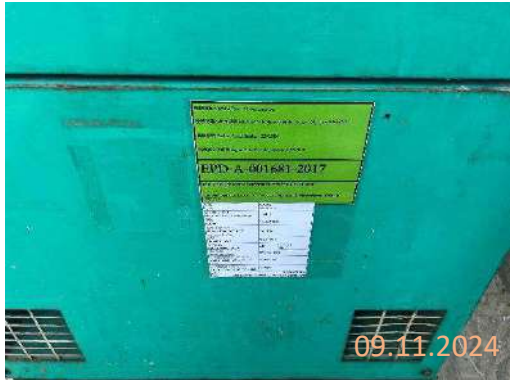
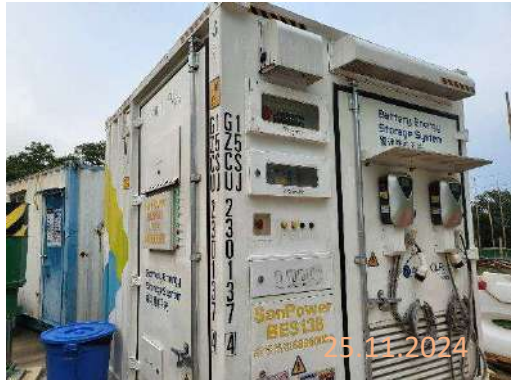
| <p>EIA 4.4.6;<br/>EM&amp;A Log<br/>3.2</p> | | | <p>Noise</p> | <ul style="list-style-type: none"> <li>• Regular inspection and maintenance of plant &amp; equipment in good condition</li> <li>• Deploy Quality Powered Mechanical Equipment (QPME) if possible</li> <li>• Valid construction noise permit should be displayed at site entrance.</li> </ul> | <div data-bbox="1541 244 2049 625"> <p>09.11.2024</p> </div> <p>By main contractor at KNP site</p> <div data-bbox="1556 678 2065 1059"> <p>25.11.2024</p> </div> <p>By main contractor at KNP site</p> |

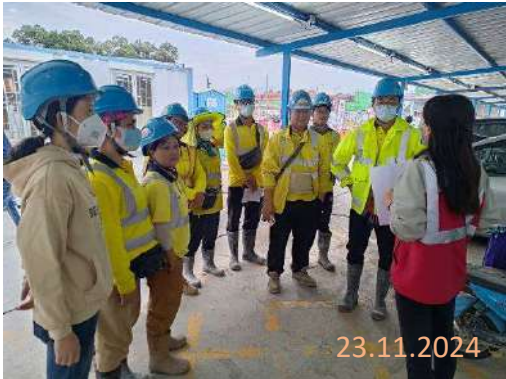
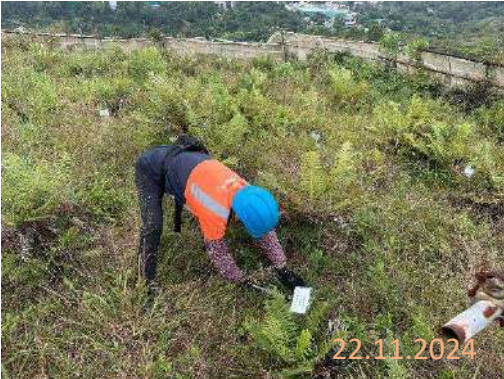
| <p>EIA 9.7.1 and<br/>EM&amp;A Log<br/>8.3</p> | | | <p>Ecology Concern</p> | <ul style="list-style-type: none"> <li>• Provide training to workers about the conservative species</li> <li>• Provision of protective fence for the conservative species</li> <li>• Regular inspection for concerned vegetation and conservative species</li> </ul> | <div data-bbox="1559 244 2063 624"> </div> <p>By main contractor at KNP site</p> <div data-bbox="1545 727 2047 1107"> </div> <p>By subcontractor at KNP site</p> |

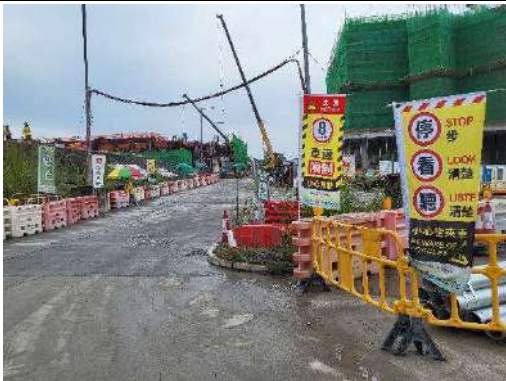
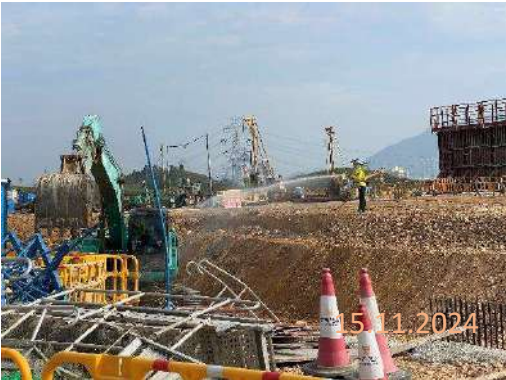
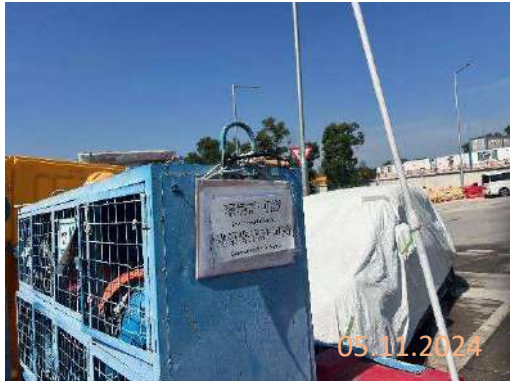
| <p>EIA 3.9.1;<br/>EM&amp;A Log<br/>2.2</p> | <p>Soil Removal</p> | <p>Kong Nga Po Site</p> | <p>Air</p> | <ul style="list-style-type: none"> <li>• Deploy water bowser for regular water spraying to enhance dust suppression</li> <li>• Cover dusty materials with impervious sheets</li> <li>• Exposed slopes covered with waterproof layers such as tarpaulin sheets or grout to reduce the potential for sediment laden runoff entering the drainage system.</li> <li>• The speed of the trucks within the site should be controlled to about 10km/hour in order to reduce adverse dust impacts and secure the safe movement around the site.</li> </ul> | <div data-bbox="1559 242 2063 624"> </div> <p>By main contractor at KNP site</p> <div data-bbox="1545 678 2049 1059"> </div> <p>By main contractor at KNP site</p> |

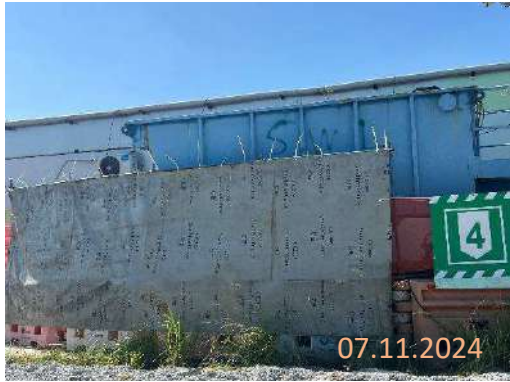
| EIA 4.4.6;<br>EM&A Log<br>3.2 | | | Noise | <ul style="list-style-type: none"> <li>Regular inspection and maintenance of plant &amp; equipment in good condition</li> <li>Deploy Quality Powered Mechanical Equipment (QPME) if possible</li> </ul> | <p>By main contractor at KNP site</p> |

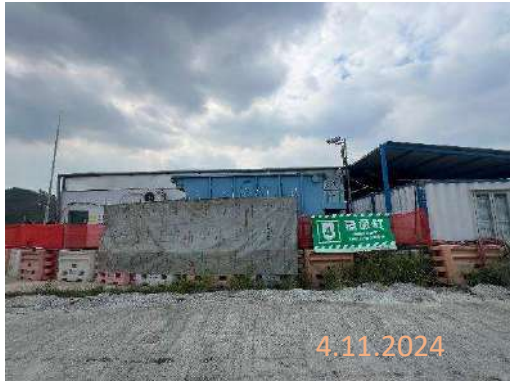
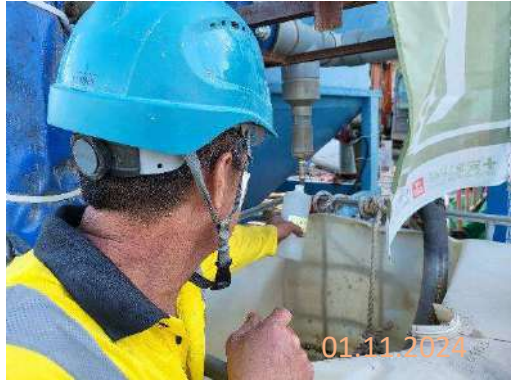
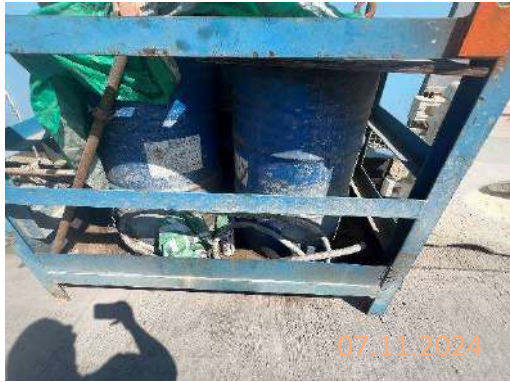
| <p>EIA 5.6.1.2<br/>and EM&amp;A<br/>Log 4.2</p> | | | <p>Water Quality</p> | <ul style="list-style-type: none"> <li>• Cover exposed slopes with impervious sheets or cement grout.</li> <li>• Wastewater pumped out of the excavation areas shall be treated to remove suspended solid prior to discharge.</li> <li>• Provide desilting/ sedimentation devices for wastewater treatment prior to discharge.</li> <li>• Provide drip tray to prevent spillage of fuels</li> </ul> | <p>4.11.2024</p> <p>By main contractor at KNP site</p><br> <p>01.11.2024</p> <p>By main contractor at KNP site</p> |

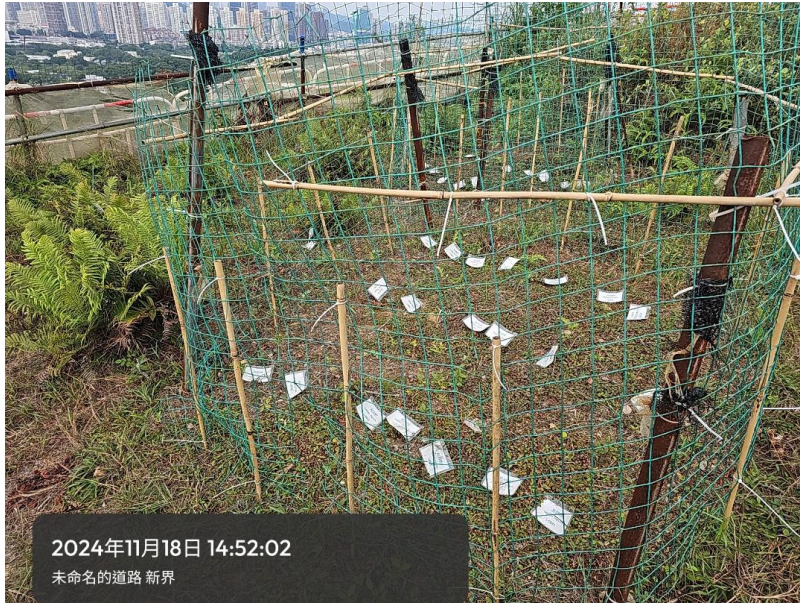
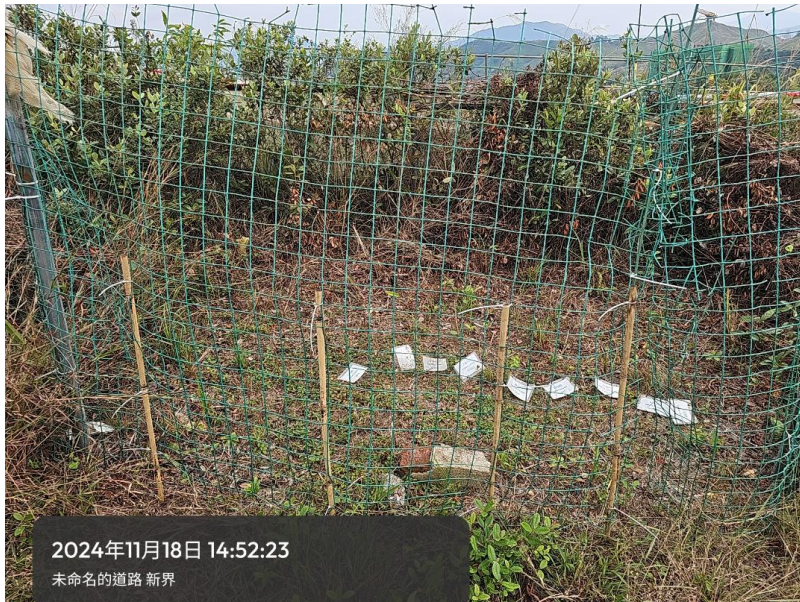
- 1) Please refer to the guidelines on soil improvement issued by the Greening, Landscape and Tree Management Section (GLTMS) of the development bureau (2022) to apply to monitoring and maintenance of transplanted flora species.
- 2) Daily watering frequency is needed to keep the soil moist.
- 3) Installation of a shaded net is provided below.
- 4) The wild plants that are growing in undesirable areas should be removed.
- 5) The damaged Black Shade Net should be repaired or replaced with a new one.
