Re: Contract No. SS K/509 Provision of Independent Environmental Checker Consultancy for Design and Construction of Kong Nga Po Police Training Facilities <u>Verification of Monthly EM&A Report (January 2025)</u>

Provision of Environmental Team consultancy for Design and Construction of Kong Nga Po Police Training Facilities (Programme No. 279LP)

Monthly Environmental Monitoring and Audit Report for December 2024 (Version 2)

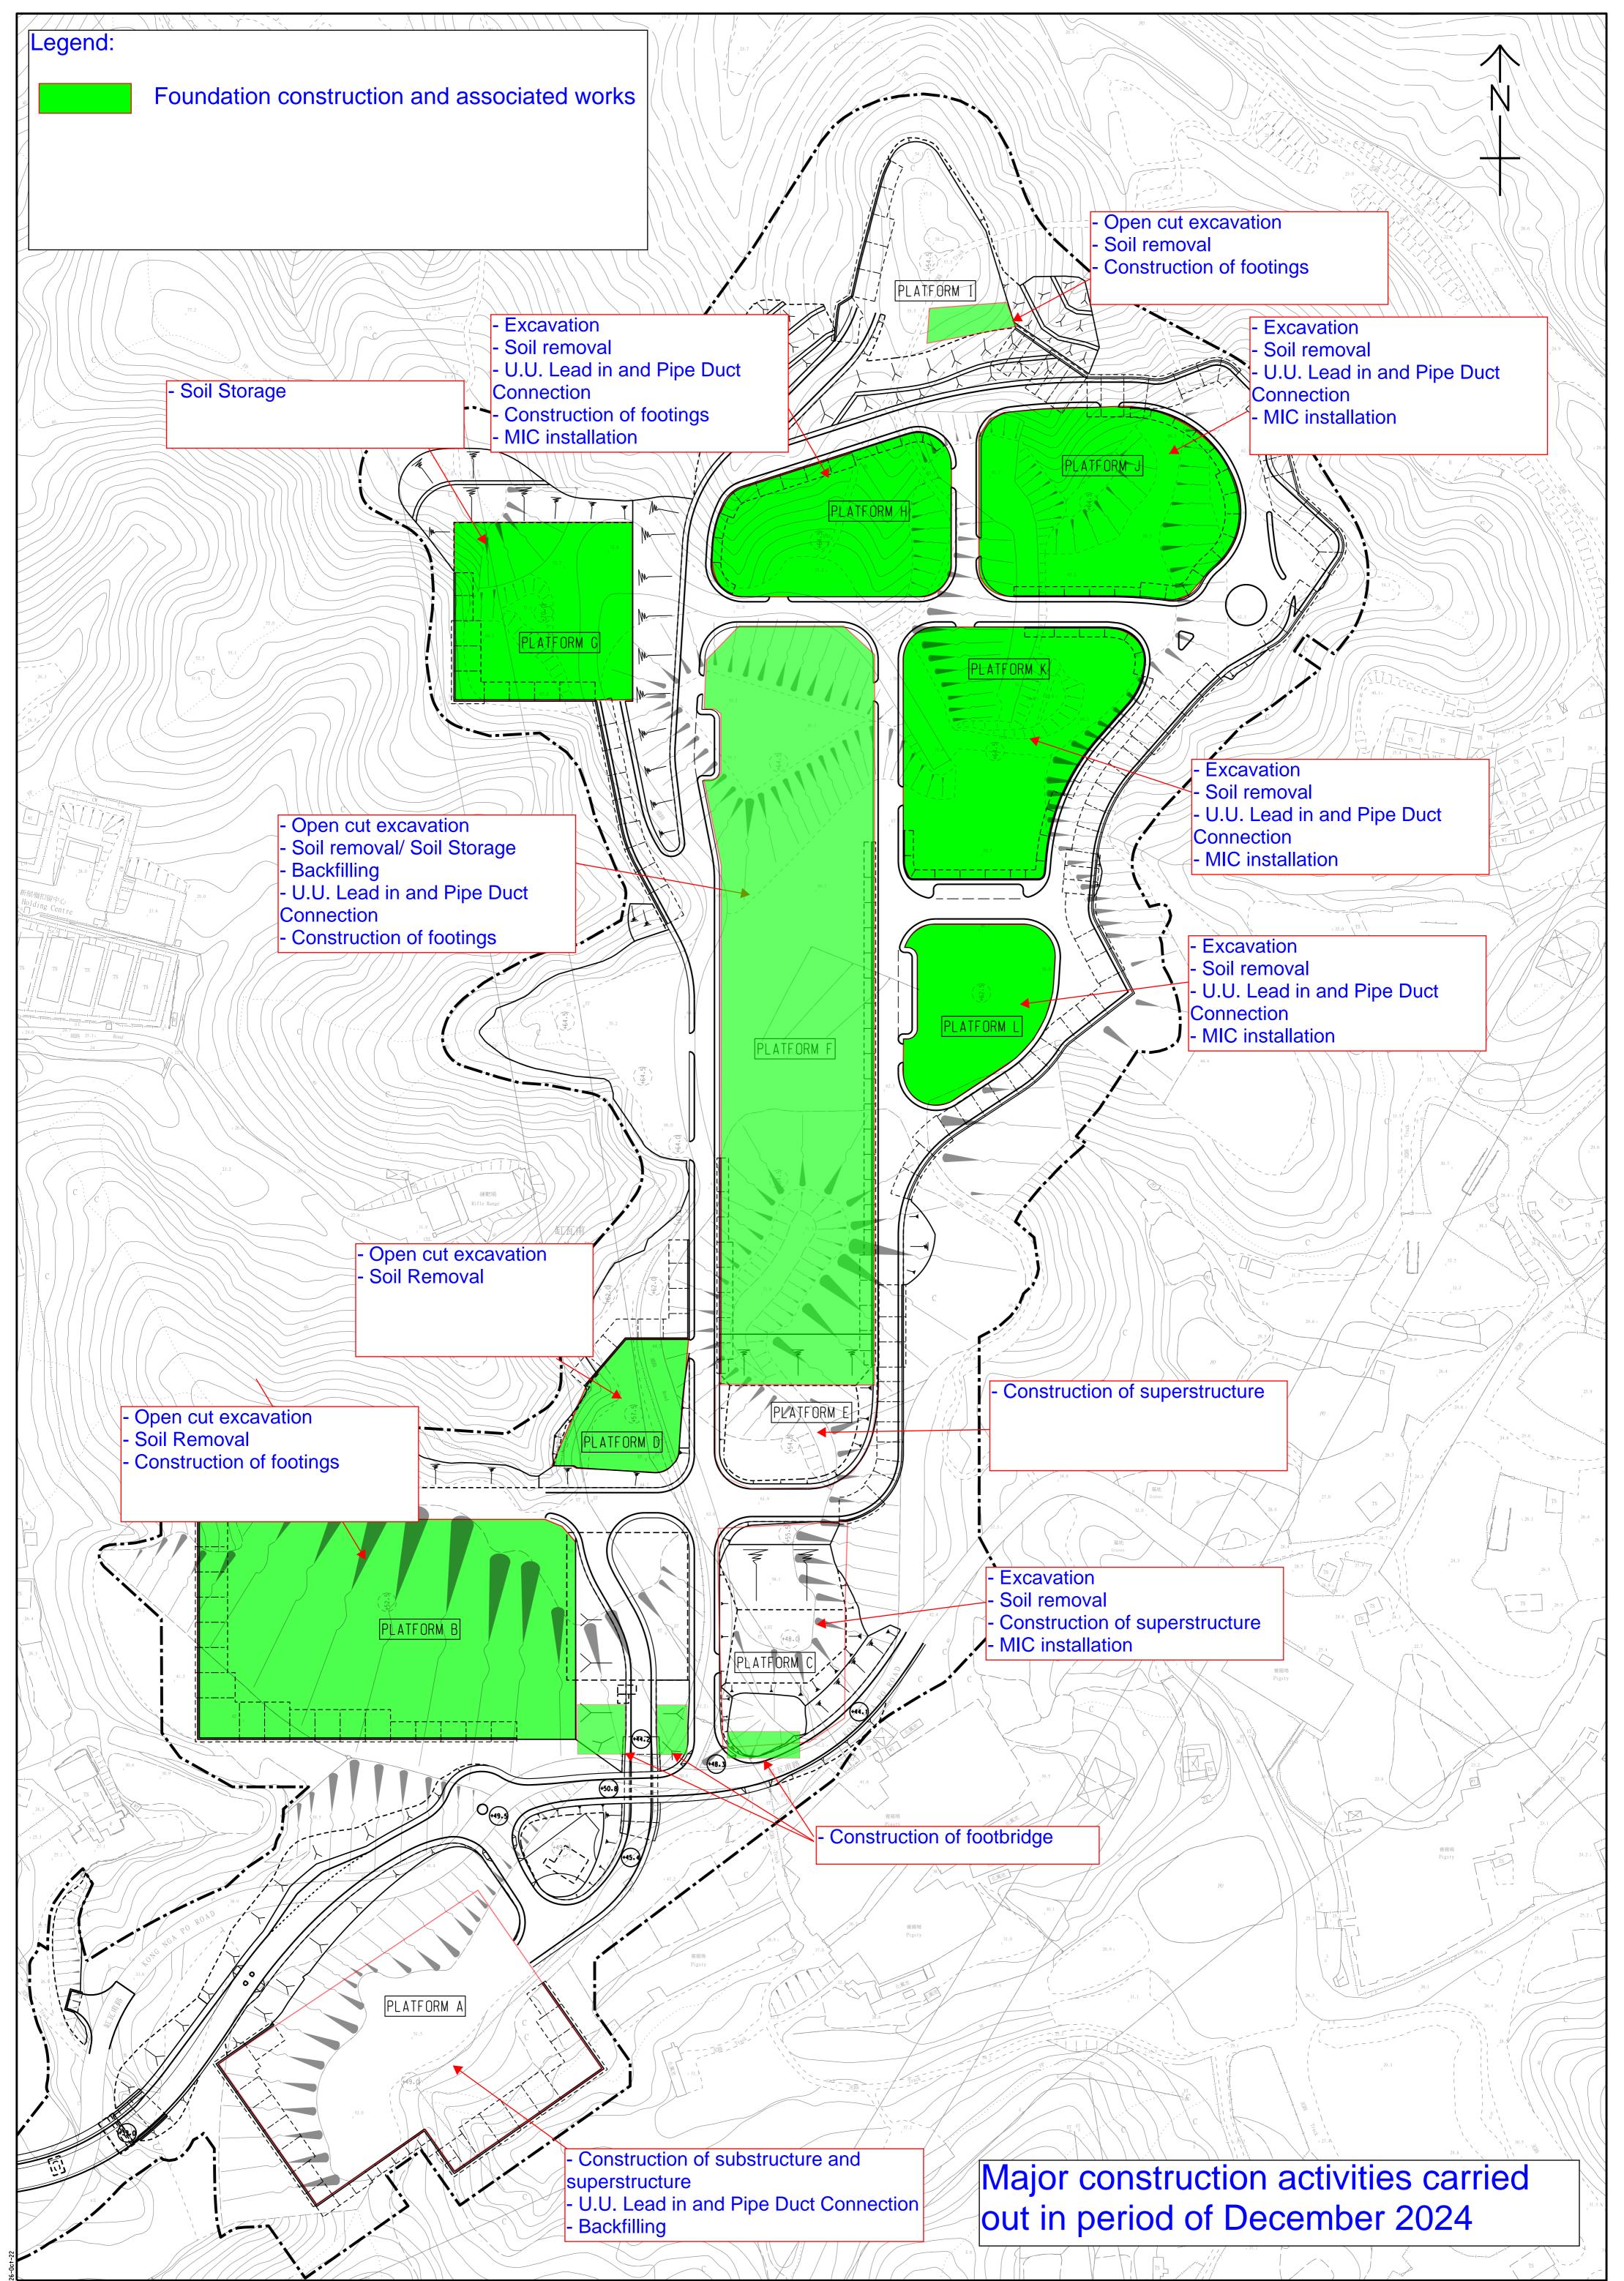
Layout Plan with major construction activities

- 6. Backfilling
 - 7. U.U. Lead in and Pipe Duct Connection
 - 8. MIC installation
- 9.2 Referring to the site layout plan found in **Appendix A**, which details the expected construction activities for the next three months, the primary environmental concerns related to these activities are likely to be construction dust, noise, water quality, waste management, landscape and visual aesthetics, and ecological impacts. The anticipated environmental effects have been factored into the mitigation strategies planned for the upcoming months.

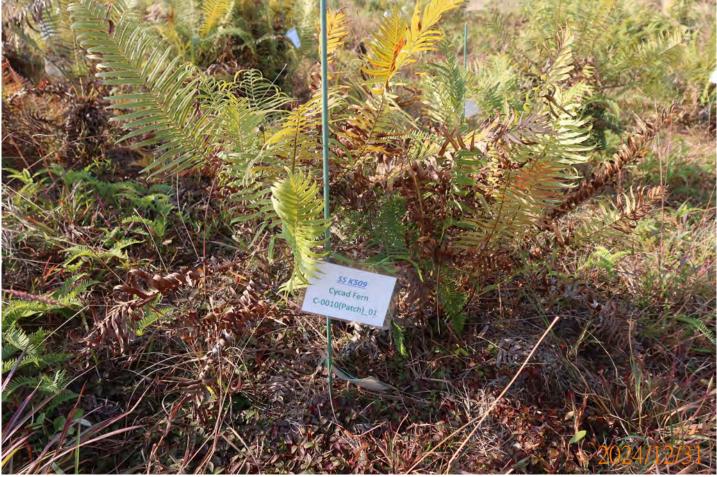
C-0009	01	Brainea insignis	F	F	Young leaves observed
C 0010	01	Brainea insignis	F	F	Young leaves observed
C-0010	02	Brainea insignis	F	F	Young leaves observed
	03	Brainea insignis	F	F	Young leaves observed
	01	Brainea insignis	Р	Р	Dry out caused by bushfire initially outside site boundary and high temperature on 2 Feb 2021
	02	Brainea insignis	F	Р	-
	03	Brainea insignis	Р	Р	Young leaves at base
	04	Brainea insignis	F	F	Young leaves at base
G 0011	05	Brainea insignis	F	Р	Young leaves at base
C-0011	06	Brainea insignis	F	F	Young leaves at base
	07	Brainea insignis	Р	Р	Young leaves at base
	08	Brainea insignis	F	F	Young leaves observed
	09	Brainea insignis	Р	Р	-
	10	Brainea insignis	F	F	Young leaves observed
	11	Brainea insignis	F	F	Young leaves observed
	12	Brainea insignis	Р	Р	-
	13	Brainea insignis	F	F	Young leaves observed

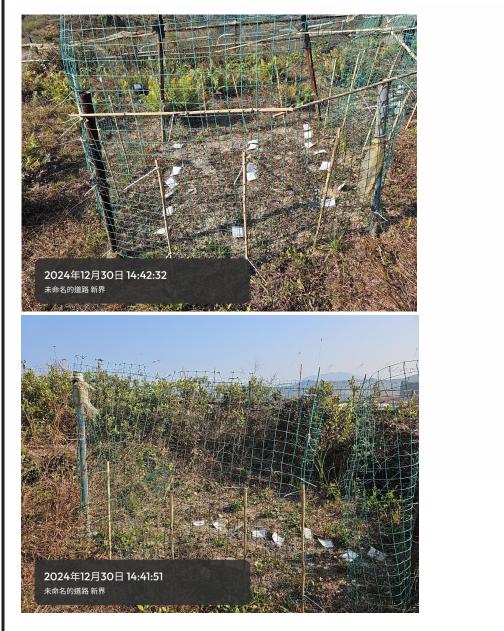
The installation of a shaded net

- 2) Daily watering frequency is needed to keep the soil moist.
- 3) Installation of a shaded net is provided below.
- 4) The wild plants that are growing in undesirable areas should be removed.
- 5) The Black Shade Net should be installed.

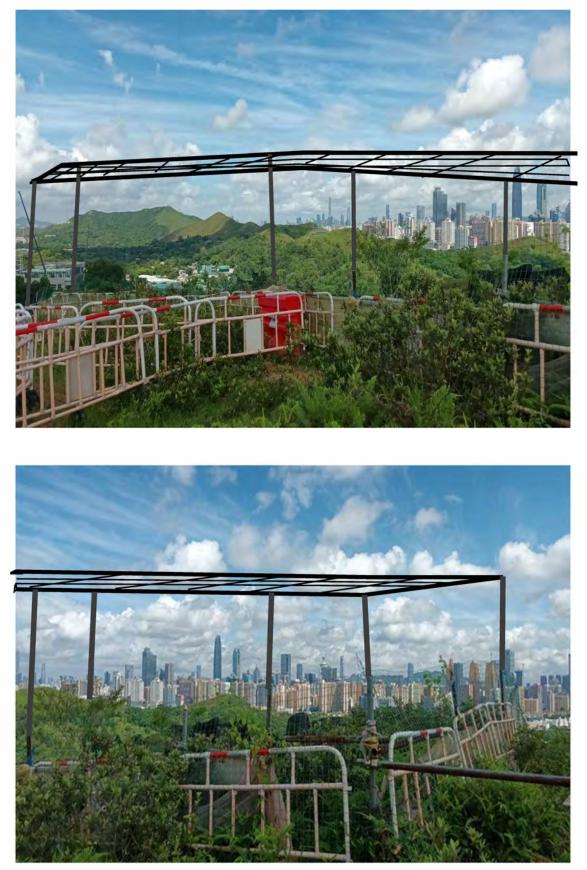
Remark: Non scale & Conceptual drawing

- To maintain soil moisture, daily watering is required;
- To install a shaded net;
- To refer to the Guidelines on Soil Improvement issued by the Greening, Landscape and Tree Management Section (GLTMS) of the Development Bureau (2022) for the effective monitoring and maintenance of transplanted flora species; and
- The wild plants that are growing in undesirable areas should be removed, as they compete with the cultivated flora species of conservation interest.
