Provision of Independent Environmental Checker Consultancy for Design and Construction of Kong Nga Po Police Training Facilities **Verification of Monthly EM&A Report (January 2025)**

Monthly Environmental Monitoring and Audit Report for January 2025 (Version 3)

Provision of Environmental Team consultancy for Design and Construction of Kong Nga Po Police Training Facilities (Programme no. 279LP) Monthly EM&A Report – January 2025

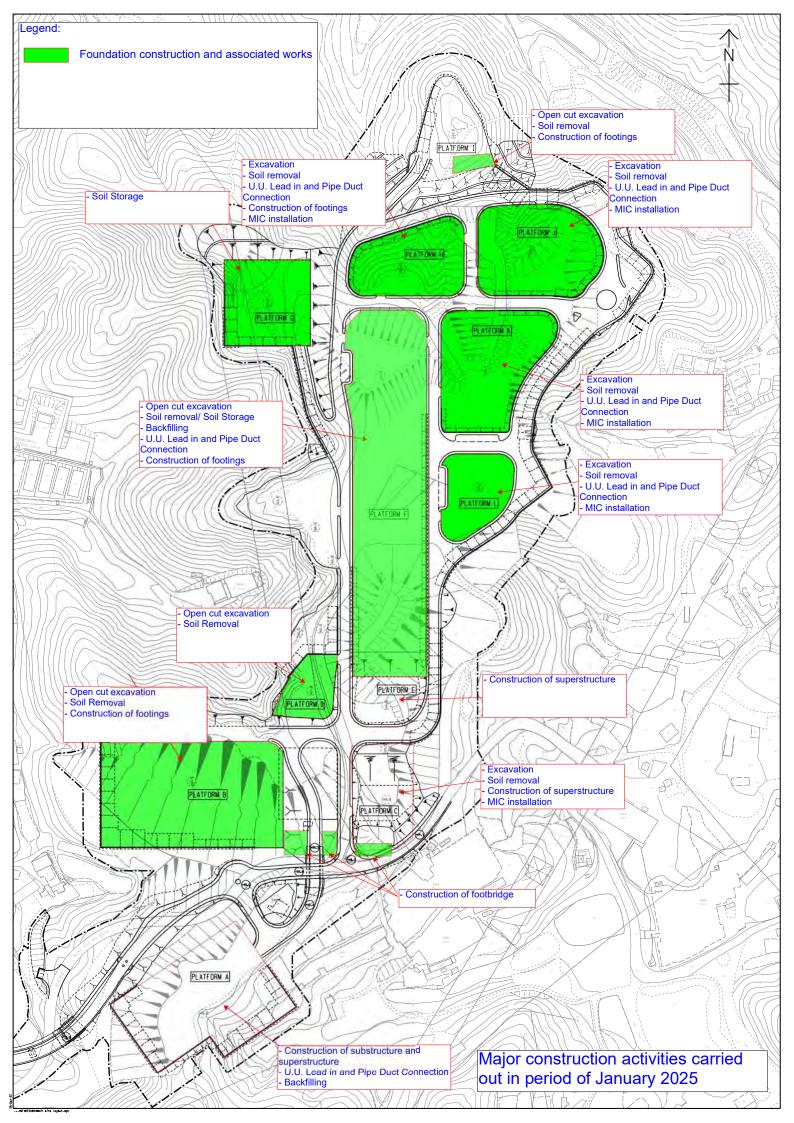
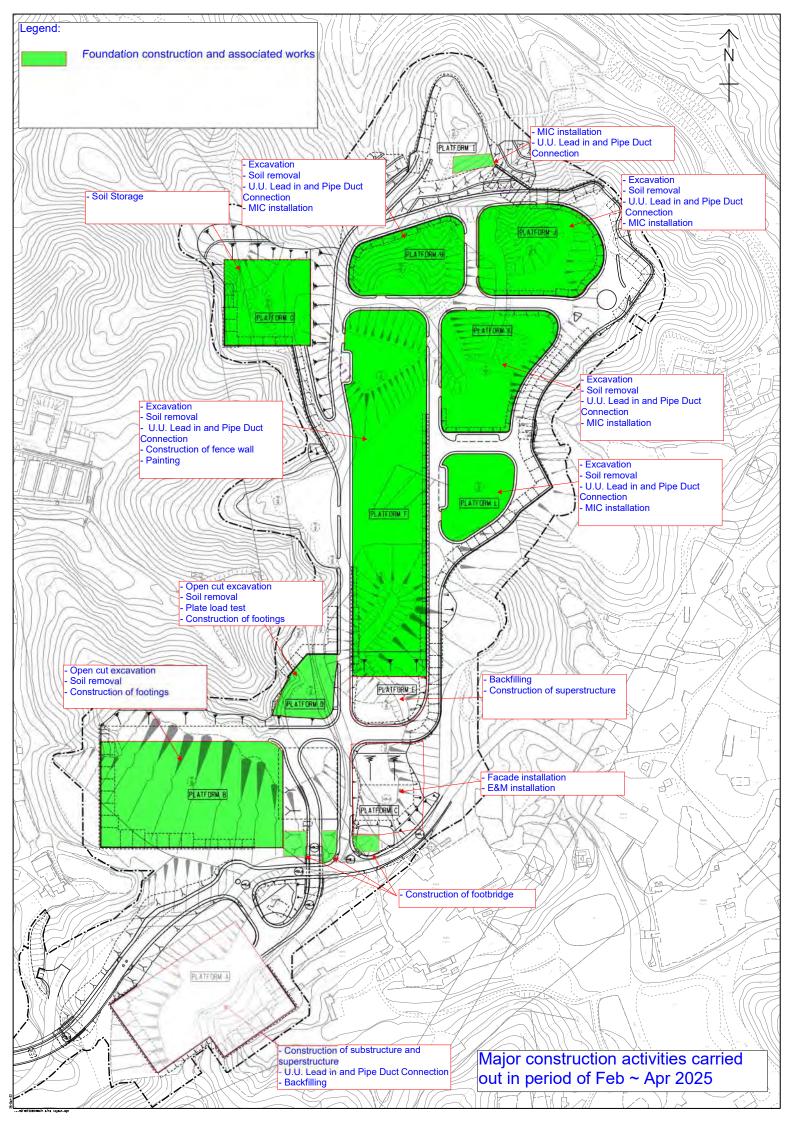
Layout Plan with major construction activities

- 6. Construction of fence wall and boundary wall
 - 7. Backfilling
 - 8. U.U. Lead in and Pipe Duct Connection
 - 9. MIC installation
- 9.2 Referring to the site layout plan found in **Appendix A**, which details the expected construction activities for the next three months, the primary environmental concerns related to these activities are likely to be construction dust, noise, water quality, waste management, landscape and visual aesthetics, and ecological impacts. The anticipated environmental effects have been factored into the mitigation strategies planned for the upcoming months.

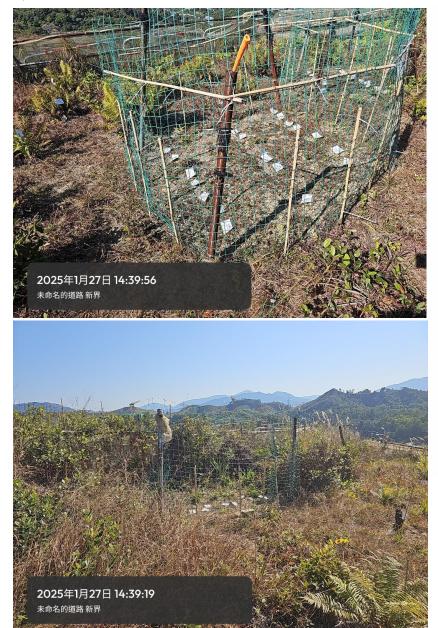
- 1) Please refer to the guidelines on soil improvement issued by the Greening, Landscape and Tree Management Section (GLTMS) of the development bureau (2022) to apply to monitoring and maintenance of transplanted flora species.
- 2) Daily watering frequency is needed to keep the soil moist.
- 3) Installation of a shaded net is provided below.
- 4) The wild plants that are growing in undesirable areas should be removed.
- 5) The Black Shade Net should be installed.

The installation of a shaded net
