Provision of Independent Environmental Checker Consultancy for Design and Construction of Kong Nga Po Police Training Facilities Verification of Monthly EM&A Report (March 2025)

Monthly Environmental Monitoring and Audit Report for March 2025 (Version 2)

Provision of Environmental Team consultancy for Design and Construction of Kong Nga Po Police Training Facilities (Programme no. 279LP) Monthly EM&A Report – March 2025

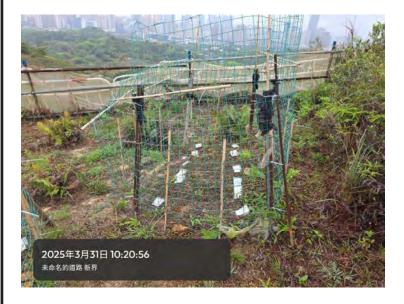
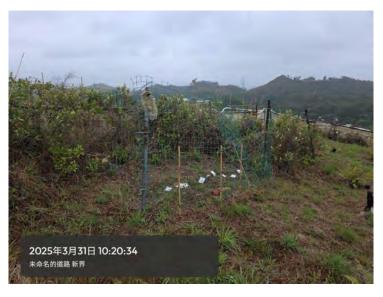
- 1) Please refer to the guidelines on soil improvement issued by the Greening, Landscape and Tree Management Section (GLTMS) of the development bureau (2022) to apply to monitoring and maintenance of transplanted flora species.
- 2) Daily watering frequency is needed to keep the soil moist.
- 3) Installation of a shaded net is provided below.
- 4) The wild plants that are growing in undesirable areas should be removed.
- 5) The Black Shade Net should be installed.

The installation of a shaded net

- To maintain soil moisture, daily watering is required;
- To install a shaded net;
- To refer to the Guidelines on Soil Improvement issued by the Greening, Landscape and Tree Management Section (GLTMS) of the Development Bureau (2022) for the effective monitoring and maintenance of transplanted flora species; and
- The wild plants that are growing in undesirable areas should be removed, as they compete with the cultivated flora species of conservation interest.
