**Provision of Independent Environmental Checker Consultancy for Design  
and Construction of Kong Nga Po Police Training Facilities  
Verification of Monthly EM&A Report (July 2025)**

**Provision of Environmental Team consultancy  
for Design and Construction of Kong Nga Po Police  
Training Facilities (Programme No. 279LP)**

**Monthly Environmental Monitoring and  
Audit Report for July 2025  
(Version 1.0)**

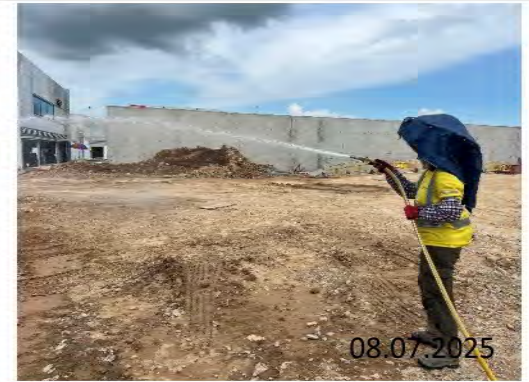
| Ref* | Proposed Construction Method | Location/Working Period | Anticipated Major Impacts | Recommended Mitigation Measures | Photo Records (Partial) |
|---|---|---|---|---|---|
| EIA 3.9.1;<br>EM&A Log<br>2.2 | Open cut excavation | Kong Nga Po Site | Dust impact | <ul style="list-style-type: none"> <li>Manual water spraying for dust suppression</li> <li>Regular inspection and maintenance of plant and equipment in good condition</li> <li>Cover stockpile with impervious sheets or grout</li> <li>Provide wheel washing facility at site entrance</li> </ul> | <p>By subcontractor at KNP site</p> |

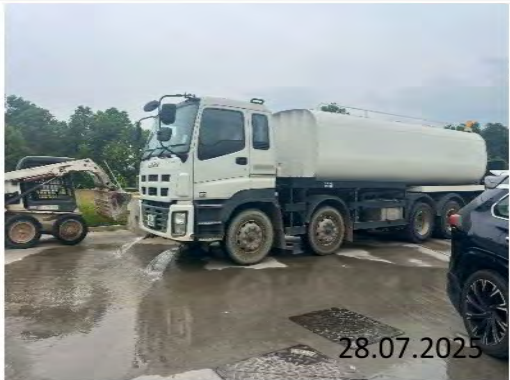
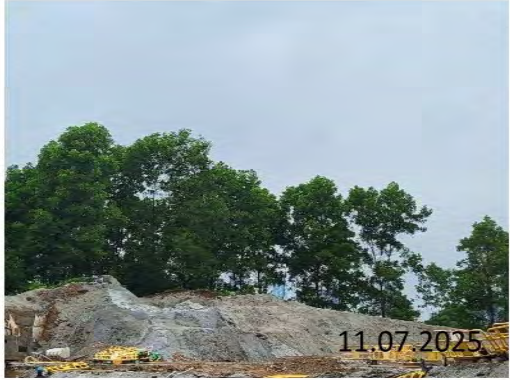
| | | | | | <div data-bbox="1541 244 2049 625"><p>28.07.2025</p></div> <div data-bbox="1541 635 1912 671"><p>By subcontractor at KNP site</p></div> <div data-bbox="1541 681 2049 1062"><p>11.07.2025</p></div> <div data-bbox="1541 1072 1912 1107"><p>By subcontractor at KNP site</p></div> |

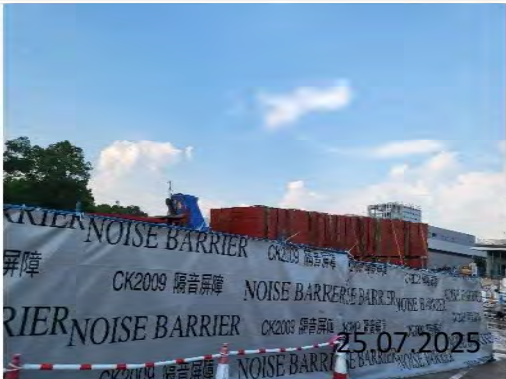
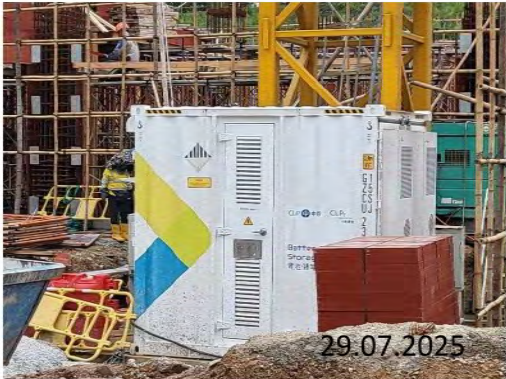
| <p>EIA 4.4.6;<br/>EM&amp;A Log<br/>3.2</p> | | | <p>Noise</p> | <ul style="list-style-type: none"> <li>• Regular inspection and maintenance of plant &amp; equipment in good condition</li> <li>• Deploy Quality Powered Mechanical Equipment (QPME) if possible</li> <li>• Valid construction noise permit should be displayed at site entrance.</li> </ul> | <div data-bbox="1559 244 2063 624"> </div> <p>By main contractor at KNP site</p> <div data-bbox="1559 679 2063 1059"> </div> <p>By main contractor at KNP site</p> |

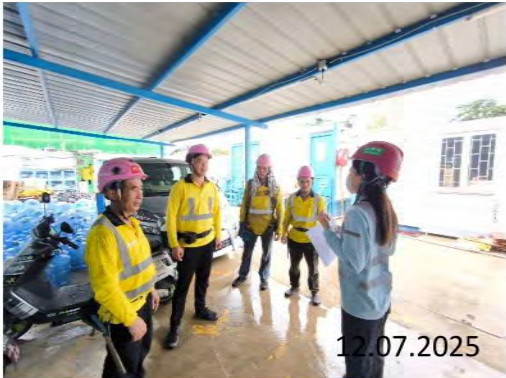
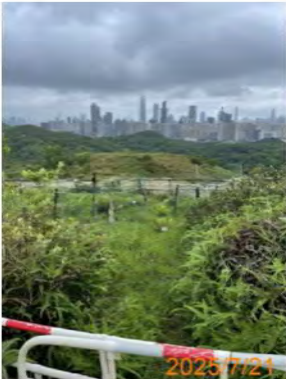
| <p>EIA 9.7.1 and<br/>EM&amp;A Log<br/>8.3</p> | | | <p>Ecology Concern</p> | <ul style="list-style-type: none"> <li>• Provide training to workers about the conservative species</li> <li>• Provision of protective fence for the conservative species</li> <li>• Regular inspection for concerned vegetation and conservative species</li> </ul> | <div data-bbox="1559 245 2063 624"> <p>12.07.2025</p> </div> <p>By main contractor at KNP site</p> <div data-bbox="1545 727 1830 1107"> <p>2025/7/21</p> </div> <p>By subcontractor at KNP site</p> |

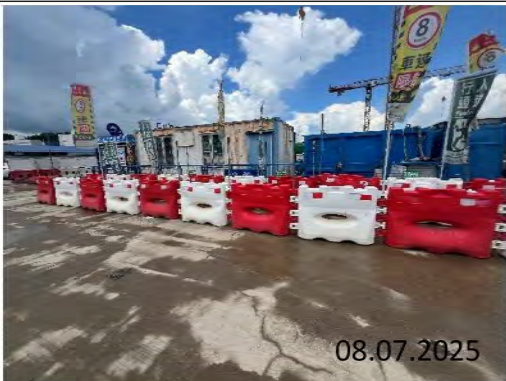
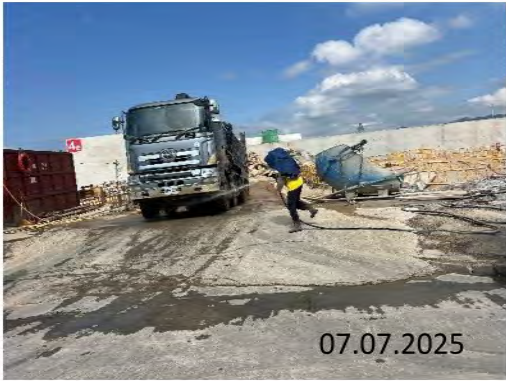
| <p>EIA 3.9.1;<br/>EM&amp;A Log<br/>2.2</p> | <p>Soil Removal</p> | <p>Kong Nga Po Site</p> | <p>Air</p> | <ul style="list-style-type: none"> <li>• Deploy water bowser for regular water spraying to enhance dust suppression</li> <li>• Cover dusty materials with impervious sheets</li> <li>• Exposed slopes covered with waterproof layers such as tarpaulin sheets or grout to reduce the potential for sediment laden runoff entering the drainage system.</li> <li>• The speed of the trucks within the site should be controlled to about 10km/hour in order to reduce adverse dust impacts and secure the safe movement around the site.</li> </ul> | <div data-bbox="1559 242 2063 624"> <p>08.07.2025</p> </div> <p>By main contractor at KNP site</p> <div data-bbox="1559 679 2063 1061"> <p>07.07.2025</p> </div> <p>By subcontractor at KNP site</p> |

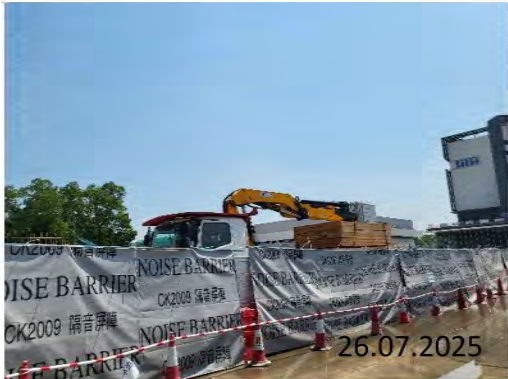
| EIA 4.4.6;<br>EM&A Log<br>3.2 | | | Noise | <ul style="list-style-type: none"> <li>Regular inspection and maintenance of plant &amp; equipment in good condition</li> <li>Deploy Quality Powered Mechanical Equipment (QPME) if possible</li> </ul> | <p>By main contractor at KNP site</p> |

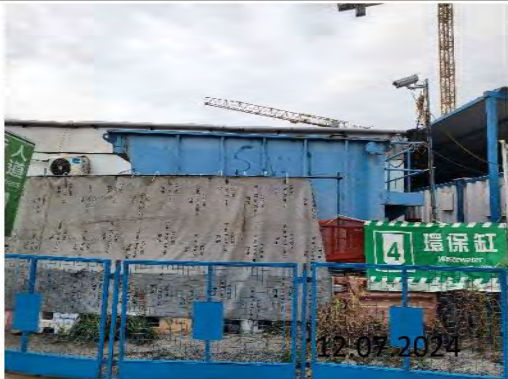
| EIA 5.6.1.2<br>and EM&A<br>Log 4.2 | | | Water Quality | <ul style="list-style-type: none"> <li>Cover exposed slopes with impervious sheets or cement grout.</li> <li>Wastewater pumped out of the excavation areas shall be treated to remove suspended solid prior to discharge.</li> <li>Provide desilting/ sedimentation devices for wastewater treatment prior to discharge.</li> </ul> | <p>By main contractor at KNP site</p> |

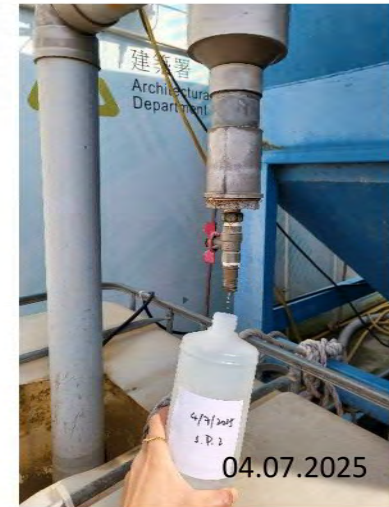
- Provide drip tray to prevent spillage of fuels

By main contractor at KNP site

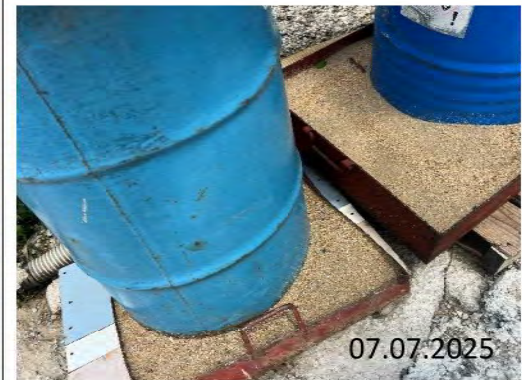
By main contractor at KNP site

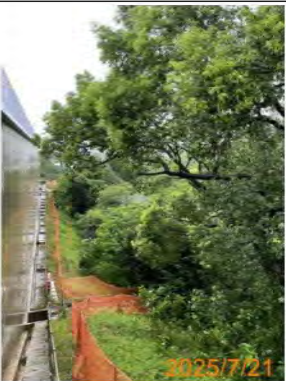
| <p>EIA Table 10.11;<br/>EM&amp;A Table 9.1</p> | | | <p>Landscape and Visual Impact</p> | <ul style="list-style-type: none"> <li>• Preservation of existing trees will be undertaken in accordance with DEVB TC(W) 7/2015 and Guidelines for Tree Risk Assessment and Management Arrangement</li> <li>• Implement temporary traffic arrangement which control construction area to minimize landscape and visual impacts</li> <li>• Minimize visual impact during construction stage. Site office not visually prominent from public room and surrounding</li> <li>• Planting will take place as soon the planting area is installed with</li> </ul> | <div data-bbox="1563 242 1848 624"> </div> <p>By main contractor at KNP site</p> |

| | | | | subsoil drainage <ul style="list-style-type: none"> <li>Decorative hoarding is provided</li> </ul> | |

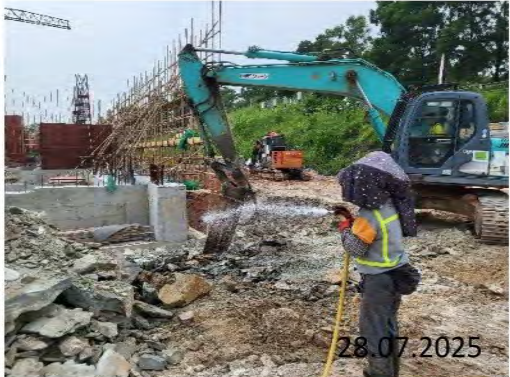
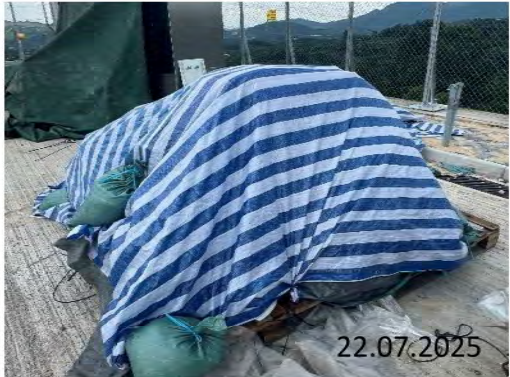
| EIA 3.9.1;<br>EM&A Log<br>2.2 | Construction of footings, substructure and superstructure | Kong Nga Po Site | Air | <ul style="list-style-type: none"> <li>Cover dusty materials with impervious sheets</li> <li>Exposed slopes covered with waterproof layers such as tarpaulin sheets or grout to reduce the potential for sediment laden runoff entering the drainage system.</li> <li>Provide wheel washing facility at site entrance</li> </ul> | <p>By subcontractor at KNP site</p> <p>By subcontractor at KNP site</p> |

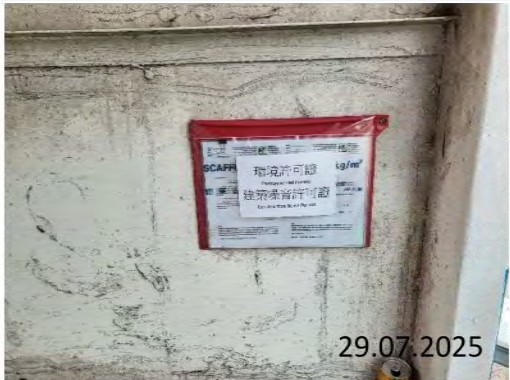
| EIA 4.4.6;<br>EM&A Log<br>3.2 | | | Noise | <ul style="list-style-type: none"> <li>Valid construction noise permit should be obtained and displayed on site</li> </ul> | <p>29.07.2025</p> <p>By main contractor at KNP site</p> |

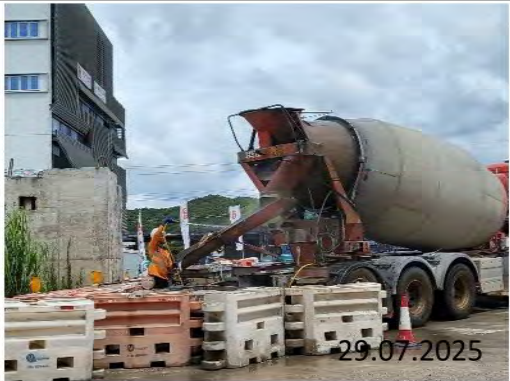
| EIA 5.6.1.3<br>and EM&A<br>Log 4.2 | | | Water Quality | <ul style="list-style-type: none"> <li>Surface water from concrete batching areas and the rest of the site should be separated as far as possible.</li> <li>Temporary drainage is free of obstruction.</li> <li>Gullies are sealed to prevent silt or debris from entering the drainage system.</li> </ul> | <p>29.07.2025</p> <p>By subcontractor at KNP site</p> |

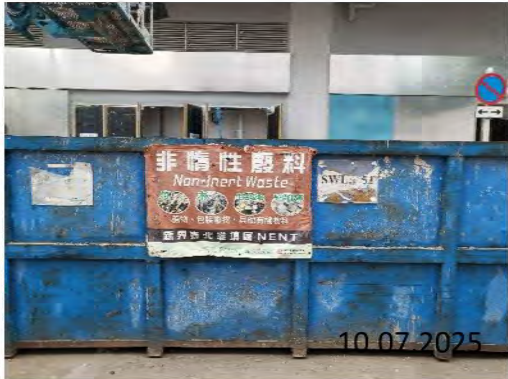
| EIA 7.5.1.2<br>and EM&A<br>Log 6.2 | | | Waste<br>Management | <ul style="list-style-type: none"> <li>• Segregation and storage of different types of waste in different containers or skips or stockpiles to enhance reuse or recycling of materials and their proper disposal</li> <li>• Sort non-inert C&amp;D materials to recover any recyclable portions</li> </ul> | <p>By main contractor at KNP site</p> |

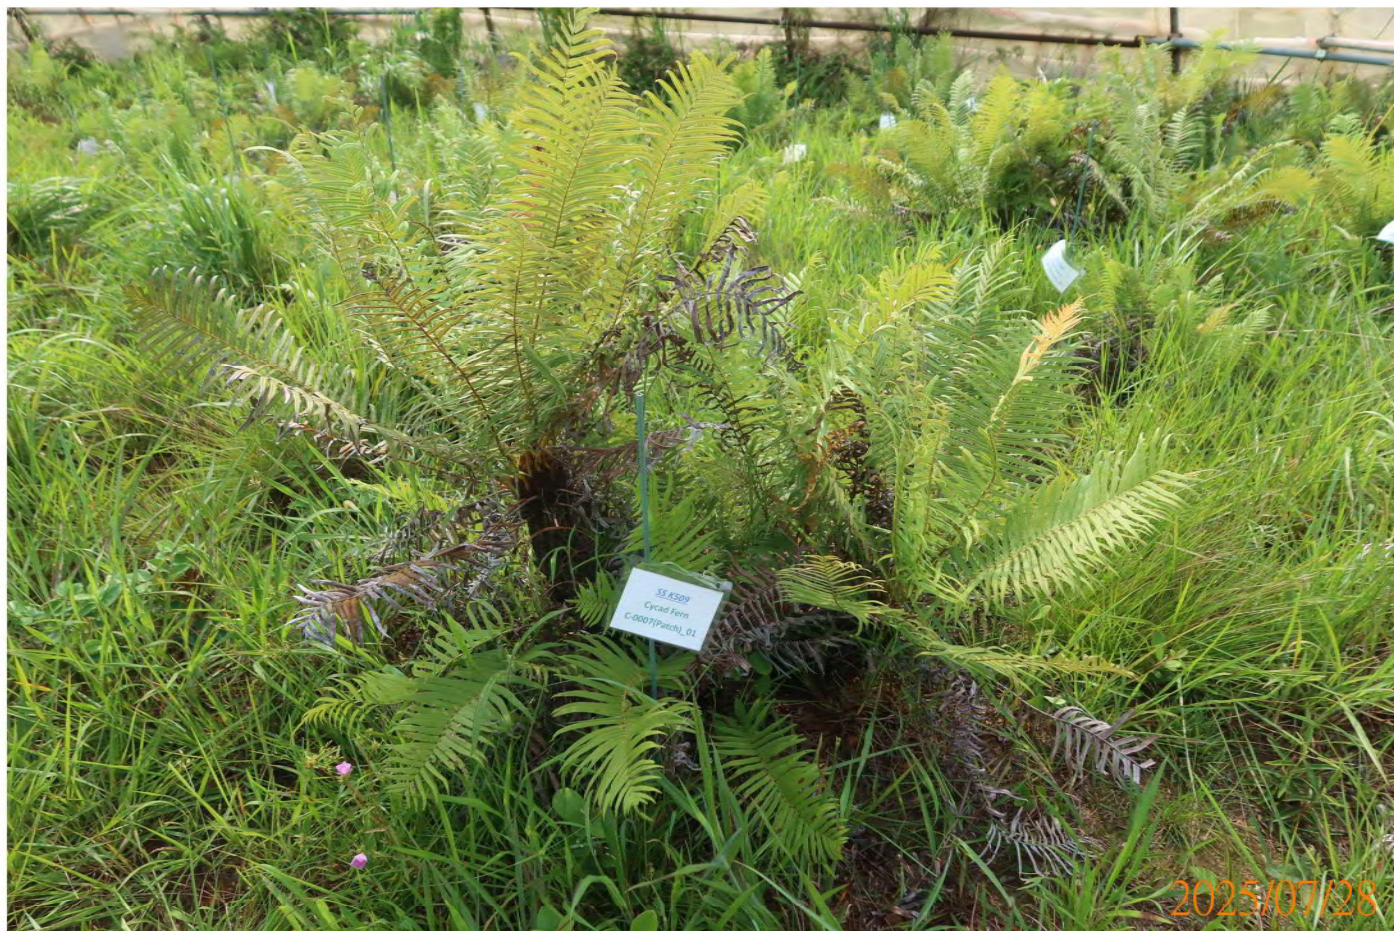
| Tree/Plant/<br>Colony No. | Number of<br>Individuals | Species Name | Form<br>(Good/Fair/Poor) | Health<br>(Good/Fair/Poor) | Remark |
|---|---|---|---|---|---|
| C-0006 | 01 | <i>Brainea insignis</i> | F | F | Young leaves observed |

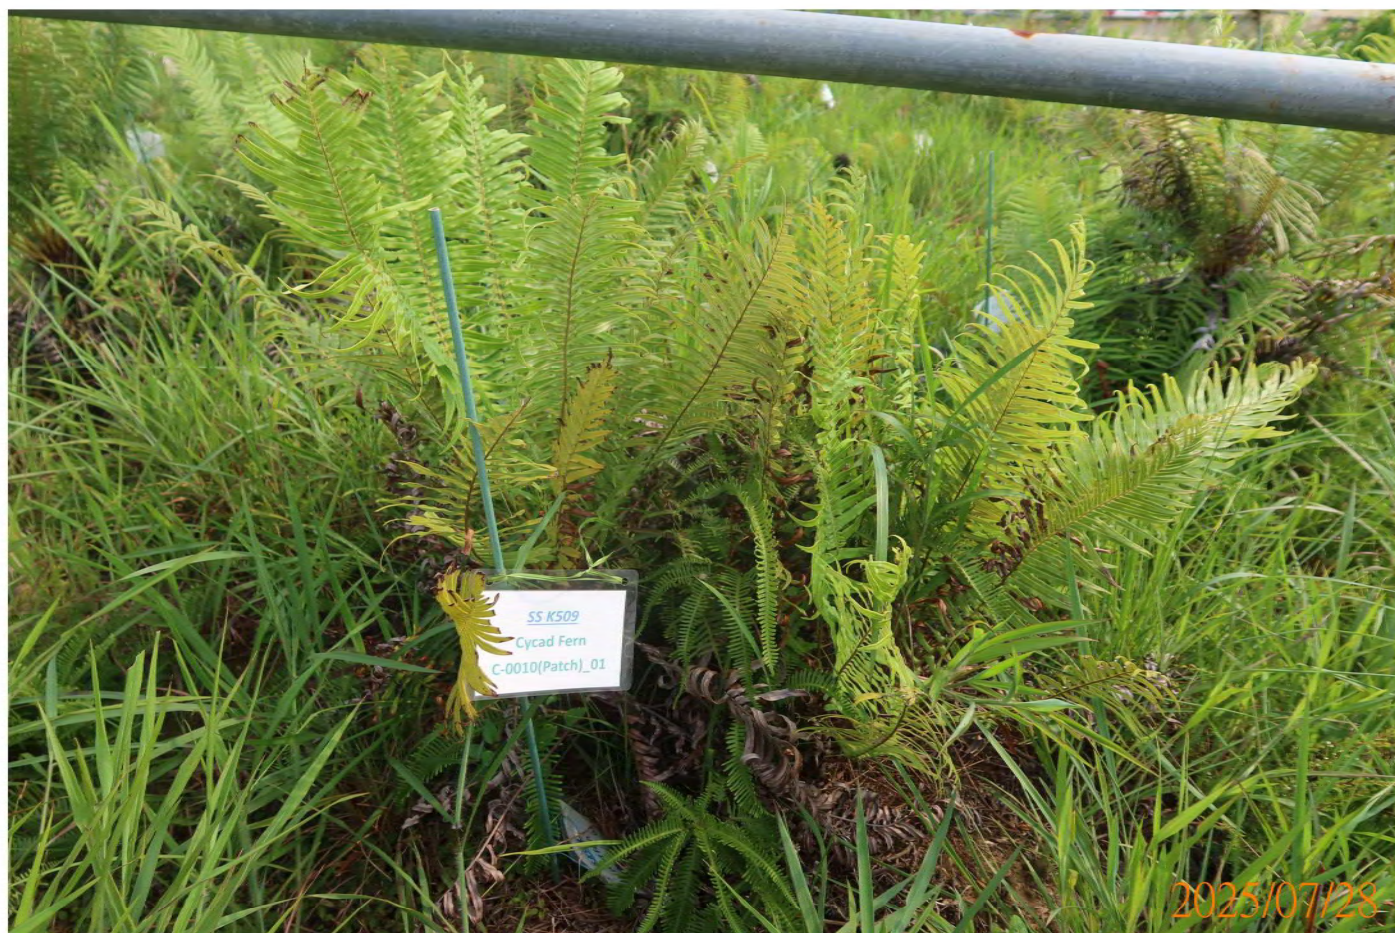
| Tree/Plant/<br>Colony No. | Number of<br>Individuals | Species Name | Form<br>(Good/Fair/Poor) | Health<br>(Good/Fair/Poor) | Remark |
|---|---|---|---|---|---|
| C-0009 | 01 | <i>Brainea insignis</i> | F | F | Young leaves observed |

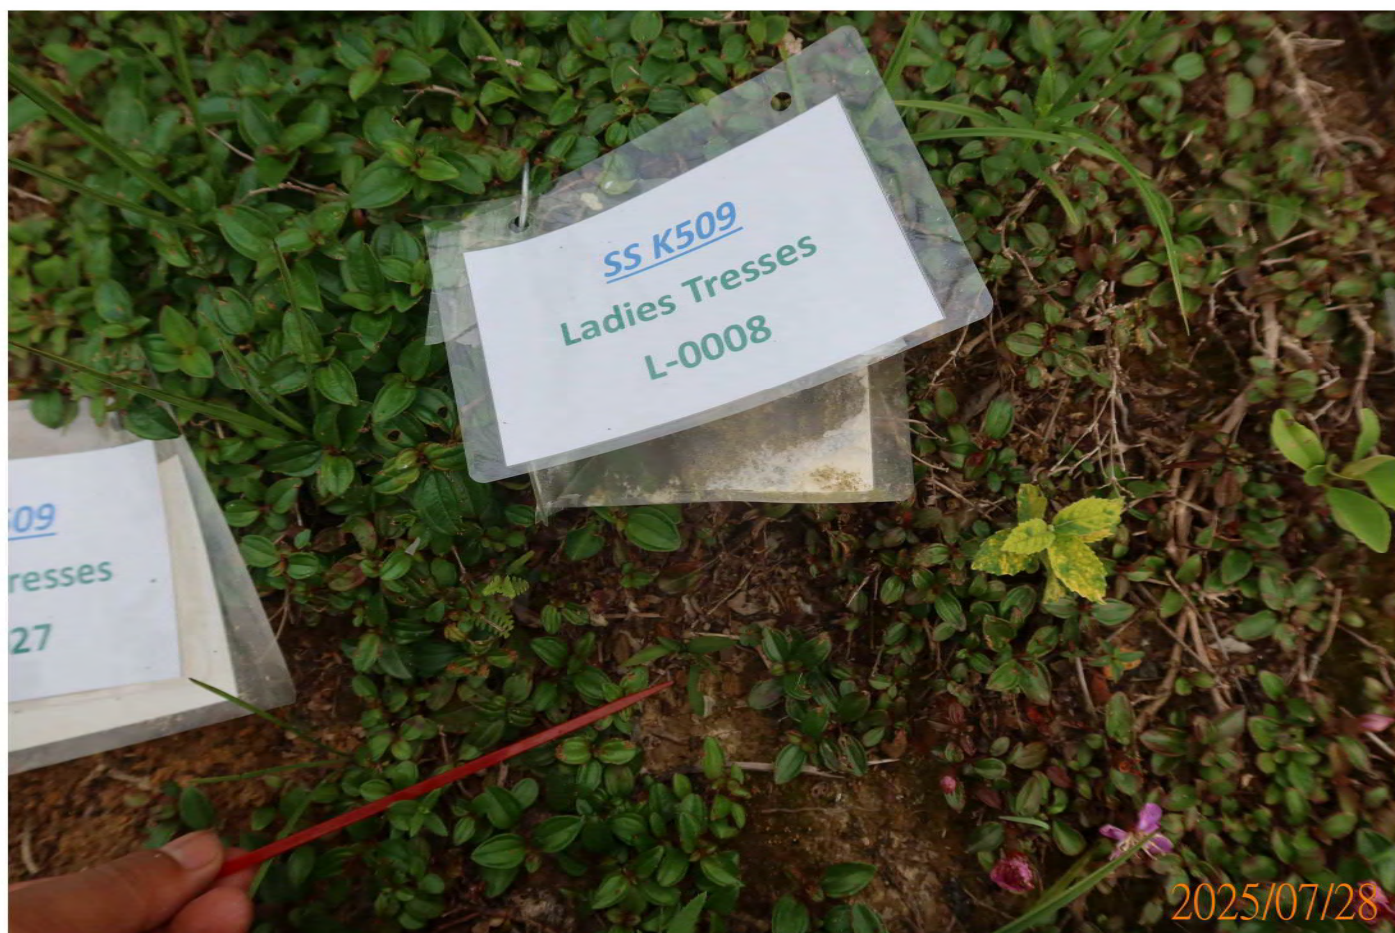
| Tree/Plant/<br>Colony No. | Species Name | Form<br>(Good/Fair/Poor) | Health<br>(Good/Fair/Poor) | Remark |
|---|---|---|---|---|
| L-0008 | <i>Spiranthes sinensis</i> | F | F | Leaf observed |

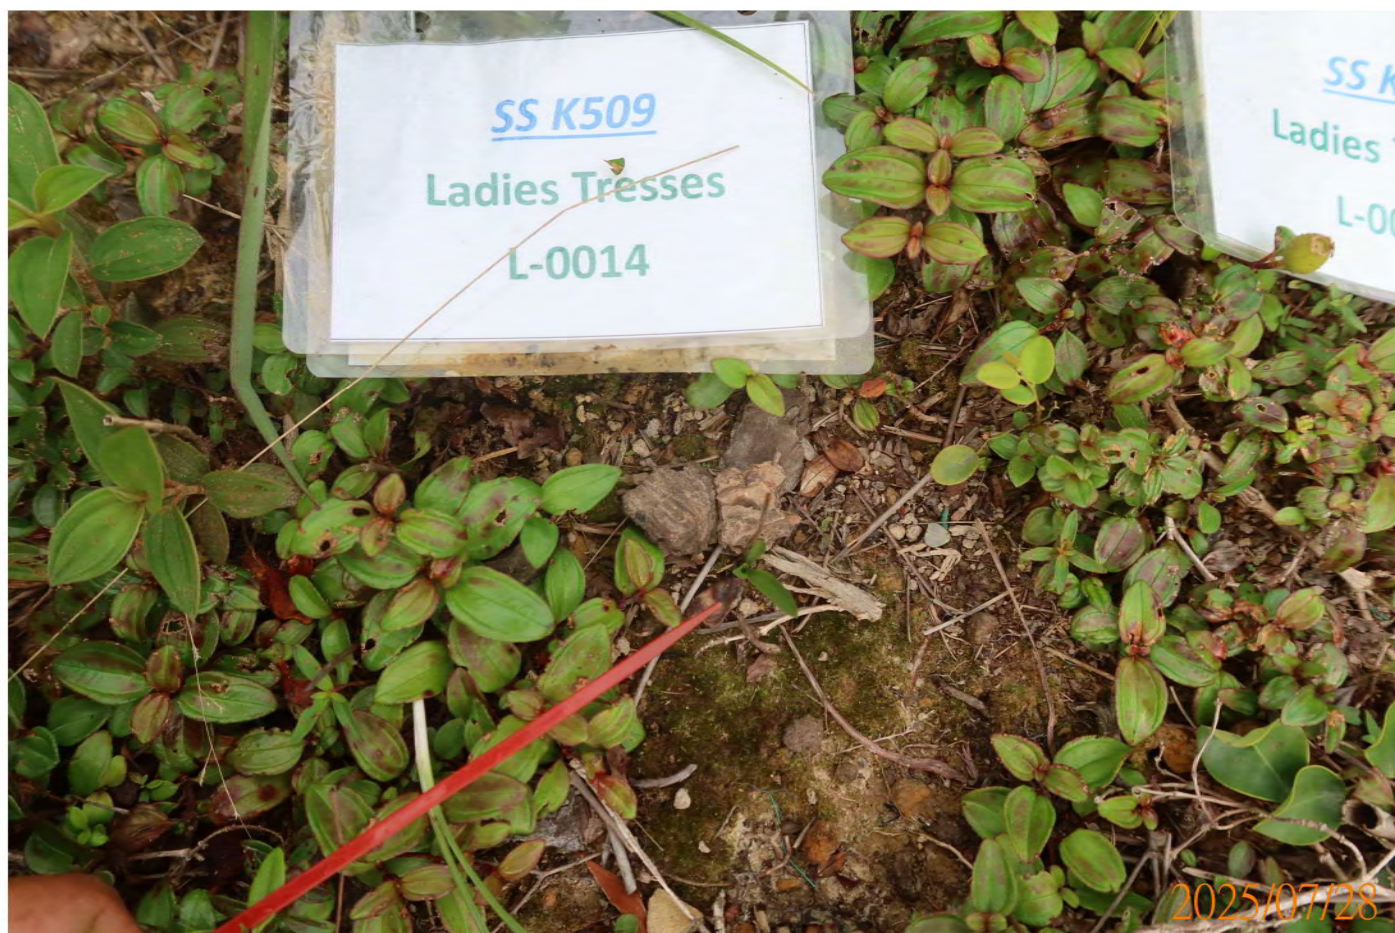
| Tree/Plant/<br>Colony No. | Species Name | Form<br>(Good/Fair/Poor) | Health<br>(Good/Fair/Poor) | Remark |
|---|---|---|---|---|
| L-0014 | <i>Spiranthes sinensis</i> | P | P | Leaf observed |

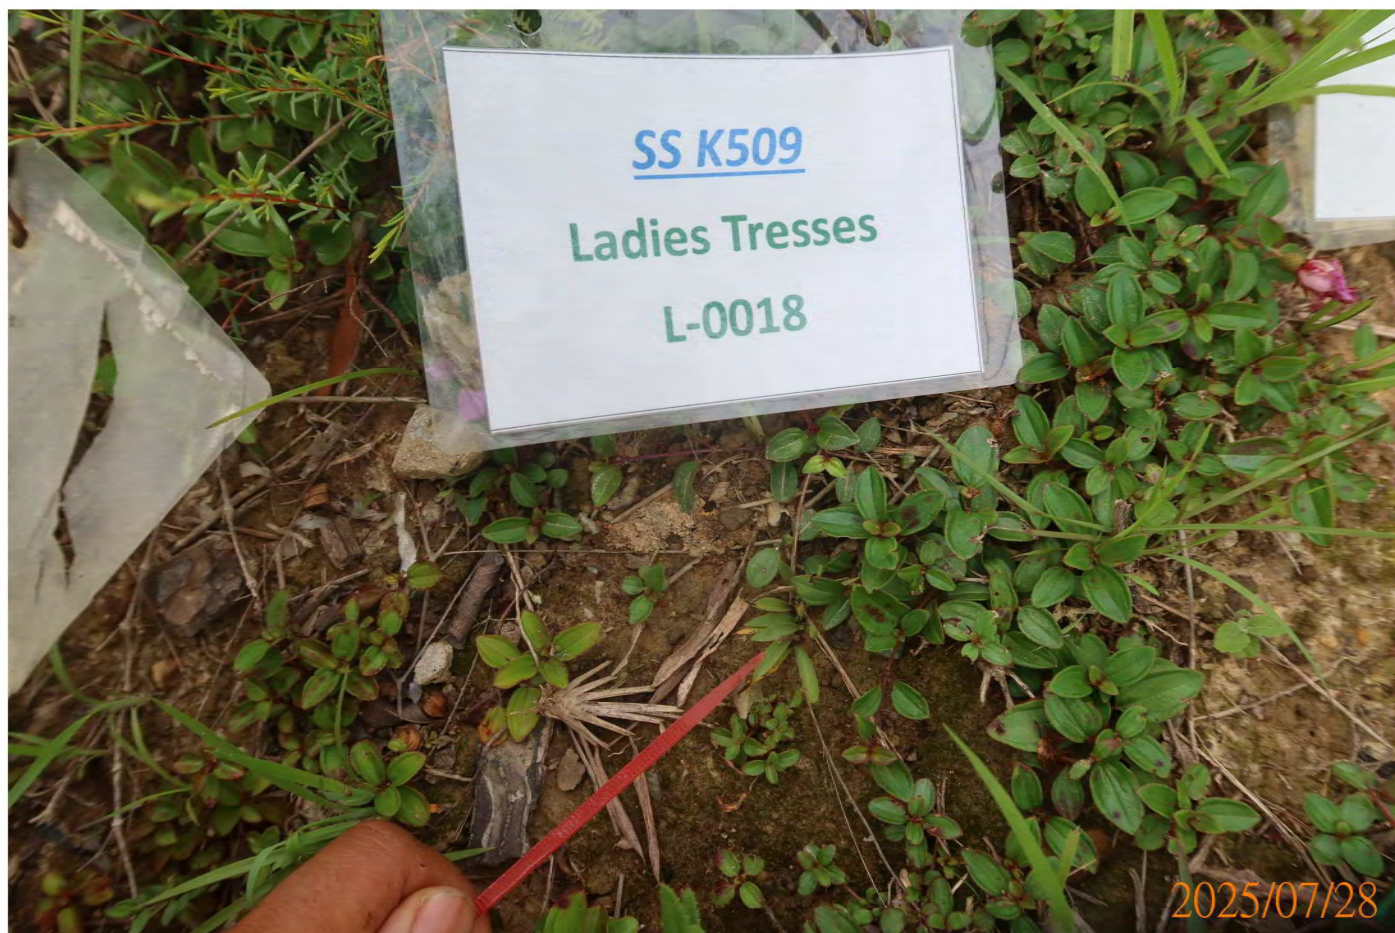
| Tree/Plant/<br>Colony No. | Species Name | Form<br>(Good/Fair/Poor) | Health<br>(Good/Fair/Poor) | Remark |
|---|---|---|---|---|
| L-0018 | <i>Spiranthes sinensis</i> | F | F | Leaf observed |

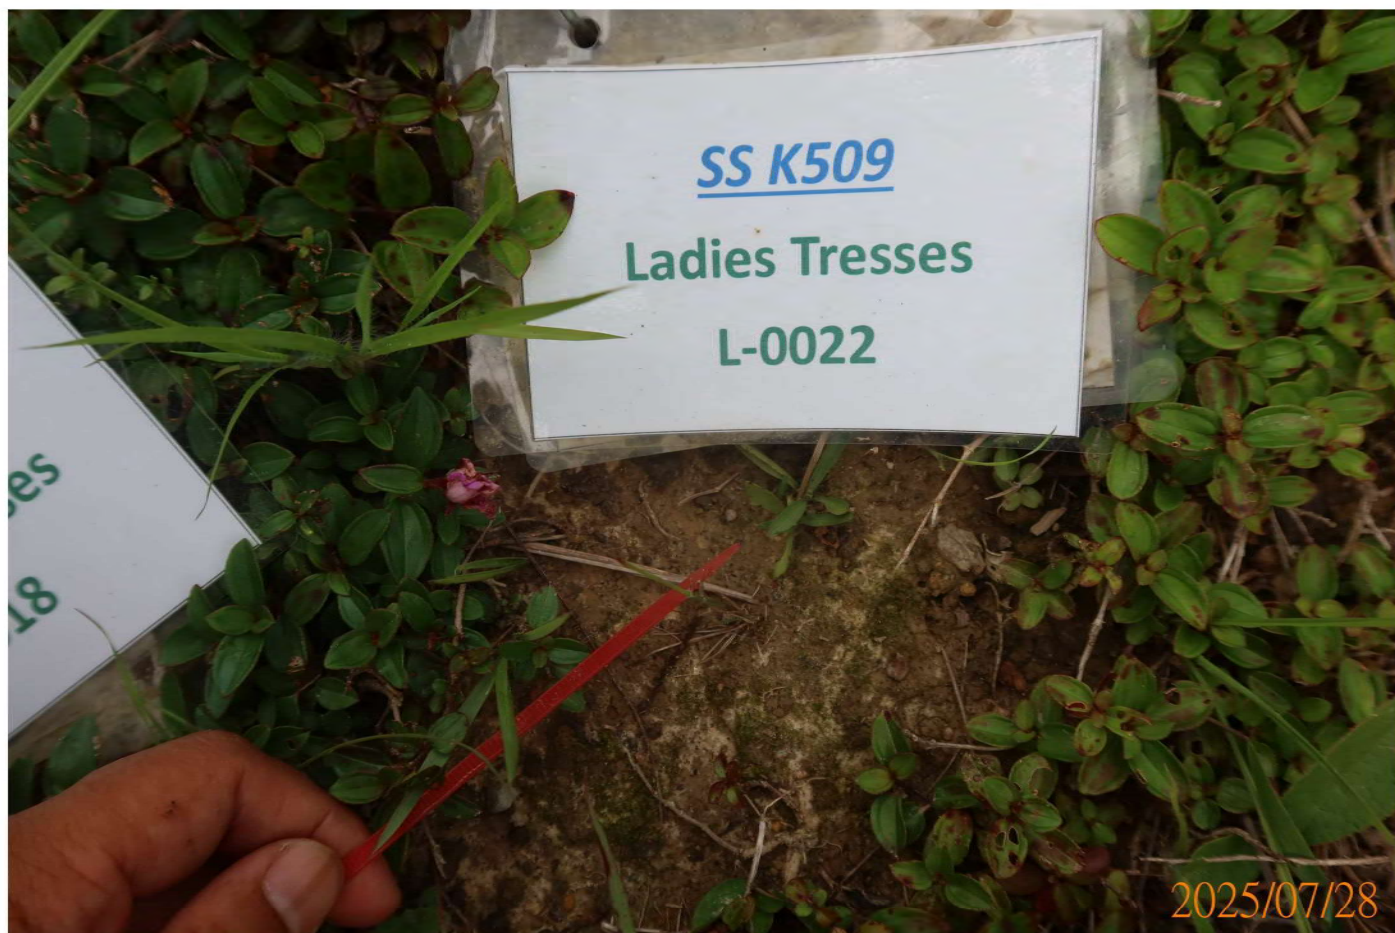
| Tree/Plant/<br>Colony No. | Species Name | Form<br>(Good/Fair/Poor) | Health<br>(Good/Fair/Poor) | Remark |
|---|---|---|---|---|
| L-0022 | <i>Spiranthes sinensis</i> | P | P | Leaf observed |

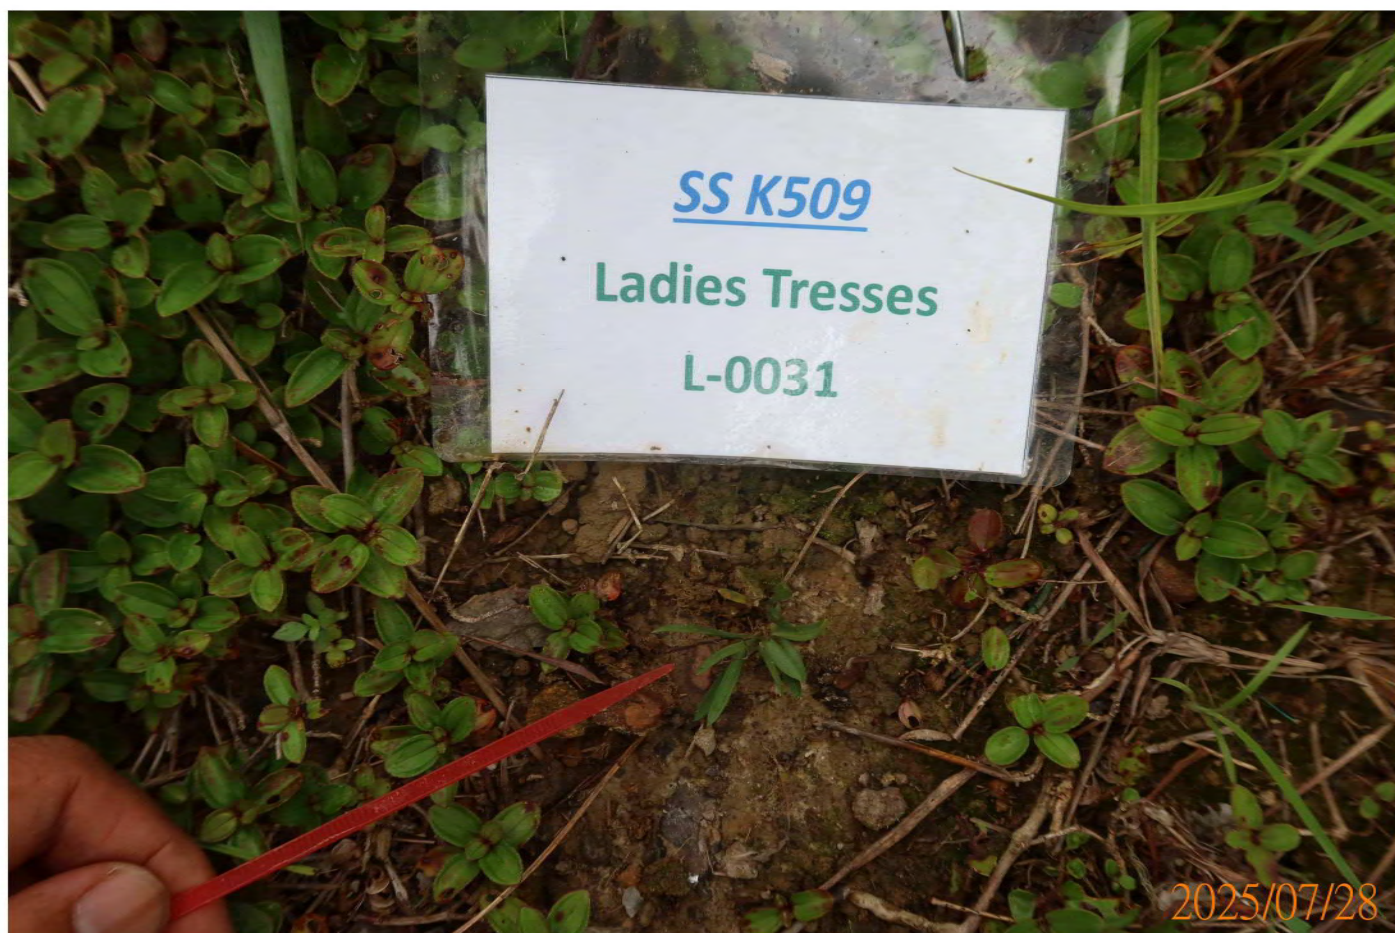
| Tree/Plant/<br>Colony No. | Species Name | Form<br>(Good/Fair/Poor) | Health<br>(Good/Fair/Poor) | Remark |
|---|---|---|---|---|
| L-0031 | <i>Spiranthes sinensis</i> | F | F | Leaf observed |

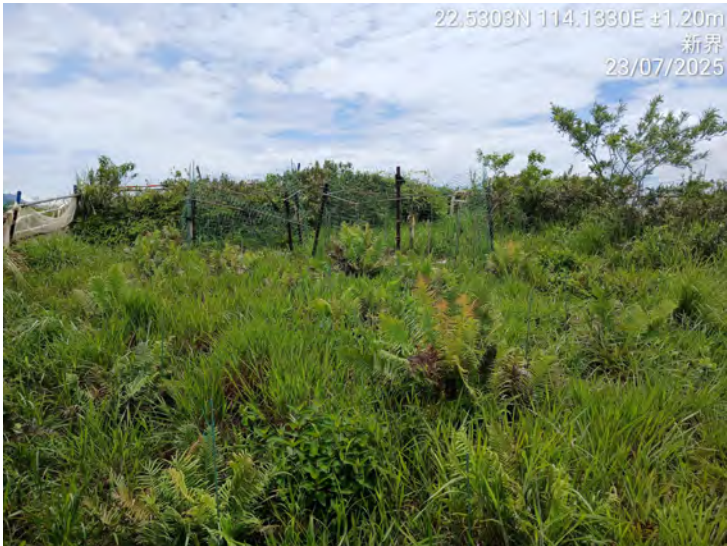
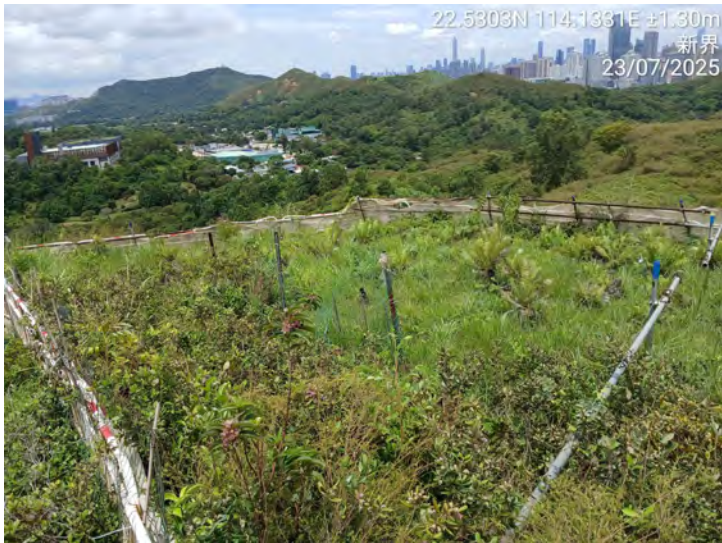
- 1) Please refer to the guidelines on soil improvement issued by the Greening,Landscape and Tree Management Section (GLTMS) of the development bureau (2022)to apply to monitoring and maintenance of transplanted flora species.
- 2) Daily watering frequency is needed to keep the soil moist.
- 3) Installation of a shaded net is provided below.
- 4) The wild plants that are growing in undesirable areas should be removed.
- 5) The Black Shade Net should be installed.

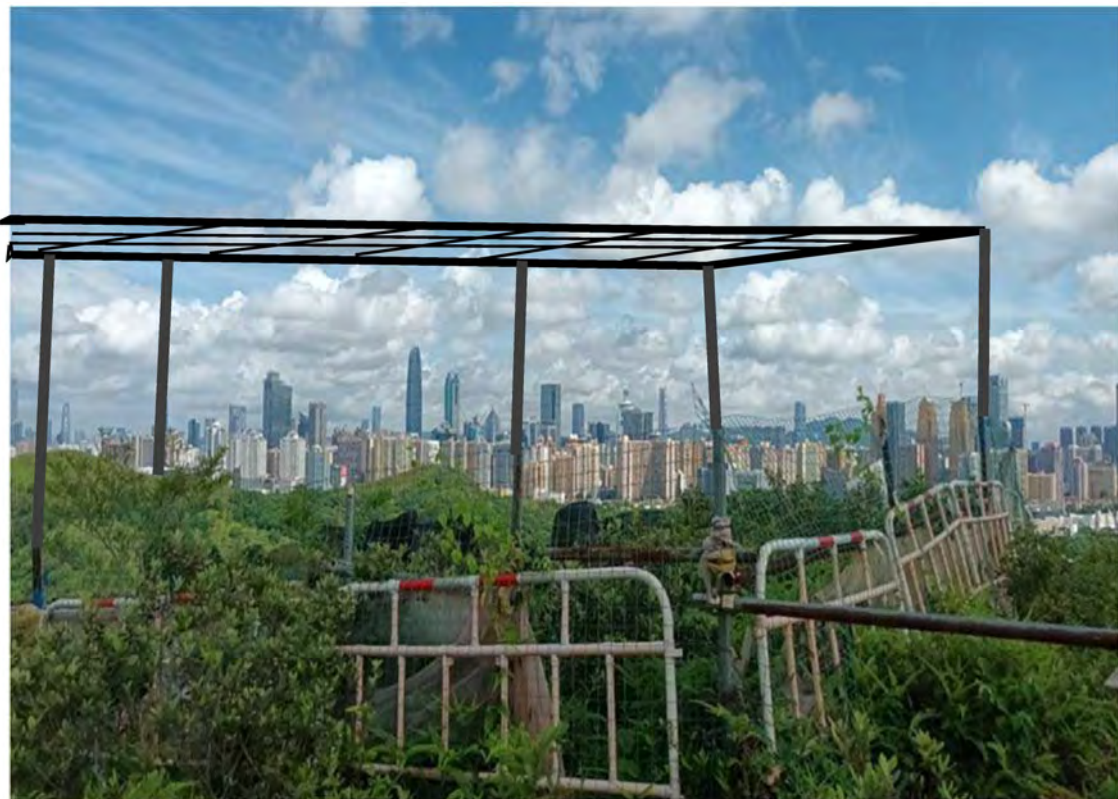
## The installation of a shaded net

Remark: Non scale & Conceptual drawing
