**Provision of Environmental Team consultancy  
for Design and Construction of Kong Nga Po Police  
Training Facilities (Programme No. 279LP)**

**Monthly Environmental Monitoring and  
Audit Report for January 2026  
(Version 1.1)**

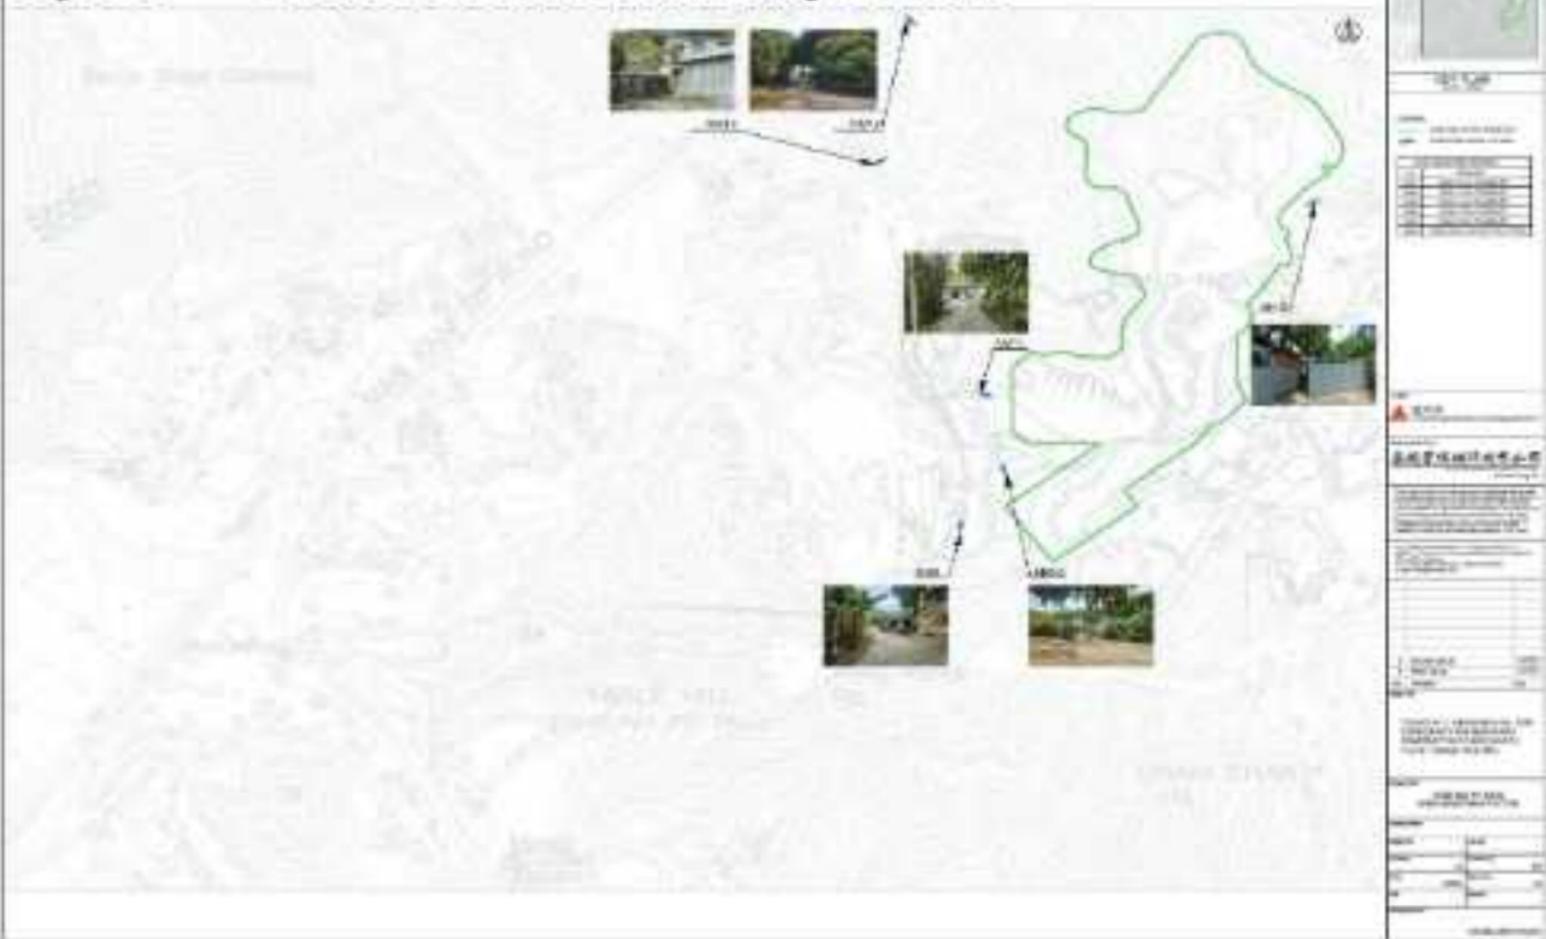
Figure 3

Location of Noise Monitoring Stations

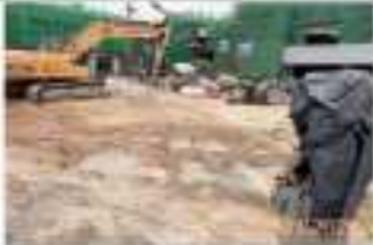
Ref*	Proposed Construction Method	Location/Working Period	Anticipated Major Impacts	Recommended Mitigation Measures	Photo Records (Partial)
EIA S.D.1: EM&O Log 3.2	Open cut excavation	Kong Nga Po Site	Dust Impact	<ul style="list-style-type: none"> <li>• Manual water spraying for dust suppression</li> <li>• Regular inspection and maintenance of plant and equipment in good condition</li> <li>• Cover stockpiles with impervious sheets or grout</li> <li>• Provide wheel washing facility at site entrance</li> </ul>

<p>By subcontractor at KNF site</p>

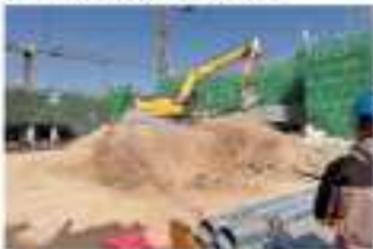
By subcontractor at KNP site.

EIA 4.3.6, EM&S Log 3.2			Noise	<ul style="list-style-type: none"> <li>• Regular inspection and maintenance of plant &amp; equipment in good condition</li> <li>• Deploy Quality Powered Mechanical Equipment (QPME) if possible</li> <li>• Valid construction noise permit should be displayed at site entrance.</li> </ul>

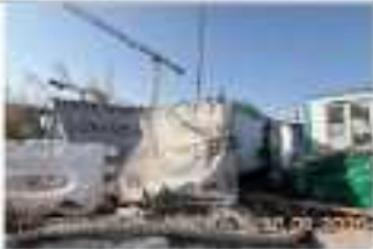
<p>By main contractor at KNP site</p>

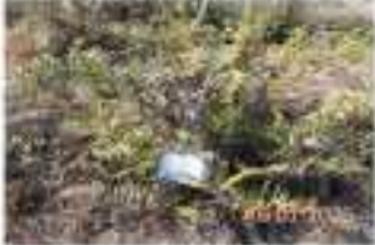
<p>By subcontractor at KNP site</p>
---	--	--	------------------------	--	---

EIA 3.9.1, EM&O Log 2.2	Soil Removal	Kong Nge Po Site	Air	<ul style="list-style-type: none"> <li>• Deploy water bowser for regular water spraying to enhance dust suppression</li> <li>• Cover dusty materials with impervious sheets</li> <li>• Exposed slopes covered with waterproof layers such as tarpaulin sheets or grout to reduce the potential for sediment laden runoff entering the drainage system.</li> <li>• The speed of the trucks within the site should be controlled to about 10km/hour in order to reduce adverse dust impacts and secure the safe movement around the site.</li> </ul>

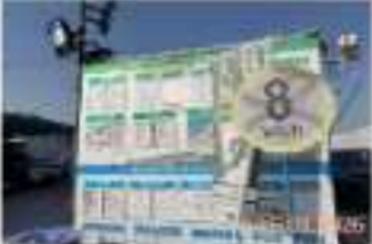
<p>By main contractor at KNP site</p>
-------------------------------	--------------	------------------	-----	--	---

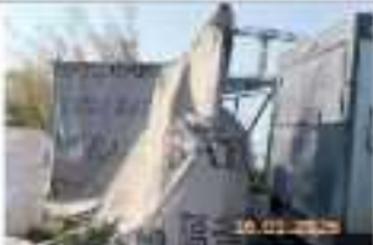
<p>E16 4.1.6, EM&amp;A Log 3.2</p>			<p>Noise</p>	<ul style="list-style-type: none"> <li>Regular inspection and maintenance of plant &amp; equipment in good condition</li> <li>Deploy Quality Powered Mechanical Equipment (QPME) if possible</li> </ul>

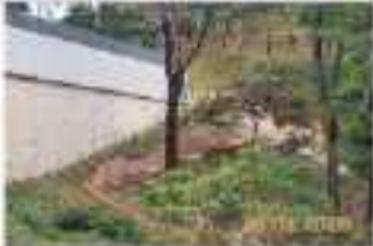
<p>By main contractor at KNP site</p>

<ul style="list-style-type: none"> <li>minimize landscape and visual impacts</li> <li>• Minimize visual impact during construction stage. site office not visually prominent from public room and surrounding</li> <li>• Planting will take place as soon the planting area is installed with subsoil drainage</li> <li>• Decorative hoarding is provided</li> </ul>	
<p>#10 3.9.1: EM&amp;A Log 2.2</p>	<p>Construction of footings, substructure and superstructure</p>	<p>Koing Nga Po Site</p>	<p>Air</p>	<ul style="list-style-type: none"> <li>• Cover dusty materials with impervious sheets</li> <li>• Exposed slopes covered with waterproof layers such as tarpaulin sheets or grout to reduce the potential for sediment laden runoff entering</li> </ul>

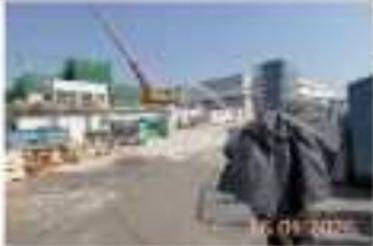
<p>the drainage system.</p> <ul style="list-style-type: none"> <li>• Provide wheel washing facility at site entrance</li> </ul>	<p>By subcontractor at KNP site</p>

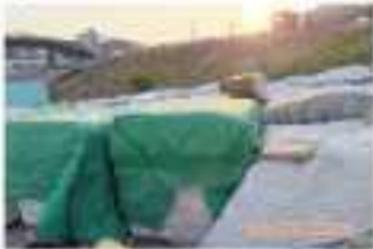
<p>By subcontractor at KNP site</p>
<p>EIA 4.4.6; EM&amp;A Log 3.2</p>			<p>Noise</p>	<ul style="list-style-type: none"> <li>• valid construction noise permit should be obtained and displayed on site</li> </ul>

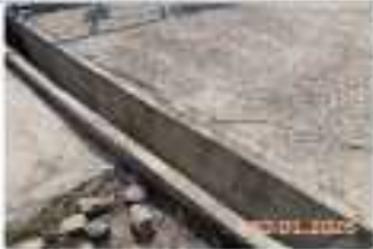
<p data-bbox="1136 412 1430 433">By main contractor at KNP site</p>
<p data-bbox="145 474 277 560">EIA 7.5.1.2 and env&amp;A Log 6.2</p>			<p data-bbox="654 474 789 526">Waste Management</p>	<ul data-bbox="835 474 1120 809" style="list-style-type: none"> <li data-bbox="835 474 1120 715">• Segregation and storage of different types of waste in different containers or skips or stockpiles to enhance reuse or recycling of materials and their proper disposal</li> <li data-bbox="835 726 1120 809">• Sort non-inert C&amp;D materials to recover any recyclable portions</li> </ul>

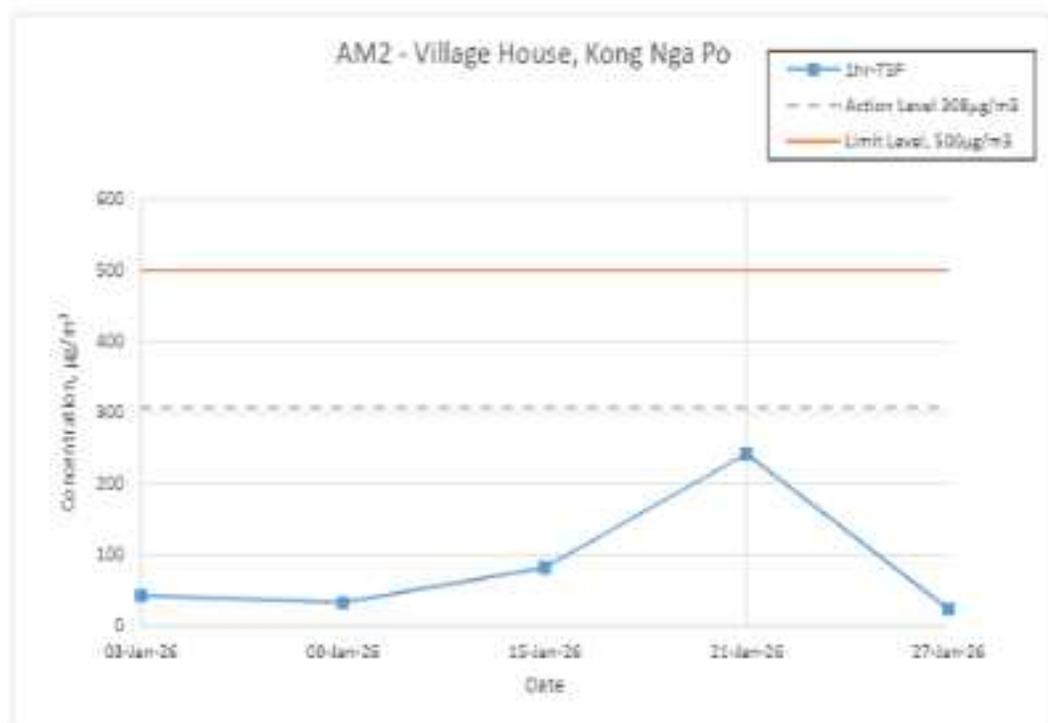
## 1-hr TSP Concentration Levels

<b>Location AM2 - Village House, Kong Nga Po</b>			
<b>Date</b>	<b>Time</b>	<b>Weather</b>	<b>Particulate Concentration (<math>\mu\text{g}/\text{m}^3</math>)</b>
03-Jan-26	8:23	Sunny	43
	9:23		46
	10:23		60
09-Jan-26	13:35	Sunny	33
	14:35		53
	15:35		92
15-Jan-26	13:05	Sunny	83
	14:05		84
	15:05		102
21-Jan-26	13:13	Sunny	243
	14:13		189
	15:13		176
27-Jan-26	14:07	Sunny	24
	15:07		157
	16:07		55
Minimum			24
Maximum			243
Average			96

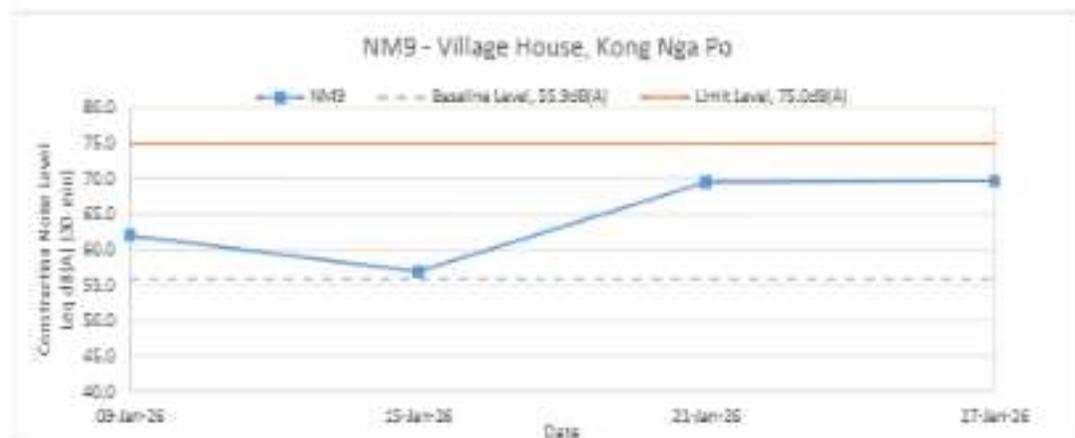
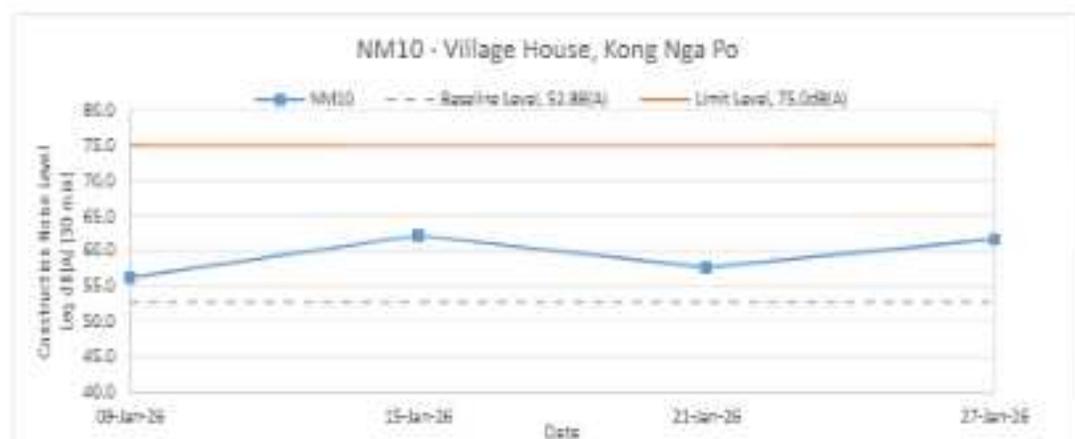
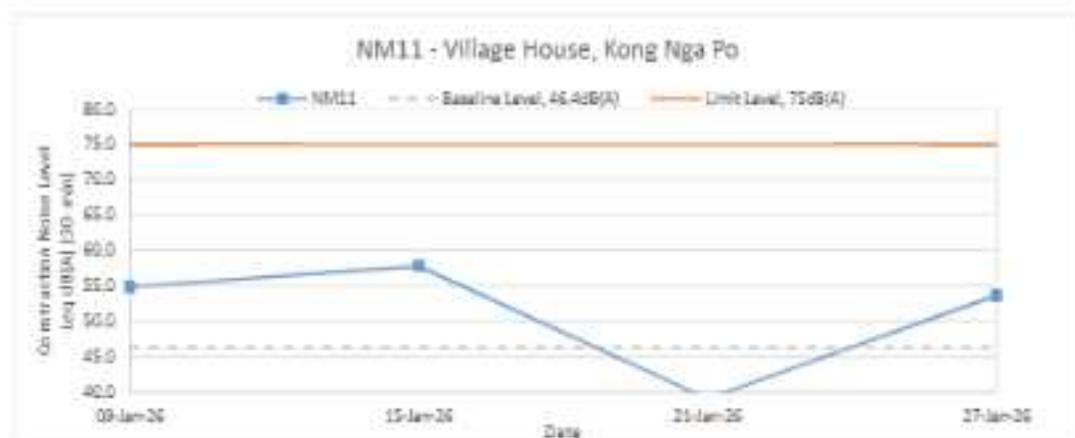
## Noise Levels

Date	Weather	Wind Speed (m/s)	Time	Unit: dB(A) (5-min)			Average $L_{eq}$	Limit Level $L_{eq}$	Baseline $L_{eq}$
				$L_{90}$	$L_{50}$	$L_{10}$			
09-Jan-26	Sunny	0.36	13:54	69.6	60.3	37.7	64.3	75.0	59.6
				49.9	51.8	41.7			
				48.5	50.5	39.8			
				49.4	52.2	40.2			
				57.3	51.7	40.7			
15-Jan-26	Sunny	0.00	13:37	67.9	59.1	45.0	56.0	75.0	59.6
				63.5	55.5	25.9			
				47.2	35.1	23.2			
				36.0	37.5	24.9			
				44.4	48.5	23.3			
21-Jan-26	Sunny	0.66	13:42	47.4	52.2	25.7	57.0	75.0	59.6
				44.9	49.1	26.9			
				63.8	58.3	45.8			
				48.8	51.1	46.1			
				49.7	55.3	46.0			
27-Jan-26	Sunny	0.67	13:36	54.9	52.9	45.7	44.3	75.0	59.6
				47.9	49.7	46.1			
				48.5	48.9	45.5			
				45.6	39.4	30.4			
				31.7	32.5	30.6			
				36.3	34.8	30.2			
				32.2	32.5	30.5			
				50.7	47.6	30.6			
				33.0	35.4	30.1

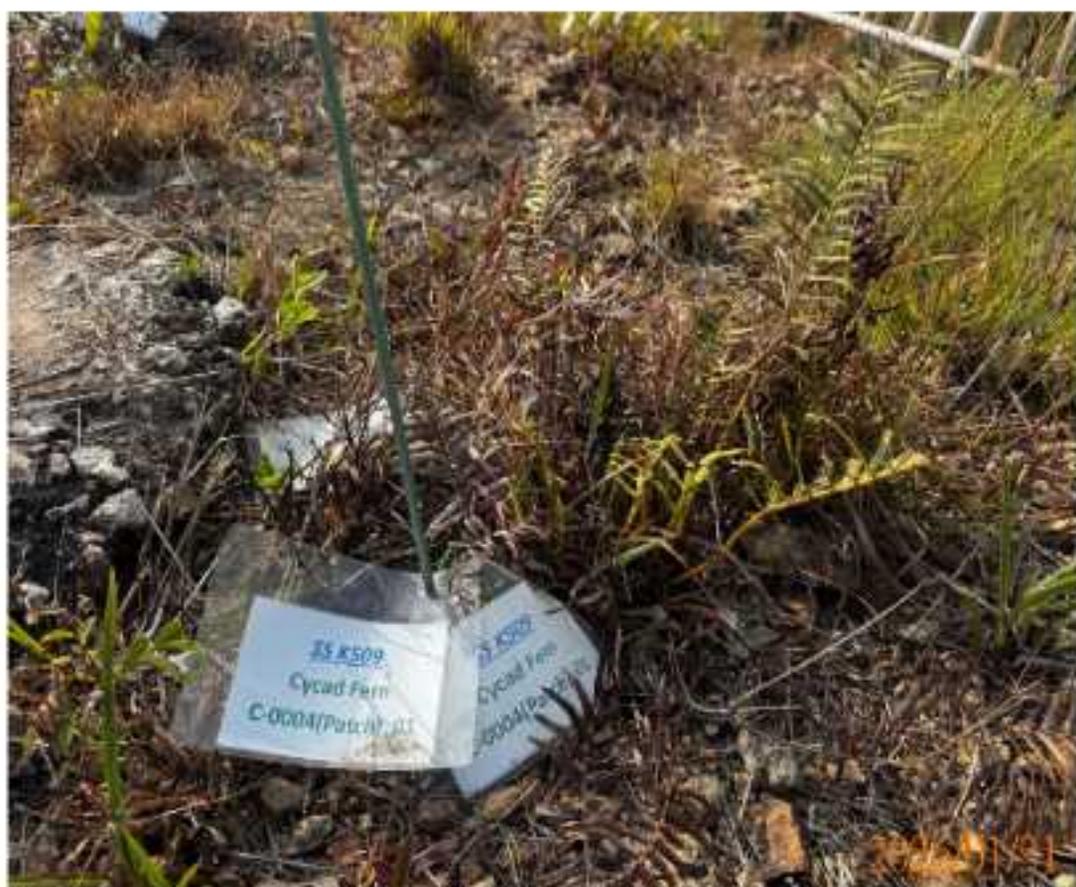
C-0004(Patch)\_01

08	<i>Brahea insignis</i>	F	F	Young leaves observed
C-0003	01	<i>Brahea insignis</i>	F	F	Young leaves observed
C-0004	01	<i>Brahea insignis</i>	P	P	Young leaves at base; Dry out caused by bushfire initially outside site boundary and high temperature on 2 Feb 2021
	02	<i>Brahea insignis</i>	F	F	Young leaves observed
	03	<i>Brahea insignis</i>	F	F	Young leaves observed
	04	<i>Brahea insignis</i>	F	F	Young leaves observed
	05	<i>Brahea insignis</i>	F	F	Young leaves observed
	06	<i>Brahea insignis</i>	F	F	Young leaves observed
	07	<i>Brahea insignis</i>	F	F	Young leaves observed
	08	<i>Brahea insignis</i>	F	F	Young leaves observed
	09	<i>Brahea insignis</i>	P	P	Dry out caused by bushfire initially outside site boundary and high temperature on 2 Feb 2021
	10	<i>Brahea insignis</i>	F	P	Young leaves at base
	11	<i>Brahea insignis</i>	F	F	Young leaves observed
	12	<i>Brahea insignis</i>	F	P	Young leaves observed

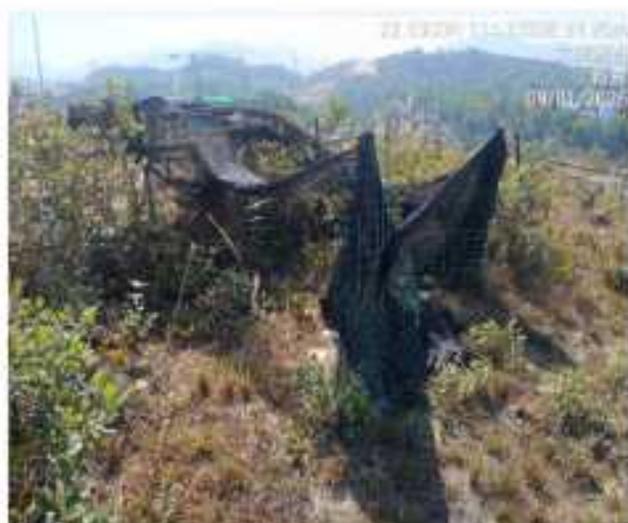
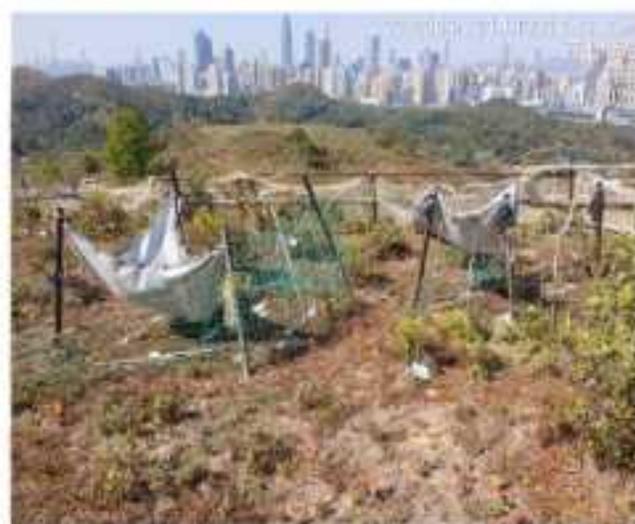
- 1) Please refer to the guidelines on soil improvement issued by the Greening, Landscape and Tree Management Section (GLTMS) of the development bureau (2022) to apply to monitoring and maintenance of transplanted flora species.
- 2) Daily watering frequency is needed to keep the soil moist.
- 3) The Damaged Sun Shade Net is replaced.
- 4) The installation of a shaded net is shown as a sample below

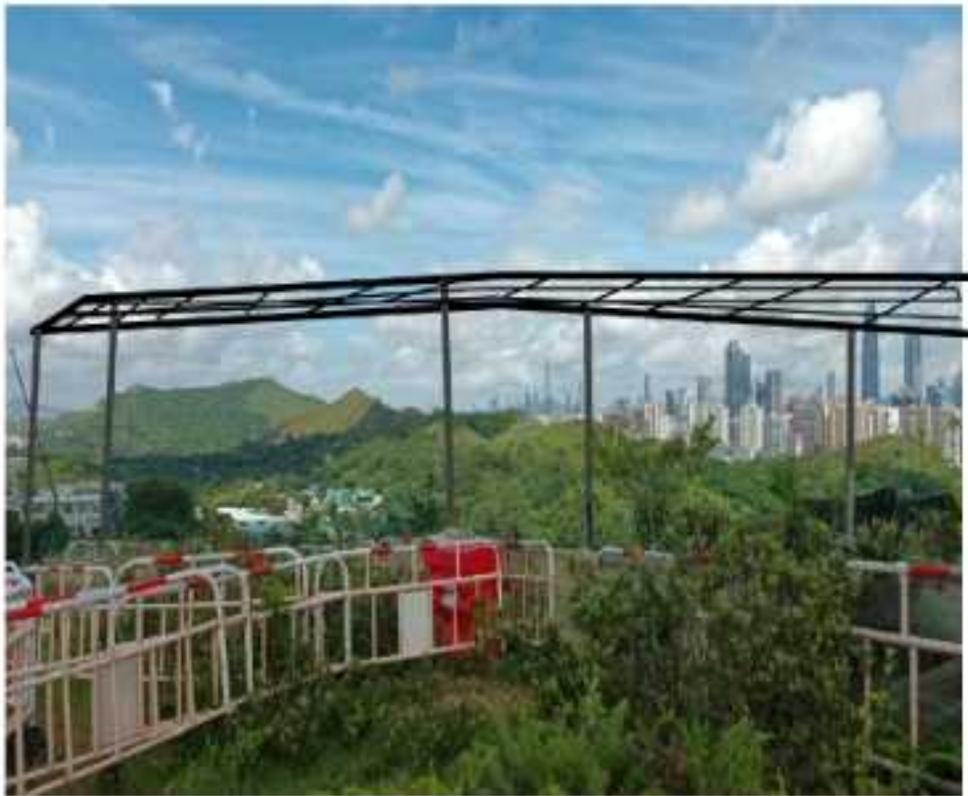
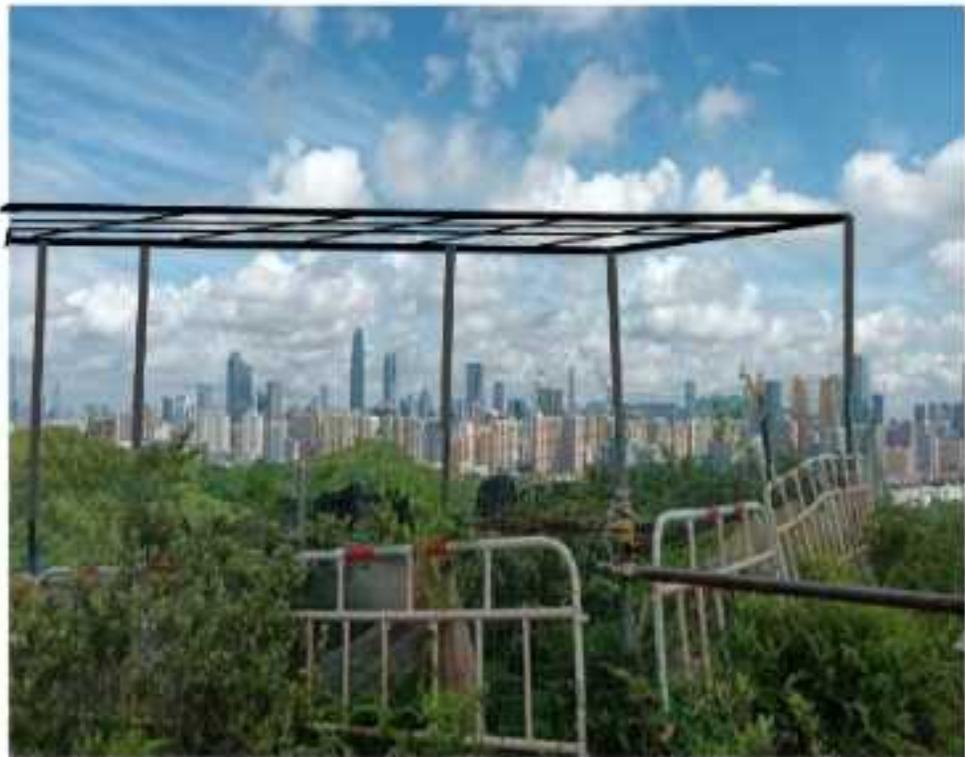
**The installation of a shaded net**

Remark: Non scale & Conceptual drawing

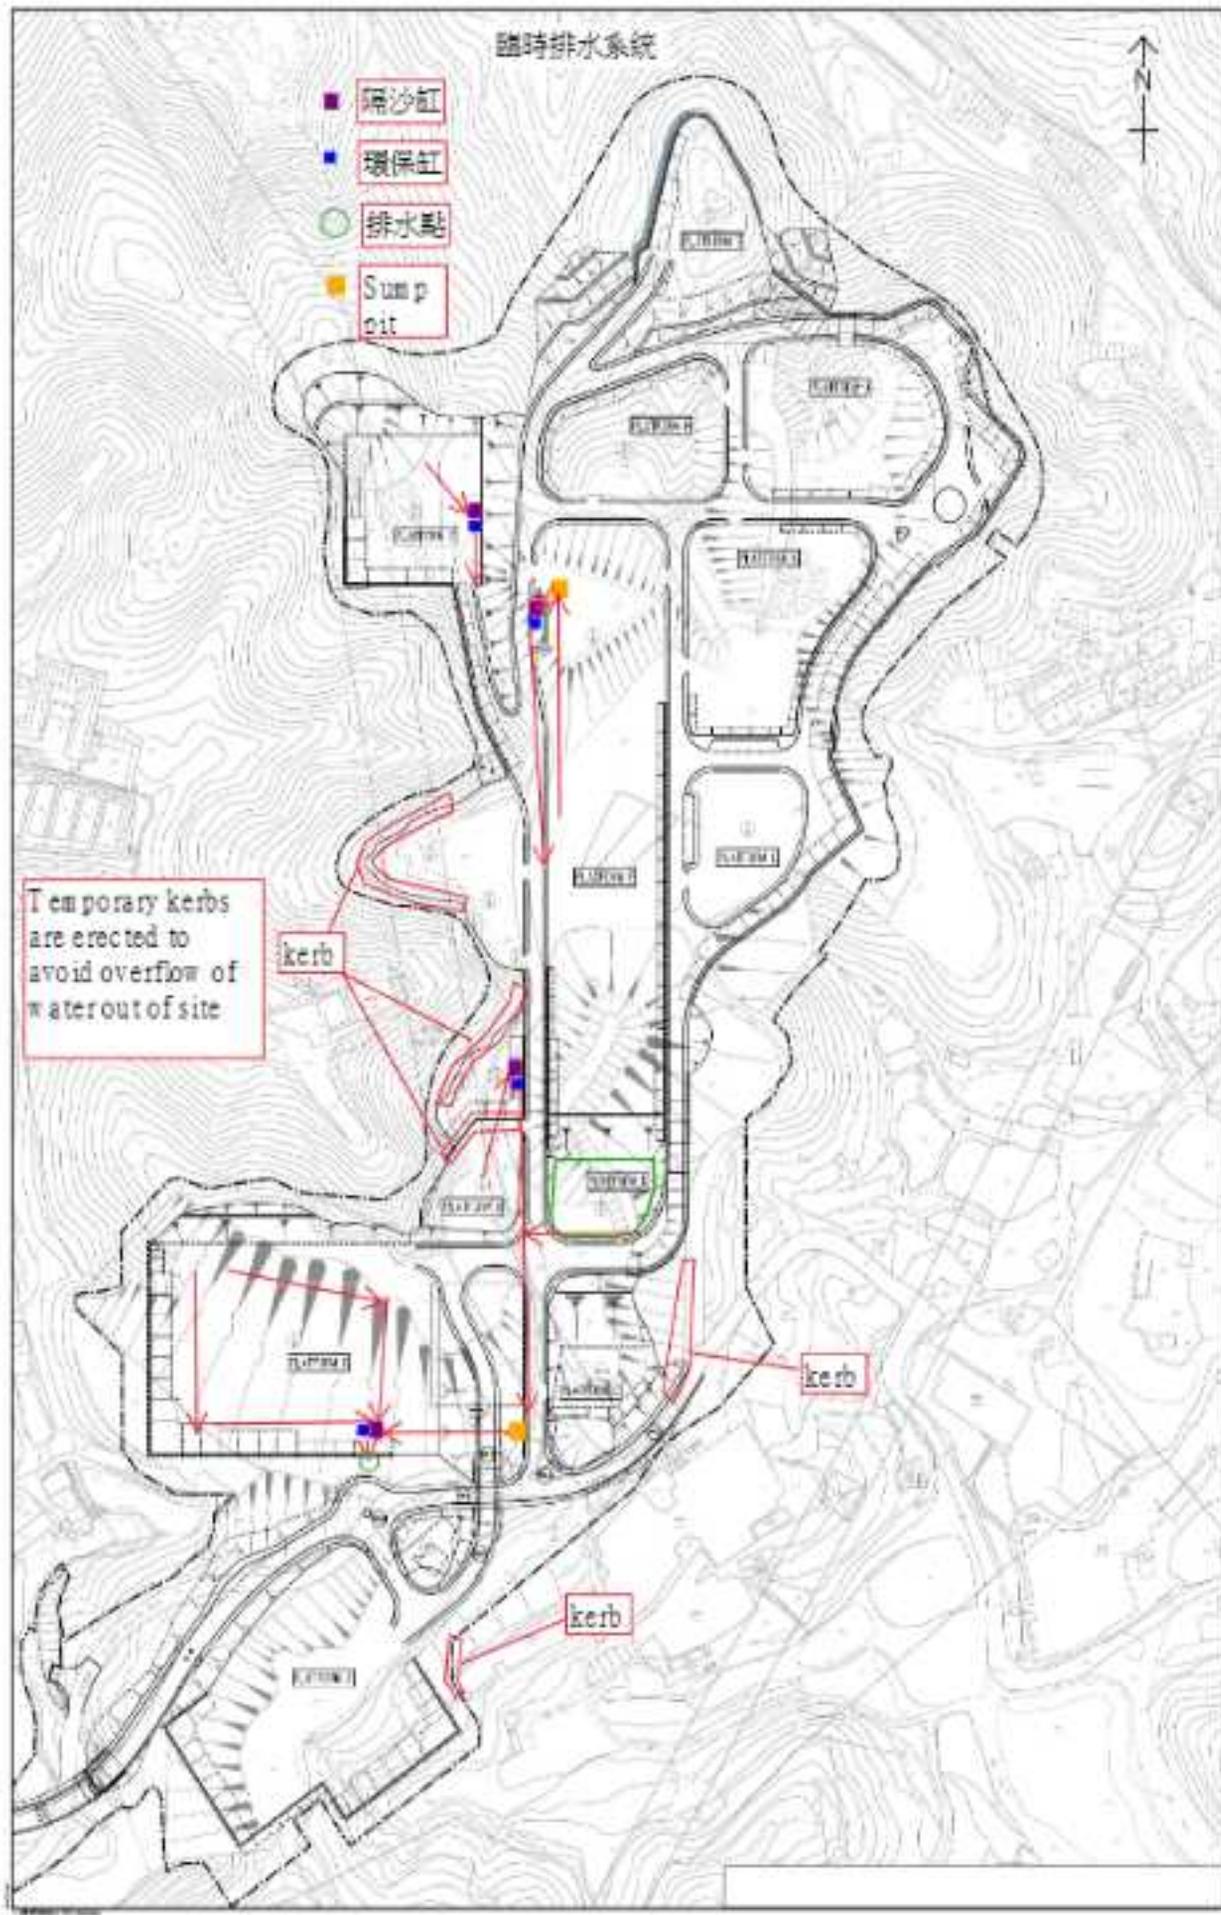
Temporary kerbs are erected to avoid overflow of water out of site
