### **FEP-01/510/2016 – Police Facilities in Kong Nga Po**

#### **Programme No. 279LP Provision of Environmental Team consultancy for Design and Construction of Kong Nga Po Police Training Facilities**

### **Quarterly Environmental Monitoring and Audit Report for October to December 2025 (Version 1.1)**

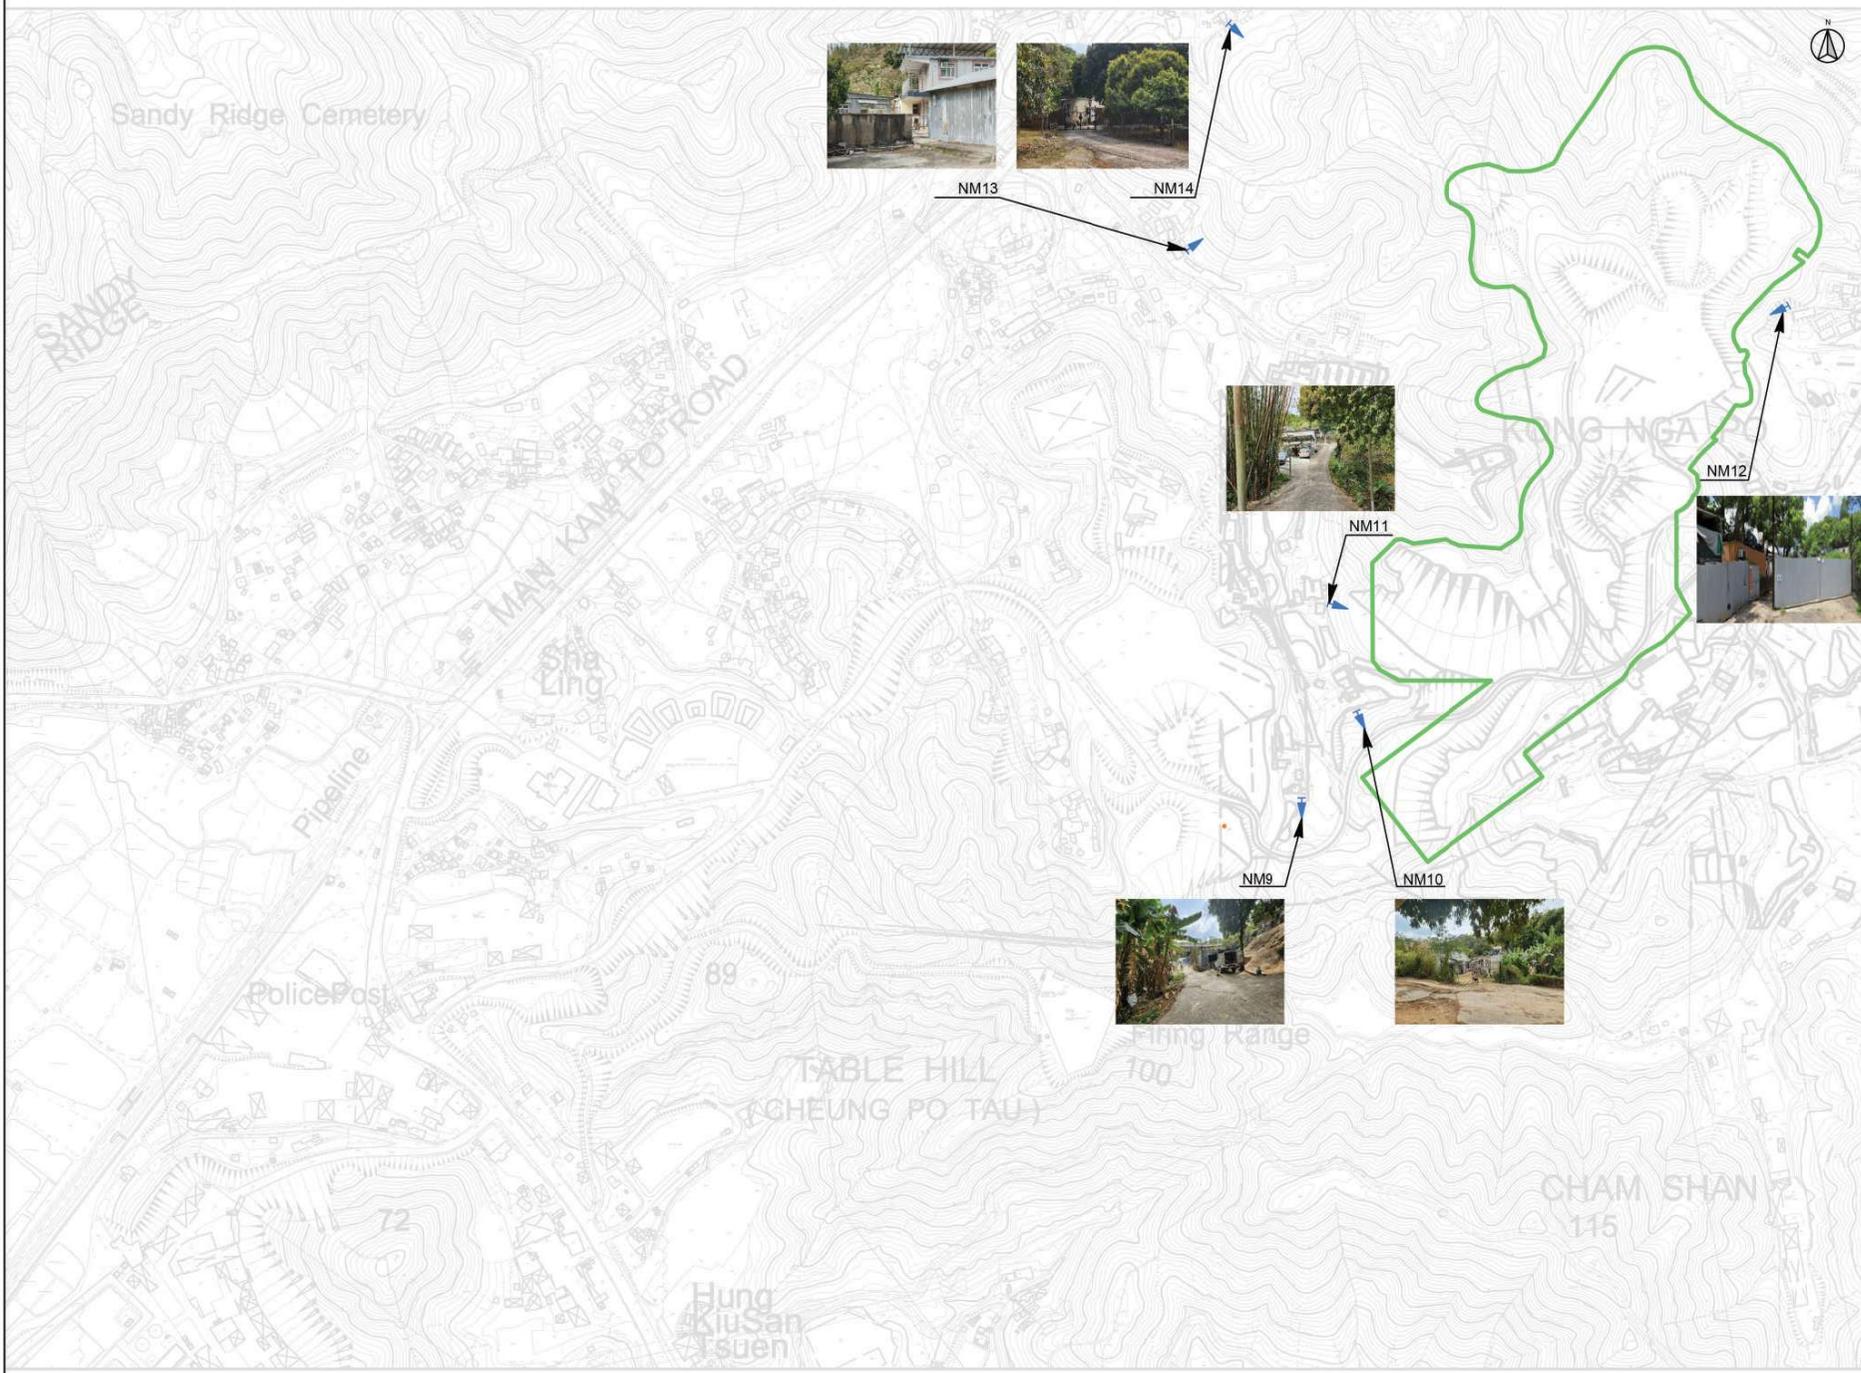
Figure 3 Location of Noise Monitoring Stations

3.3 In accordance with the EM&A Manual, construction noise monitoring were conducted to monitor the construction noise arising from the construction activities. The locations of the monitoring stations are shown in **Figure 3**. **Table 3.3** describes the location of the noise monitoring stations.

Monitoring Station	Location of Measurement
NM9	Village House, Kong Nga Po
NM10	Village House, Kong Nga Po
NM11	Village House, Kong Nga Po
NM12	Village House, Kong Nga Po
NM13	Village House, Kong Nga Po
NM14	Village House, near Man Kam To Road
