**Re: Contract No. SS K/509
Provision of Independent Environmental Checker Consultancy for Design
and Construction of Kong Nga Po Police Training Facilities
Verification of Monthly EM&A Report (February 2026)**

**Provision of Environmental Team consultancy
for Design and Construction of Kong Nga Po Police
Training Facilities (Programme No. 279LP)**

**Monthly Environmental Monitoring and
Audit Report for February 2026
(Version 1.1)**

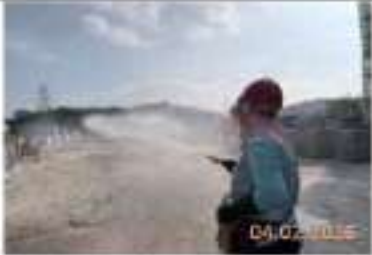
<p>By subcontractor at KNP site</p>

Ref*	Proposed Construction Method	Location/Working Period	Anticipated Major Impacts	Recommended Mitigation Measures	Photo Records (Partial)
EIA 3.9.1; EM&A Log 2.2	Open cut excavation	Kong Nga Po Site	Dust impact	<ul style="list-style-type: none">• Manual water spraying for dust suppression• Regular inspection and maintenance of plant and equipment in good condition• Cover stockpile with impervious sheets or grout• Provide wheel washing facility at site entrance

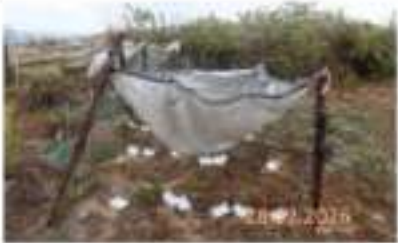
<p>By subcontractor at KNP site</p>
EIA 3.9.1; EM&A Log 2.2	Soil Removal	Kong Nga Po Site	Air	<ul style="list-style-type: none"> • Deploy water bowser for regular water spraying to enhance dust suppression • Cover dusty materials with impervious sheets • Exposed slopes covered with waterproof layers such as tarpaulin sheets or grout to reduce the potential for sediment laden runoff entering 	  <p>By main contractor at KNP site</p>

<p>the drainage system.</p> <ul style="list-style-type: none"> The speed of the trucks within the site should be controlled to about 10km/hour in order to reduce adverse dust impacts and secure the safe movement around the site. 	
<p>EIA 4.4.6; EM&A Log 3.2</p>			<p>Noise</p>	<ul style="list-style-type: none"> Regular inspection and maintenance of plant & equipment in good condition Deploy Quality Powered Mechanical Equipment (QPME) if possible

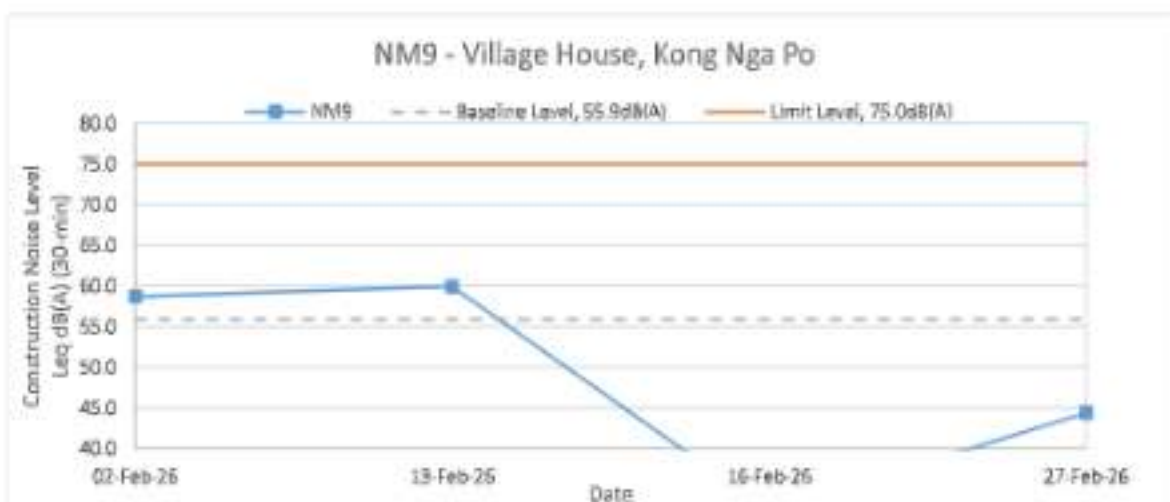
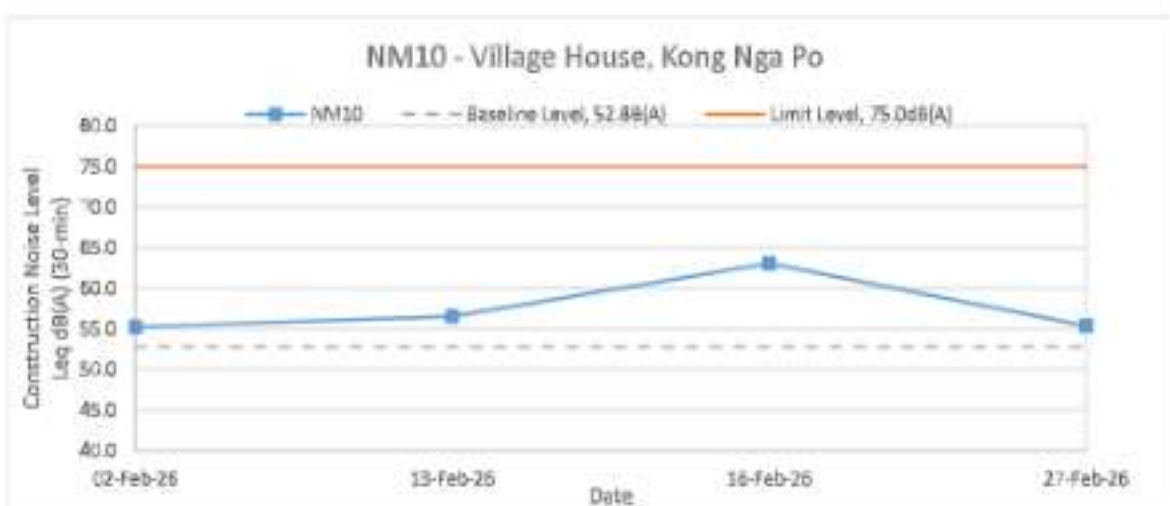
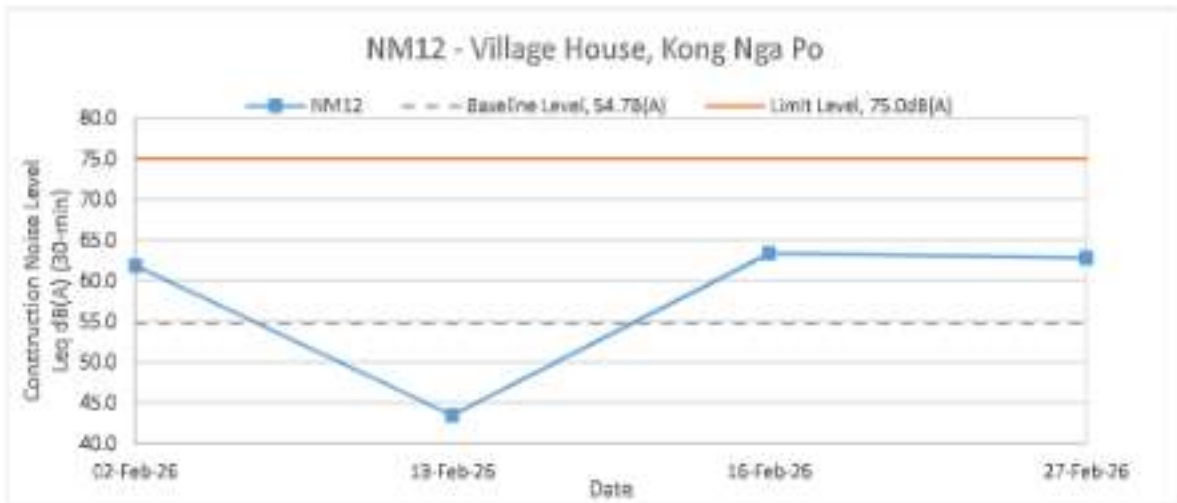
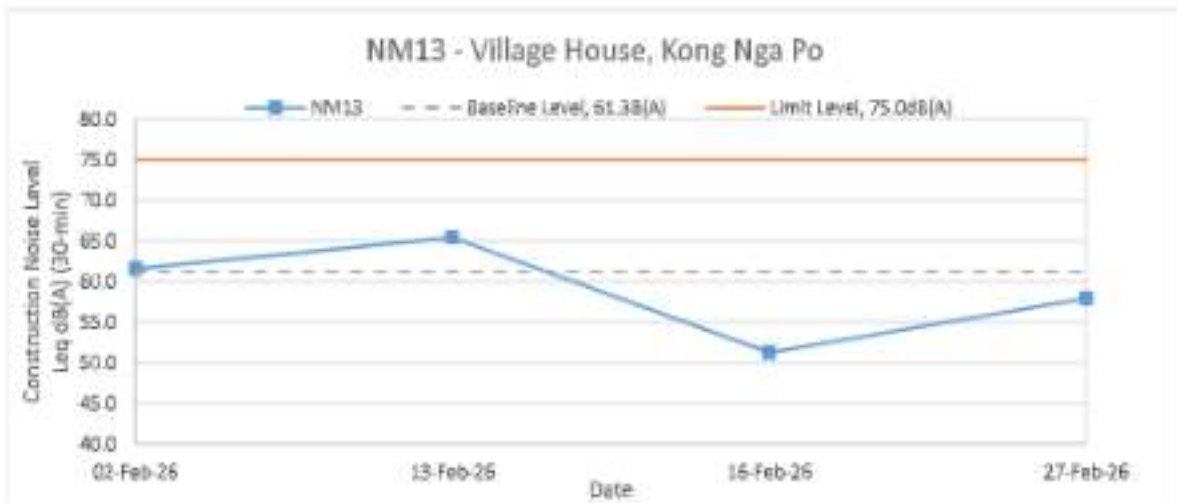
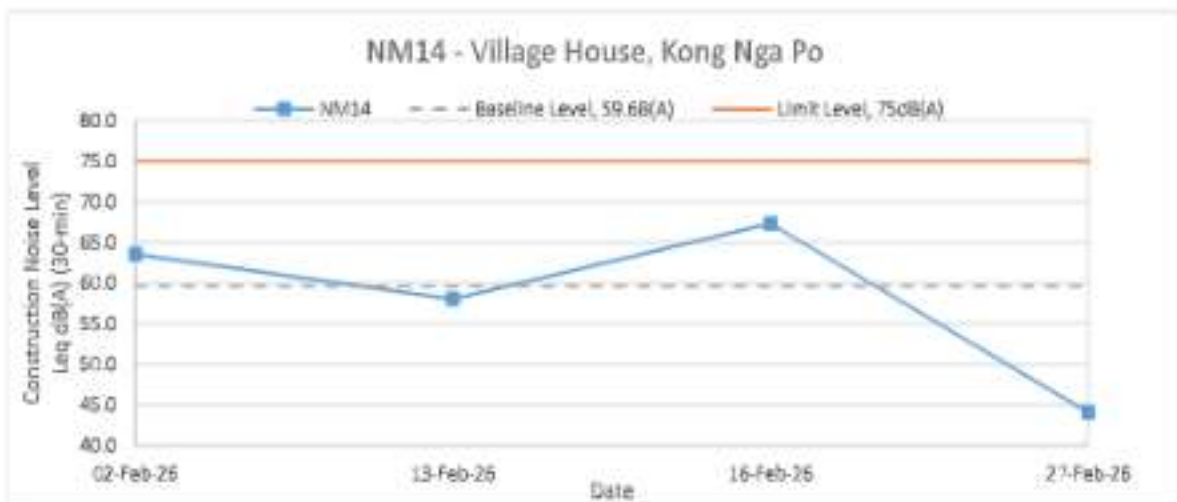
Noise Levels

Date	Weather	Wind Speed (m/s)	Time	Unit: dB(A) (5-min)			Average	Limit Level	Baseline
				L ₉₀	L ₁₀	L ₅₀			
02-Feb-26	Sunny	0.35	14:22	64.7	64.8	50.9	63.5	75.0	59.6
				63.0	63.1	48.3			
				51.4	52.4	49.7			
				59.4	61.2	49.8			
				65.8	68.5	59.2			
				65.8	68.3	58.8			
13-Feb-26	Sunny	0.00	13:44	65.5	63.0	40.9	58.0	75.0	59.6
				46.7	50.3	37.0			
				47.6	50.6	38.7			
				46.5	49.8	39.1			
				48.6	51.5	39.9			
				47.6	51.0	37.5			
16-Feb-26	Sunny	8.60	13:46	62.2	62.9	41.1	67.3	75.0	59.6
				67.7	70.2	62.5			
				64.0	65.9	45.6			
				66.0	69.3	50.1			
				63.8	67.1	43.5			
				72.0	67.8	27.9			
27-Feb-26	Sunny	0.35	13:36	44.3	36.7	31.1	44.1	75.0	59.6
				44.0	47.7	31.1			
				42.9	45.9	31.9			
				46.7	46.3	33.1			
				45.3	47.0	31.9			
				31.7	32.6	30.7

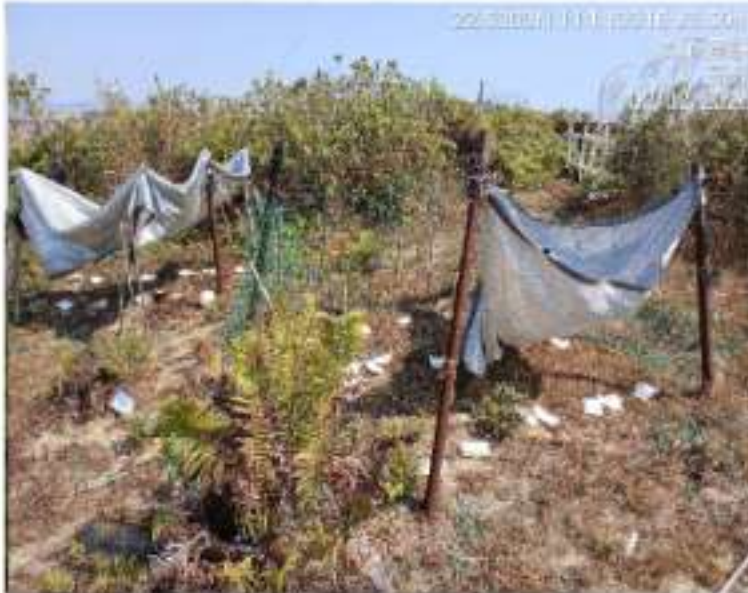
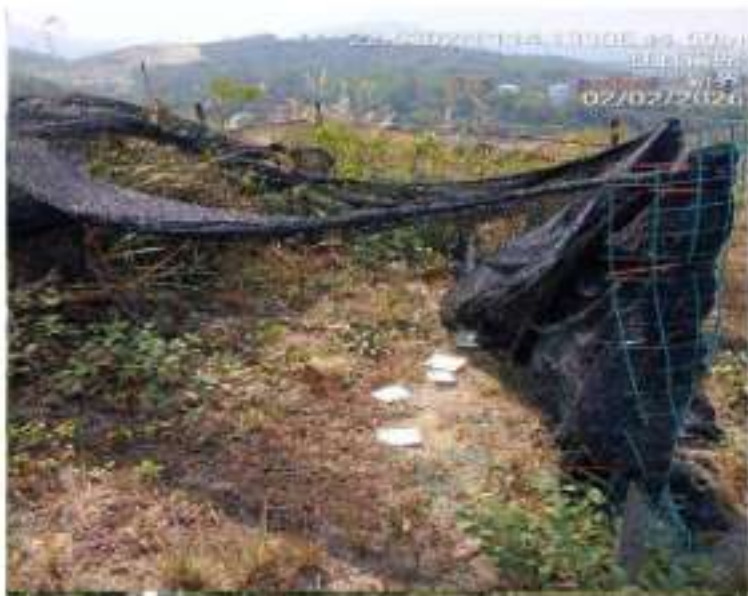
- 1) Please refer to the guidelines on soil improvement issued by the Greening, Landscape and Tree Management Section (GLTMS) of the development bureau (2022) to apply to monitoring and maintenance of transplanted flora species.
- 2) Daily watering frequency is needed to keep the soil moist.
- 3) The Damaged Sun Shade Net is replaced
- 4) The installation of a shaded net is shown as a sample below

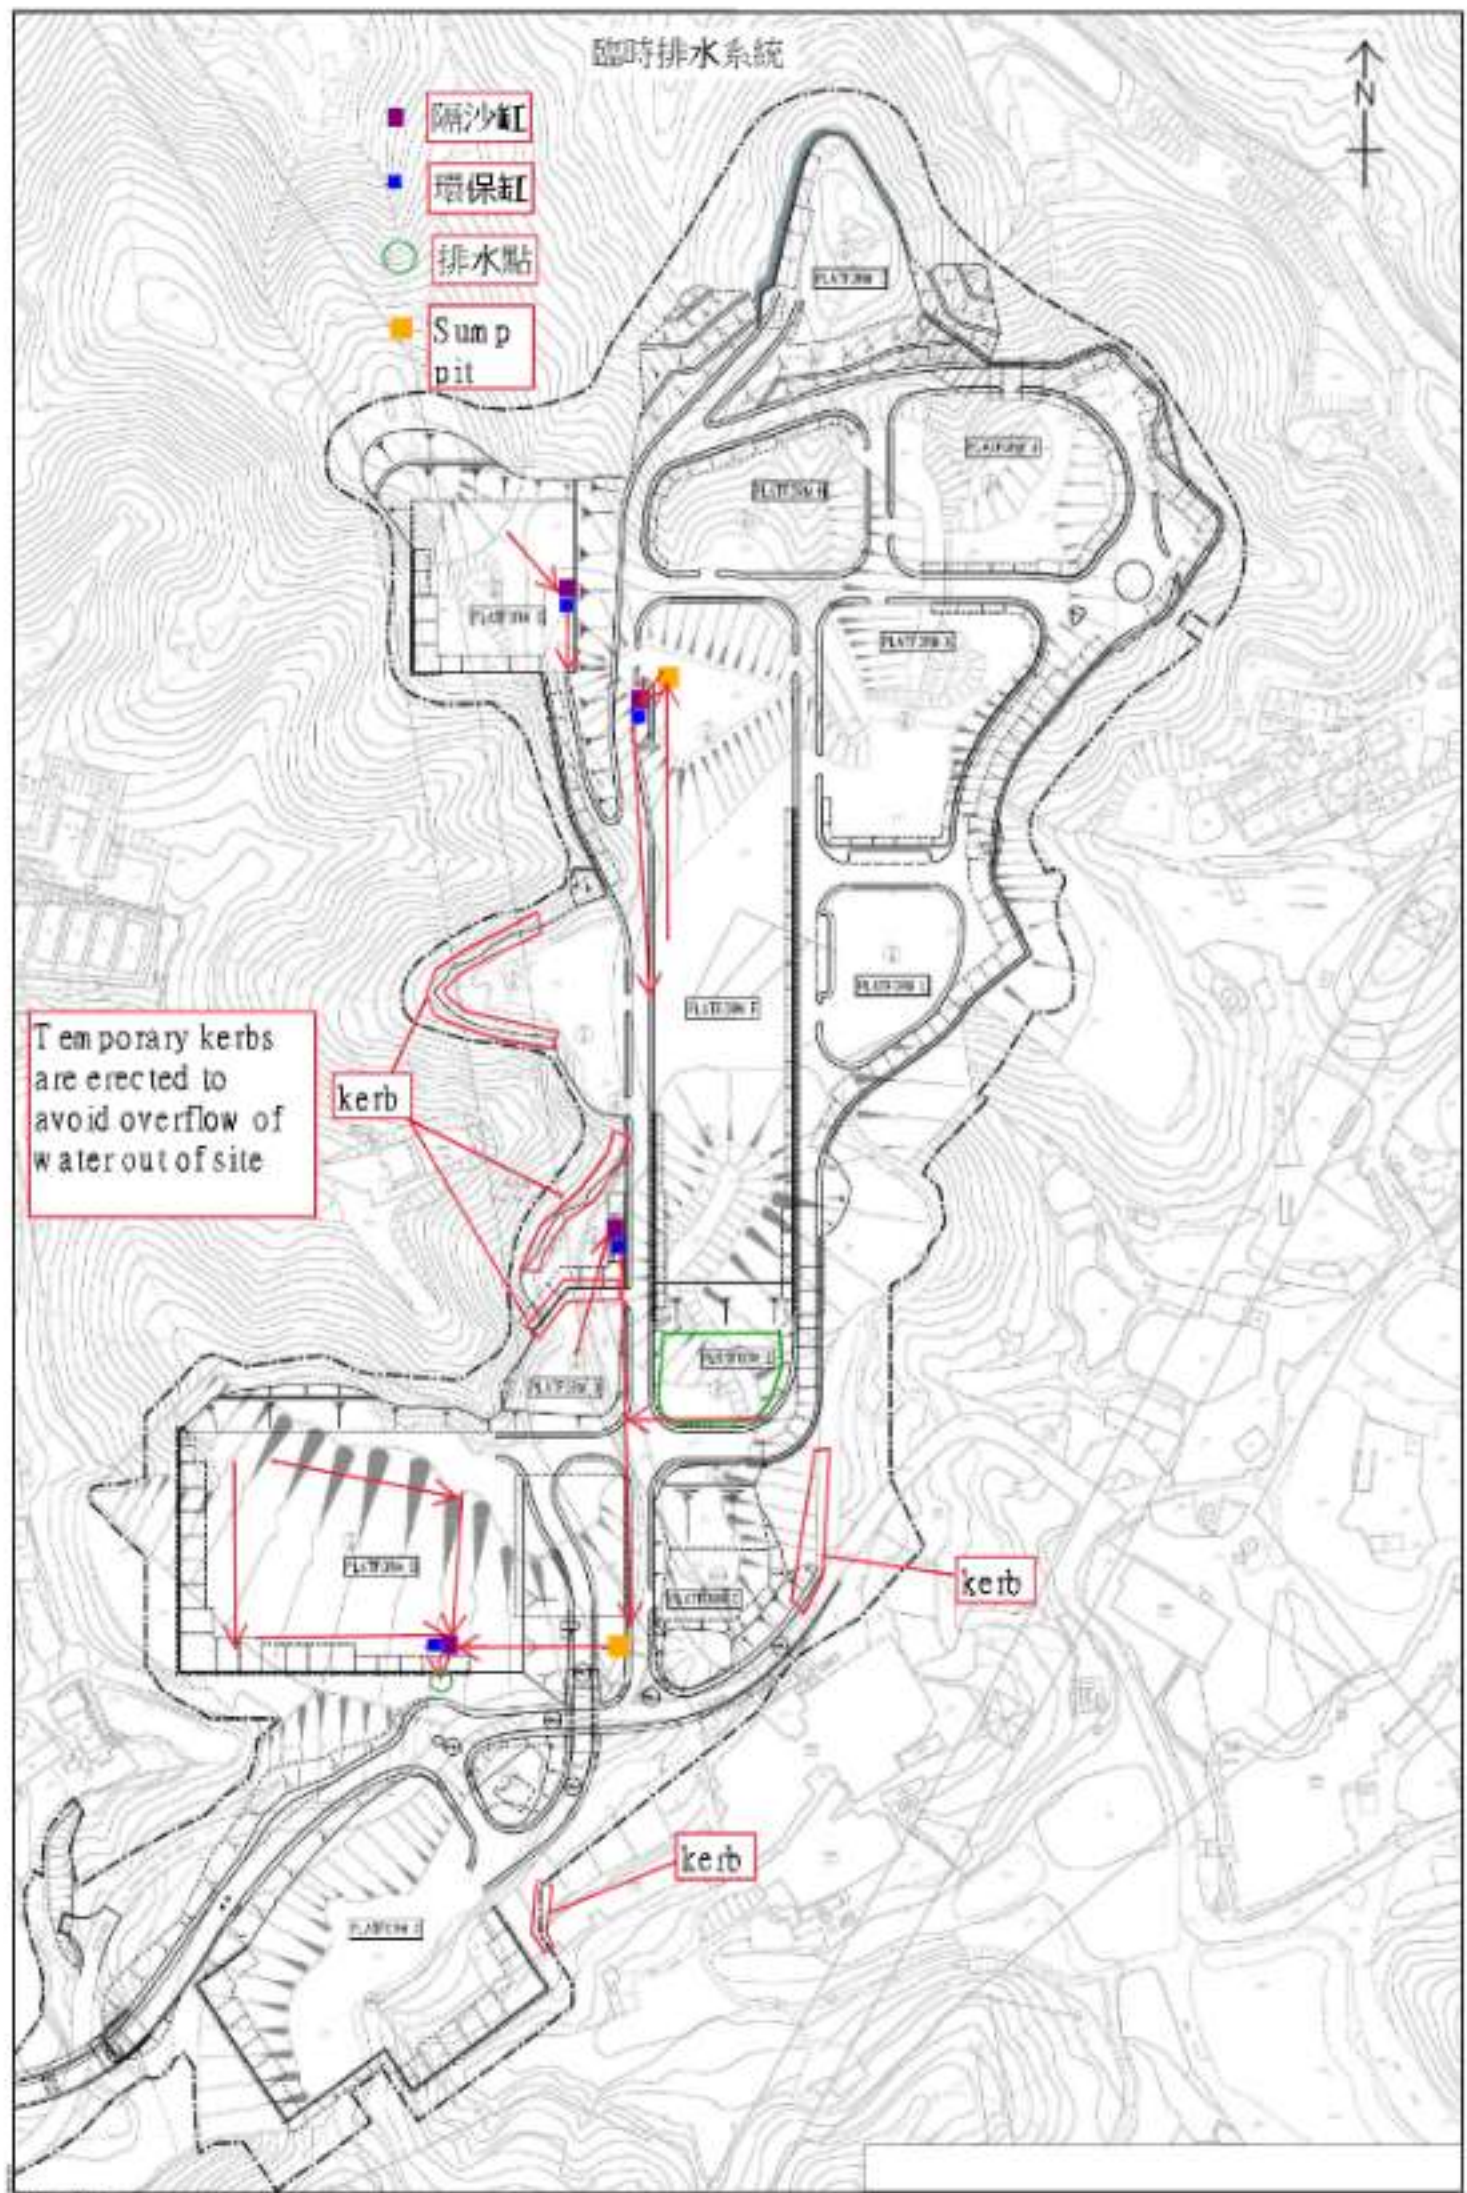
- 隔沙缸
- 環保缸
- 排水點
- Sump pit

Temporary kerbs are erected to avoid overflow of water out of site
