Re: Contract No. SS K/509
Provision of Independent Environmental Checker Consultancy for Design
and Construction of Kong Nga Po Police Training Facilities
Verification of Monthly EM&A Report (March 2026)

**Provision of Environmental Team consultancy
for Design and Construction of Kong Nga Po Police
Training Facilities (Programme No. 279LP)**

**Monthly Environmental Monitoring and
Audit Report for March 2026
(Version 1.1)**

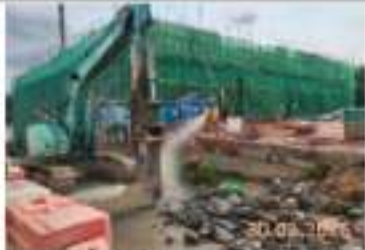
Ref*	Proposed Construction Method	Location/Working Period	Anticipated Major Impacts	Recommended Mitigation Measures	Photo Records (Partial)
EIA 3.9.1: EMS&A Log 1.2	Open cut excavation	Kong Nga Po Site	Dust Impact	<ul style="list-style-type: none"> • Manual water spraying for dust suppression • Regular inspection and maintenance of plant and equipment in good condition • Cover stockpile with impervious sheets or grout • Provide wheel washing facility at site entrance

<p data-bbox="1117 601 1386 622">By subcontractor at XNP site</p>

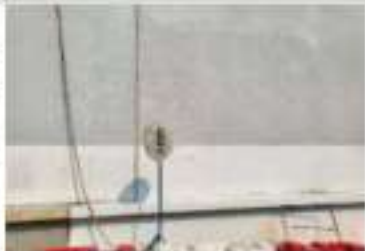
<p>By subcontractor at KNP site</p>
EIA 3.9.1; EM&A Log 1.2	Soil Removal	Kong Nga Po Site	Air	<ul style="list-style-type: none"> • Deploy water bowser for regular water spraying to enhance dust suppression • Cover dusty materials with impervious sheets • Exposed slopes covered with waterproof layers such as tarpaulin sheets or grout to reduce the potential for sediment laden runoff entering

<p>By main contractor at KNP site</p>

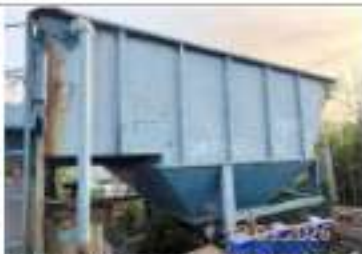
- Cover exposed slopes with impervious sheets or cement grout.
- Wastewater pumped out of the excavation areas shall be treated to remove suspended solid prior to discharge.
- Provide desilting/ sedimentation devices for wastewater treatment prior to discharge.
- Provide drip tray to prevent spillage of fuels

By main contractor at KNP site

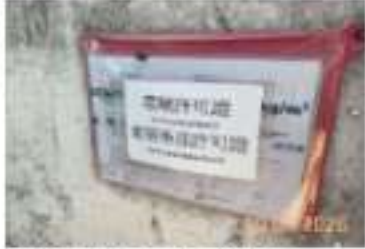
<p>EIA 4.4.6; EM&A Log 3.2</p>			<p>Noise</p>	<ul style="list-style-type: none"> Valid construction noise permit should be obtained and displayed on site

<p>By main contractor at KNP site</p>
<p>EIA 5.6.1.3 and EM&A Log 4.2</p>			<p>Water Quality</p>	<ul style="list-style-type: none"> Surface water from concrete batching areas and the rest of the site should be separated as far as possible. Temporary drainage is free of obstruction. Gullies are sealed to prevent silt or debris from entering the drainage system.

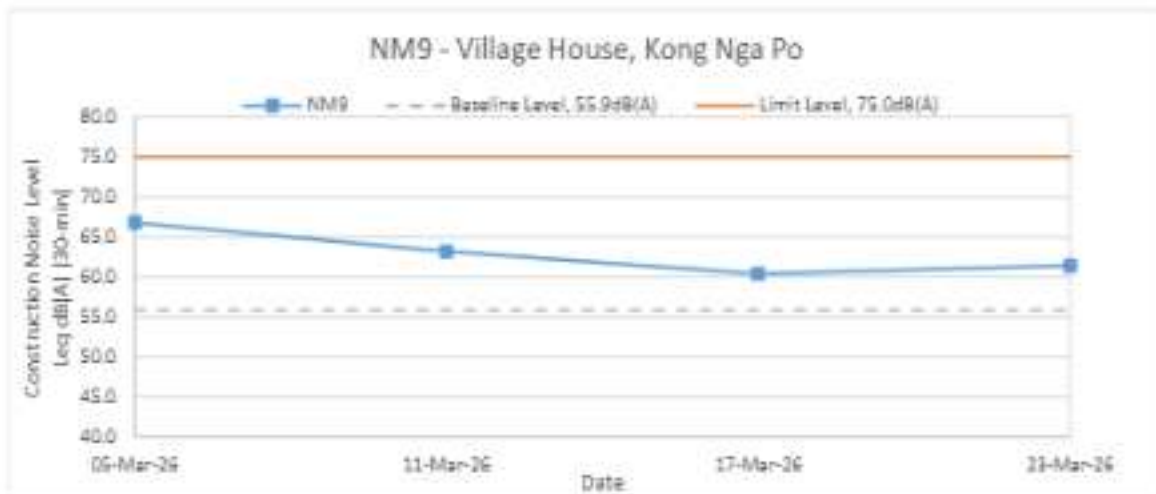
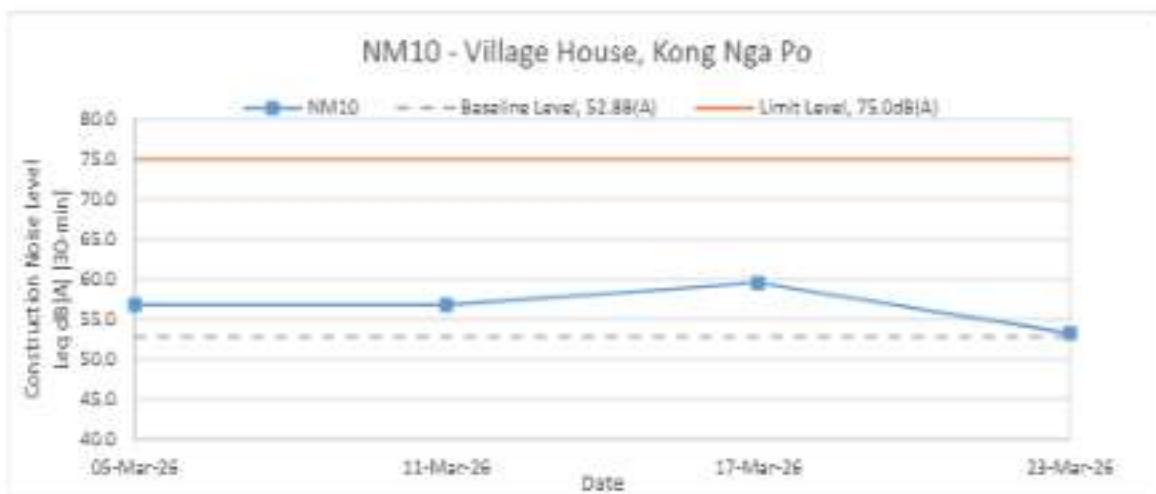
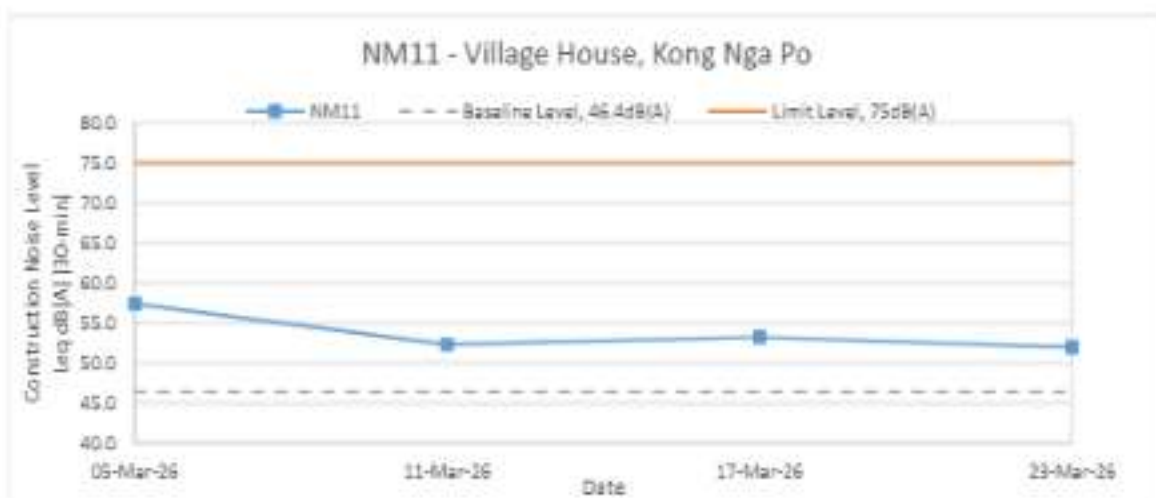
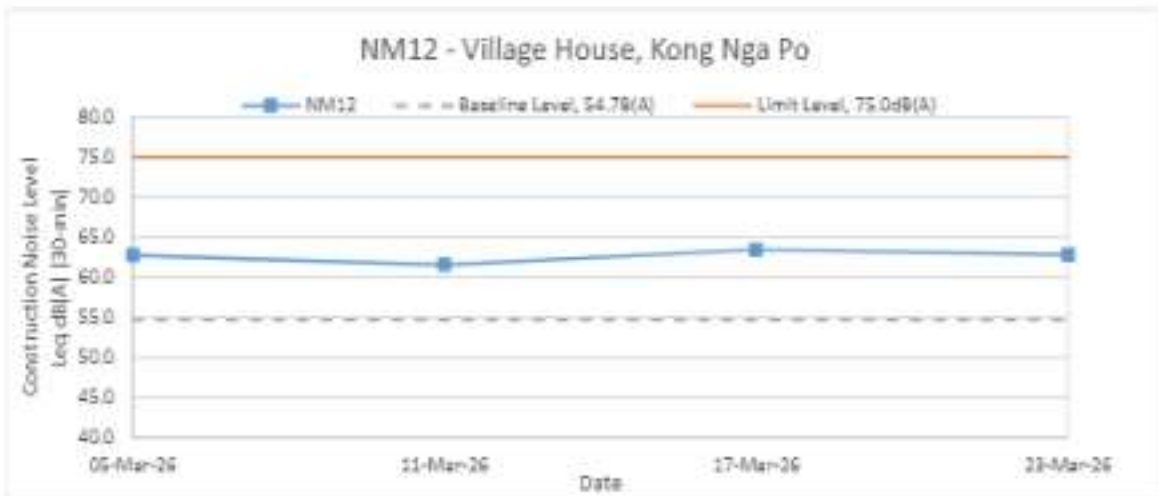
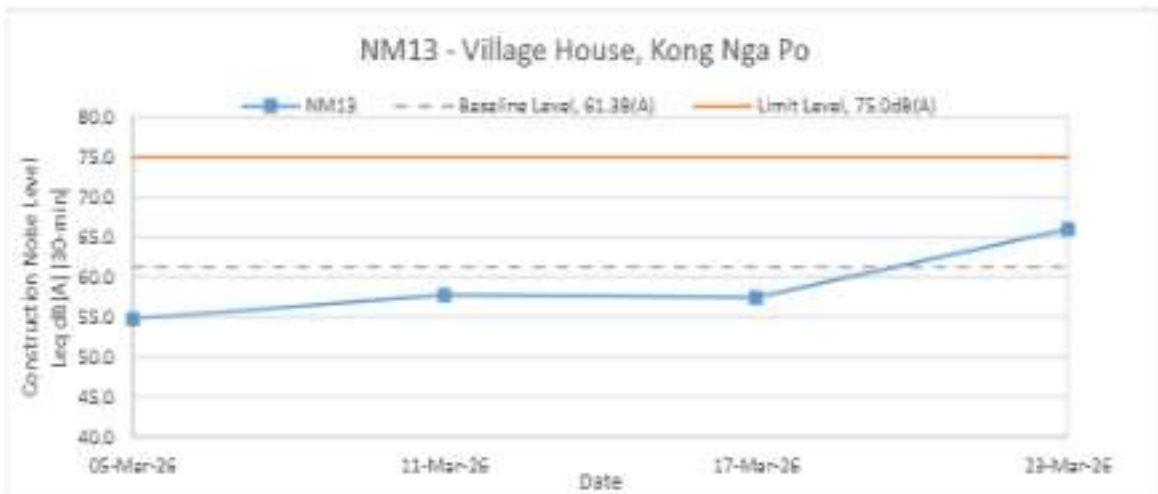
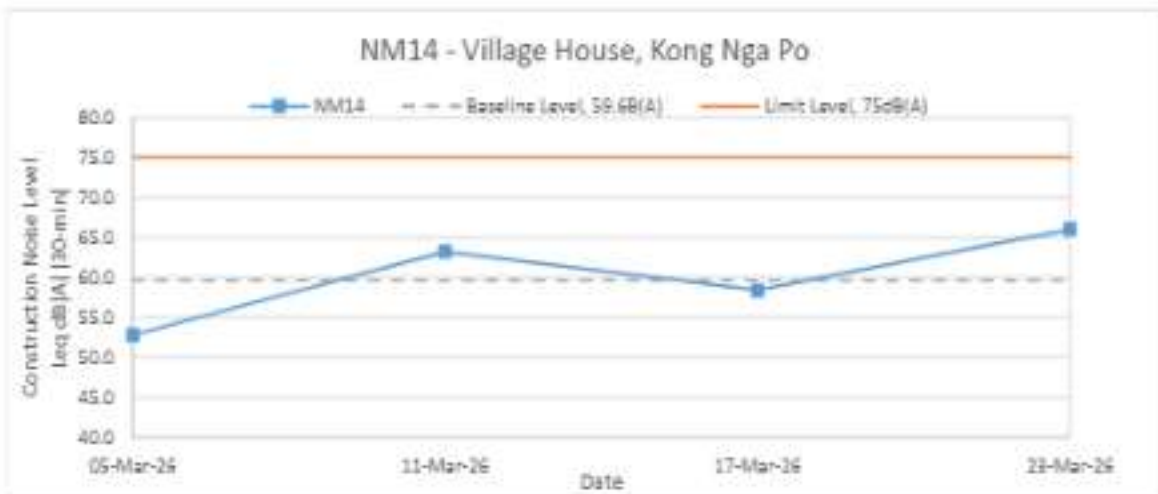
Noise Levels

Date	Weather	Wind Speed (m/s)	Time	Unit: dB(A) (5-min)			Average L_{90}	Limit Level L_{90}	Baseline L_{90}
				L_{10}	L_{50}	L_{90}			
05-Mar-26	Sunny	0.00	13:51	58.8	56.9	46.3	52.8	75.0	59.6
				49.3	52.3	43.1			
				48.8	51.5	40.9			
				49.8	53.0	43.0			
				48.3	51.5	41.9			
				47.6	51.6	40.0			
11-Mar-26	Sunny	0.08	14:04	62.4	56.7	41.0	63.2	75.0	59.6
				66.9	53.2	46.6			
				61.8	66.1	46.6			
				56.7	58.9	46.9			
				62.6	65.9	48.1			
				63.3	58.8	50.7			
17-Mar-26	Sunny	0.10	13:48	56.3	54.4	49.1	58.4	75.0	59.6
				51.3	52.7	49.0			
				51.2	52.0	49.9			
				51.4	52.6	48.8			
				52.1	52.7	50.1			
				65.0	66.9	49.3			
23-Mar-26	Sunny	0.08	13:40	58.7	57.2	48.3	66.0	75.0	59.6
				53.3	52.7	48.7			
				73.3	58.6	48.4			
				49.9	51.3	48.2			
				59.8	55.7	49.4			
				58.4	55.4	49.2

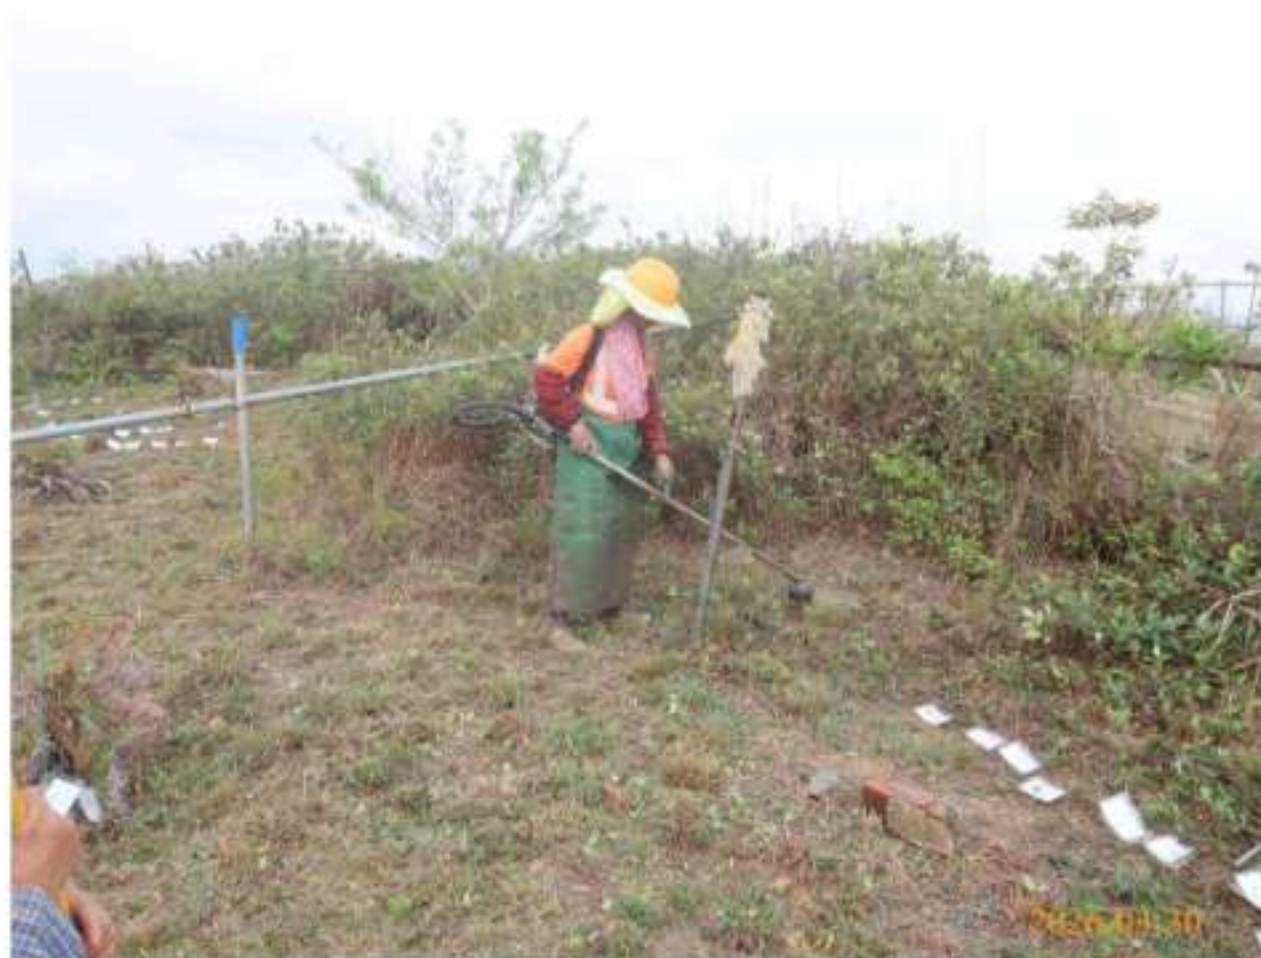
Maintenance work (1)

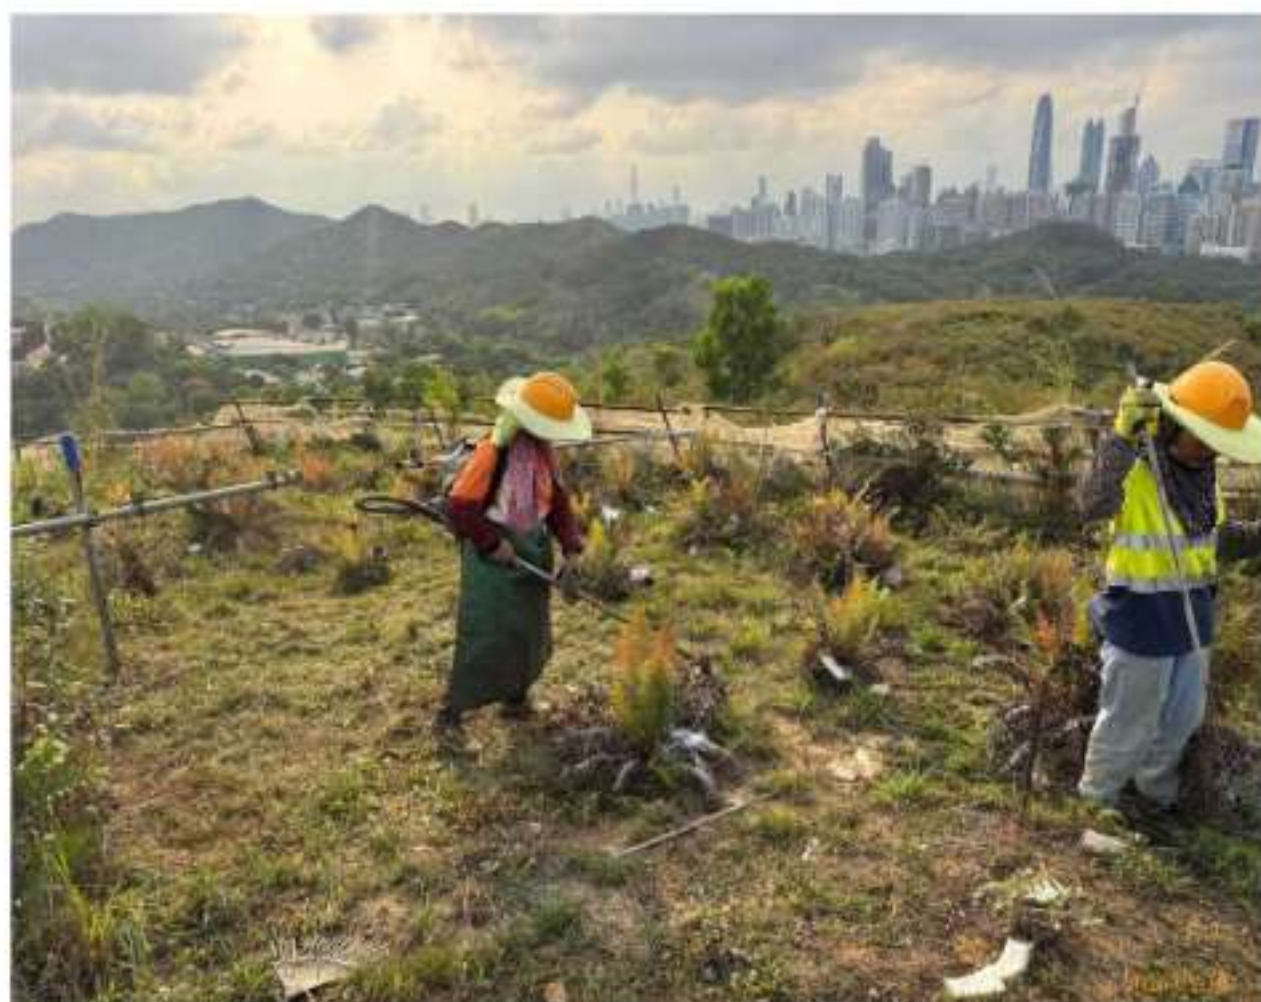
Maintenance work (2)

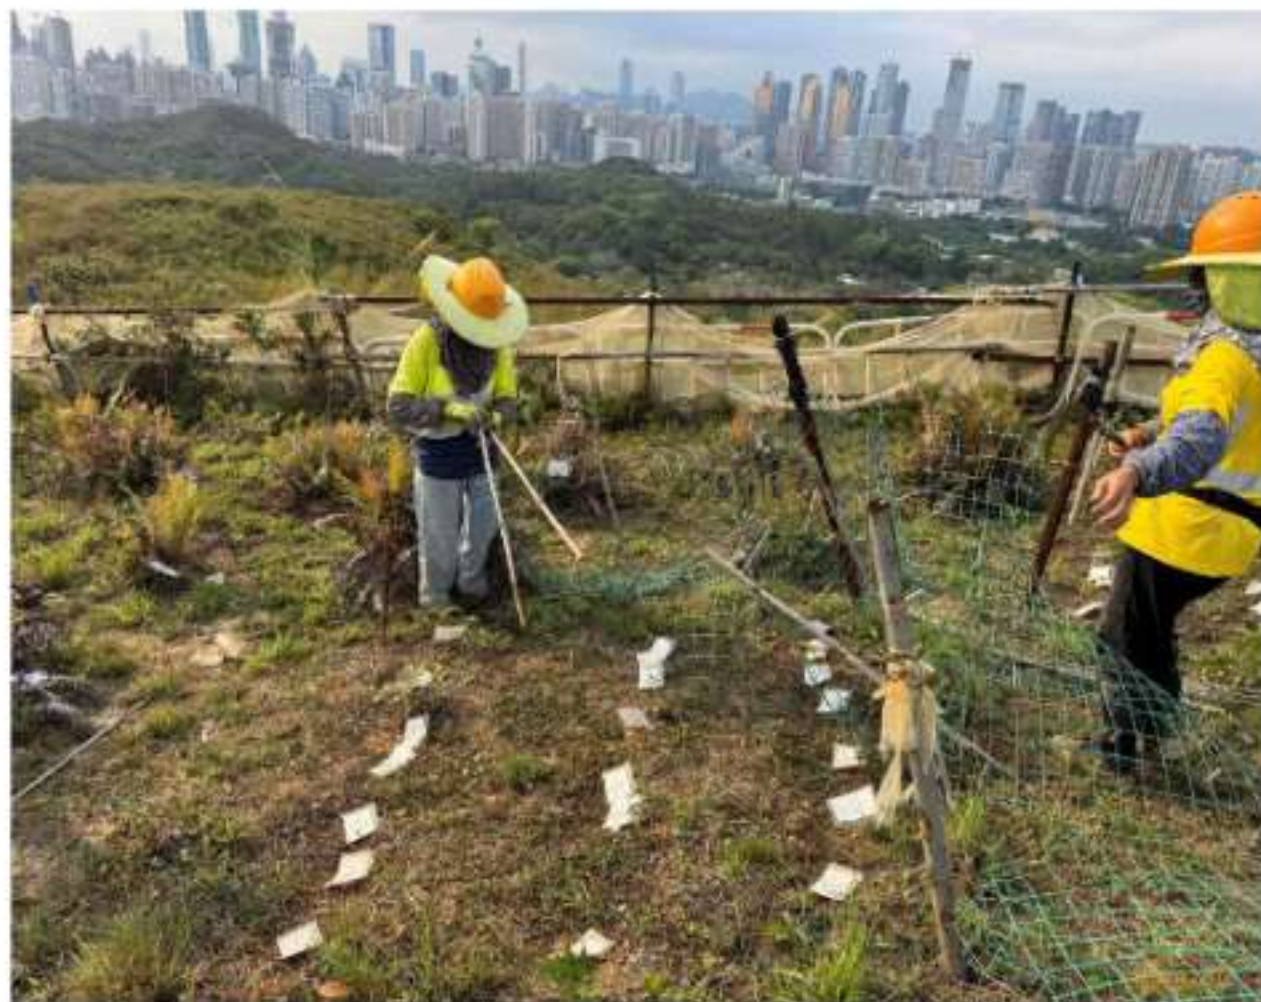
Maintenance work (3)

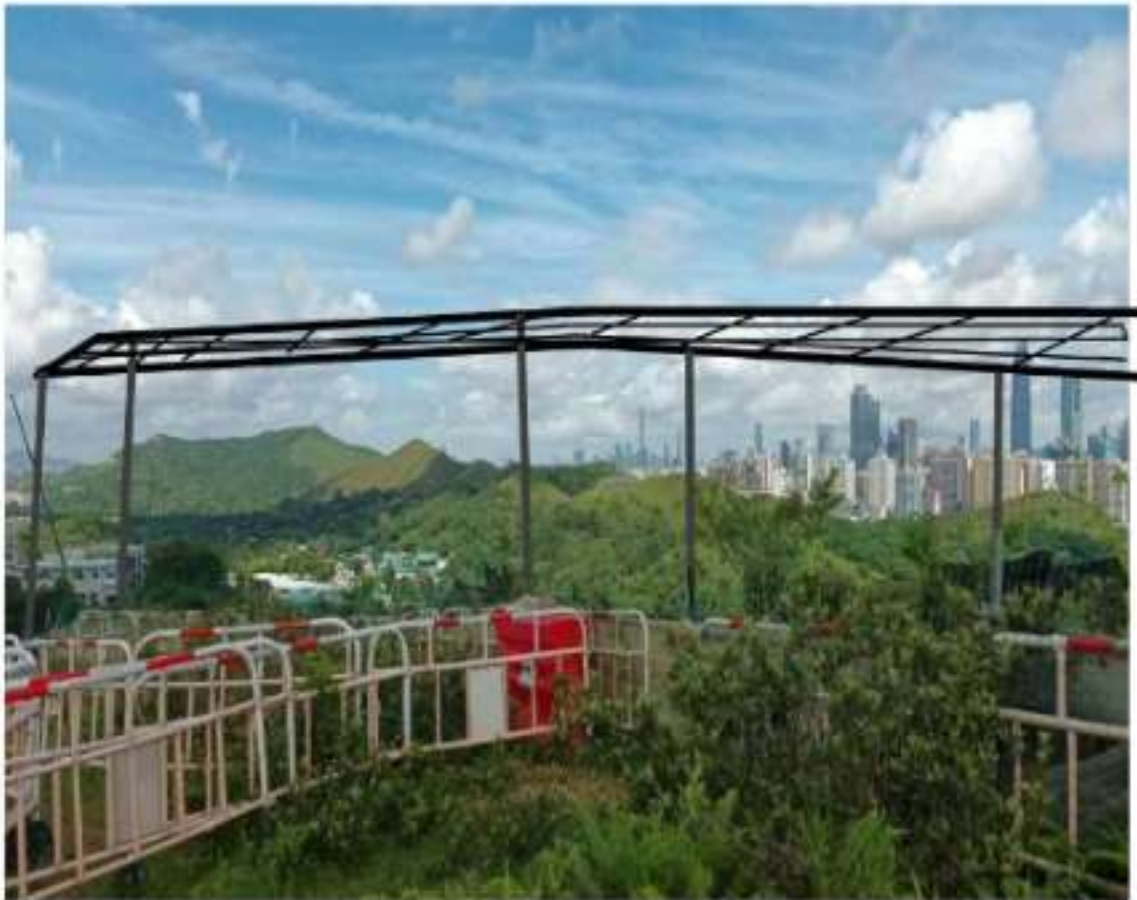
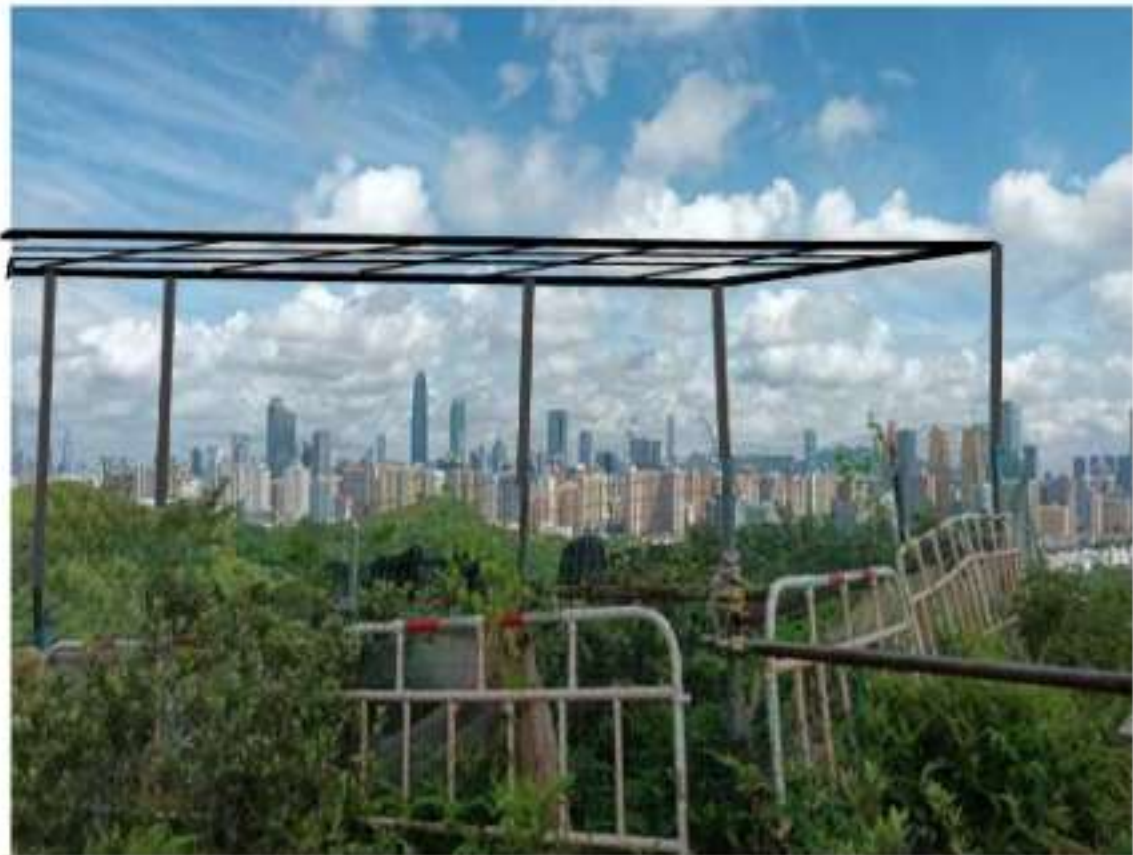
The installation of a shaded net

Remark: Non scale & Conceptual drawing

- 1) Please refer to the guidelines on soil improvement issued by the Greening, Landscape and Tree Management Section (GLTMS) of the development bureau (2022) to apply to monitoring and maintenance of transplanted flora species.
- 2) Daily watering frequency is needed to keep the soil moist.
- 3) The Damaged Sun Shade Net is replaced
- 4) The installation of a shaded net is shown as a sample below
