**Re: Contract No. SS K/509**  
**Provision of Independent Environmental Checker Consultancy for Design**  
**and Construction of Kong Nga Po Police Training Facilities**  
**Verification of Monthly EM&A Report (May 2026)**

**Provision of Environmental Team consultancy  
for Design and Construction of Kong Nga Po Police  
Training Facilities (Programme No. 279LP)**

**Monthly Environmental Monitoring and  
Audit Report for May 2026  
(Version 1.1)**

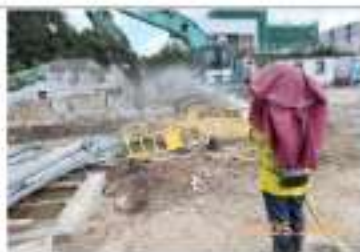
| Ref* | Proposed Construction Method | Location/Working Period | Anticipated Major Impacts | Recommended Mitigation Measures | Photo Records (Partial) |
|---|---|---|---|---|---|
| EIA 3.9.1;<br>EM&A Log<br>2.2 | Open cut excavation | Kong Nga Po Site | Dust Impact | <ul style="list-style-type: none"> <li>Manual water spraying for dust suppression</li> <li>Regular inspection and maintenance of plant and equipment in good condition</li> <li>Cover stockpile with impervious sheets or grout</li> <li>Provide wheel washing facility at site entrance</li> </ul> | <p>By subcontractor at KNP site</p> |

By subcontractor at KNP site
