**Re: Contract No. SS K/509  
Provision of Independent Environmental Checker Consultancy for Design  
and Construction of Kong Nga Po Police Training Facilities  
Verification of Monthly EM&A Report (June 2026)**

**Provision of Environmental Team consultancy  
for Design and Construction of Kong Nga Po Police  
Training Facilities (Programme No. 279LP)**

**Monthly Environmental Monitoring and  
Audit Report for June 2026  
(Version 1.1)**

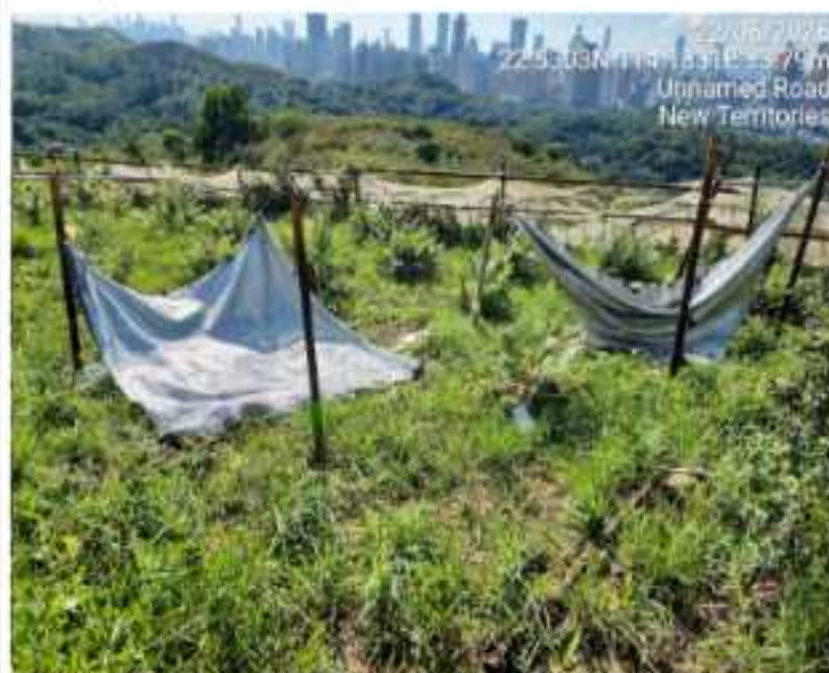
| Parameters | Date | Observations | Advice |
|---|---|---|---|
| Other | 22-6-2026 | Sun Shade Nets are in damage | Damaged Sun Shade Net is replaced |

The Damaged Sun Shade Net is replaced
