Provision of Independent Environmental Checker Consultancy for Design and Construction of Kong Nga Po Police Training Facilities Verification of Monthly EM&A Report (August 2023)

Provision of Environmental Team consultancy for Design and Construction of Kong Nga Po Police Training Facilities (Programme No. 279LP)

Monthly Environmental Monitoring and Audit Report for August 2023 (Version 3)

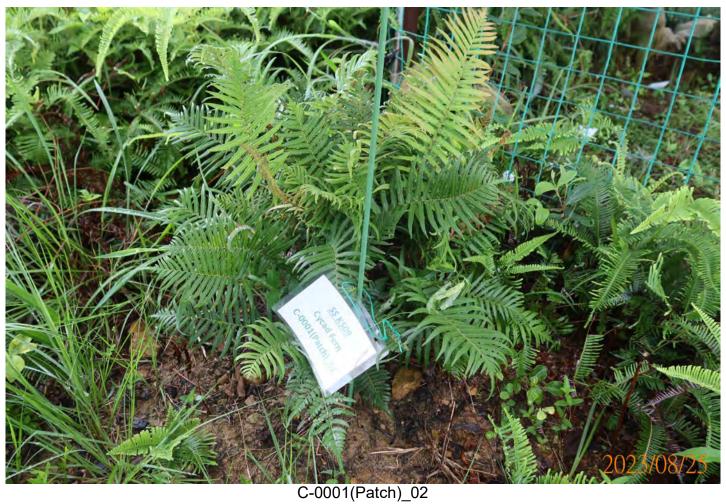
C-0001(Patch)_01

Tree/Plant/	Number of		Form	Health	
Colony No.	Individuals	Species Name	(Good/Fair/Poor)	(Good/Fair/Poor)	Remark
colony ive.	01	Brainea insignis	F	F	Young leaves observed
	02	Brainea insignis	F	F	Young leaves observed
	03	Brainea insignis	F	F	Young leaves observed
G 0001	04	Brainea insignis	F	F	Young leaves observed
C-0001	05	Brainea insignis	F	F	Young leaves observed
	06	Brainea insignis	F	F	Young leaves observed
	07	Brainea insignis	F	F	Young leaves observed
	08	Brainea insignis	F	F	Young leaves observed
	01	Brainea insignis	F	F	Young leaves observed
	02	Brainea insignis	F	F	Young leaves observed
	03	Brainea insignis	F	P	Young leaves observed
	04	Brainea insignis	F	P	Young leaves observed
C-0002	05	Brainea insignis	F	F	Young leaves observed
	06	Brainea insignis	F	F	Young leaves observed
	07	Brainea insignis	F	F	Young leaves observed
	08	Brainea insignis	F	F	Young leaves observed
C-0003	01		F	F	Young leaves observed

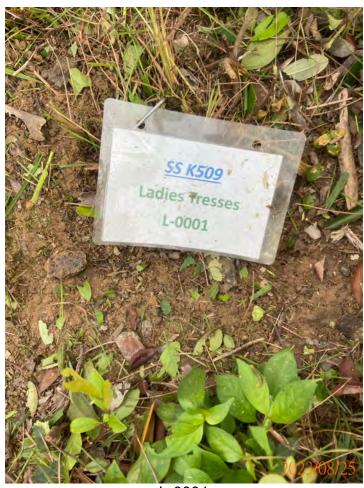
L-0001

L-0021	Spiranthes sinensis	-	-	Not observed
L-0022	Spiranthes sinensis	F	F	Leaf observed
L-0023	Spiranthes sinensis	-	-	Not observed
L-0024	Spiranthes sinensis	P	P	Leaf observed
L-0025	Spiranthes sinensis	-	-	Not observed
L-0026	Spiranthes sinensis	-	-	Not observed
L-0027	Spiranthes sinensis	-	-	Not observed
L-0028	Spiranthes sinensis	-	-	Not observed
L-0029	Spiranthes sinensis	-	-	Not observed
L-0030	Spiranthes sinensis	-	-	Not observed
L-0031	Spiranthes sinensis	F	F	Leaf observed
L-0032	Spiranthes sinensis	-	-	Not observed
L-0033	Spiranthes sinensis	-	-	Not observed
L-0034	Spiranthes sinensis	-	-	Not observed
L-0035	Spiranthes sinensis	-	-	Not observed
L-0036	Spiranthes sinensis	-	-	Not observed
L-0037	Spiranthes sinensis	P	P	Leaf observed
L-0038	Spiranthes sinensis	-	-	Not observed
L-0039	Spiranthes sinensis	-	-	Not observed
L-0040	Spiranthes sinensis	F	F	Leaf observed
L-0041	Spiranthes sinensis	-	-	Not observed

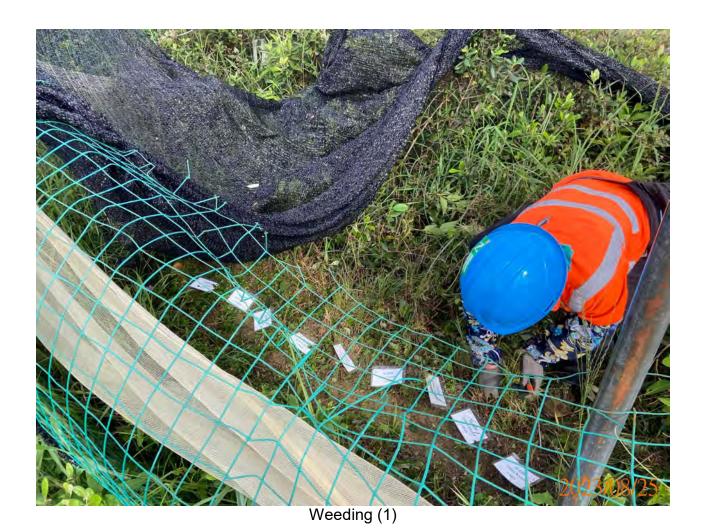
Rectify guard fence

Weeding (2)
